Pre-purchase Home Inspection Report

23 year old 2,500 square foot house with spa

Steve Garcia Inspections

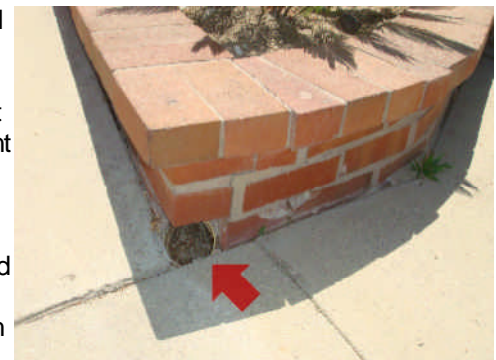
[CR] One grate screens is missing at the right front suspected drain pipe termination adjacent to the planter.

[FE] The drain system at one or more of the grates is dirty or clogged with debris and would be ineffective during rains. I recommend all debris be removed rather than flushed through the piping if possible and all drains should be cleaned on a regular basis.

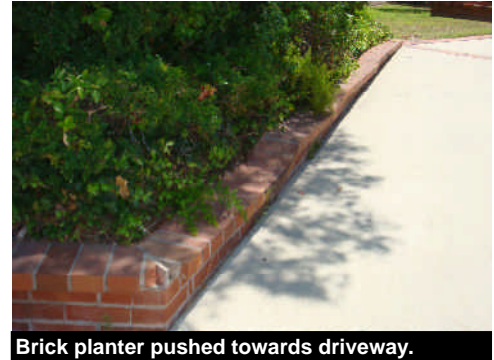
[CR] The driveway bricks have settled at areas, and the mortar is broken. Small section of the concrete is broken.

Brick planter pushed towards driveway.

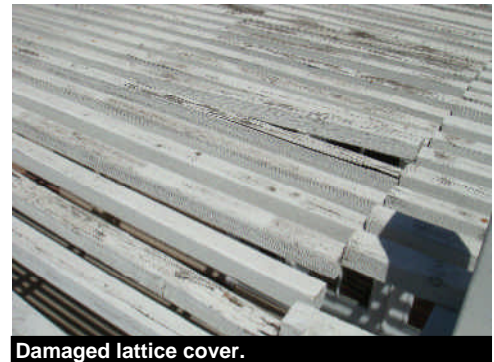
Damaged lattice cover.

[FE] Damage/deterioration is evident on the patio lattice cover.

[RU] I recommend removing the weathered and damaged lattice cover, painting the framing and replacing the lattice with plastic lattice.

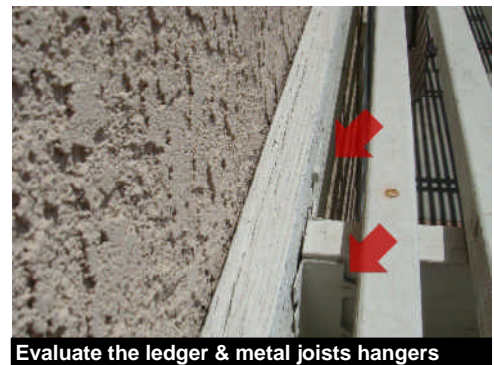
[FE] The framing ledger board is lag screwed onto the stucco surface. The fastening of the ledger board is suspect.

Evaluate the ledger & metal joists hangers

There is no flashing between the patio framing ledger and the stucco wall. This condition could be conducive to moisture intrusion into the interior wall from the lag screws.

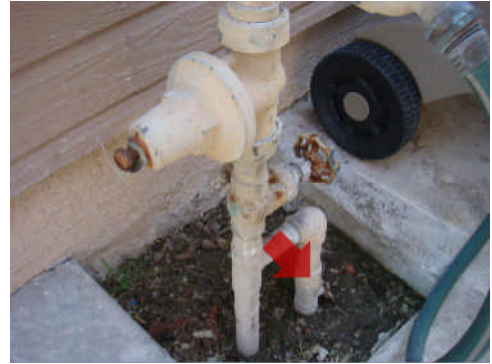
[CR] The sprinkler water supply valve is improperly in the soil.

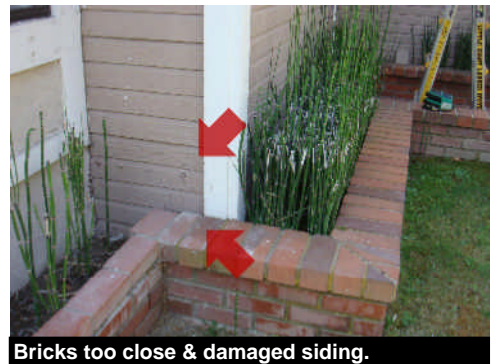
[CR] The brick planter is too close to the siding, and should be removed to prevent additional damage to the wall /siding.

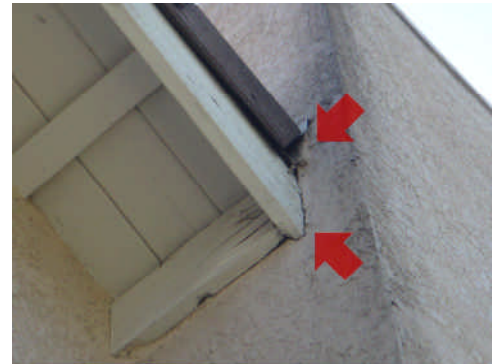
[CR] The right side fascia board is improperly into the stucco wall, and the adjacent board is moisture damaged.

[FE] The roof flashing appears to have been installed improperly, should be evaluated, and the fascia board cut back.

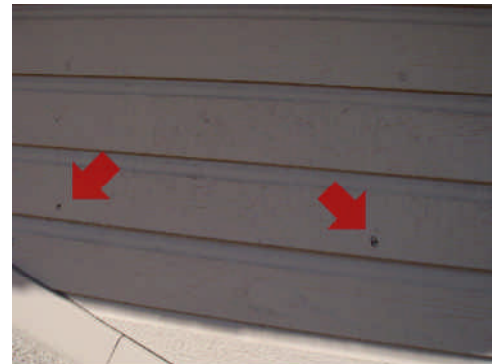
[CR] The manufactured siding is loose, and moisture damaged at areas. This condition is conducive to moisture intrusion/deterioration.

[FE] There are under-driven and overdriven fasteners evident. This condition is conducive to moisture intrusion and deterioration of the siding.

The overdriven fasteners should be caulked and painted, and exposed fasteners driven flush with the siding.

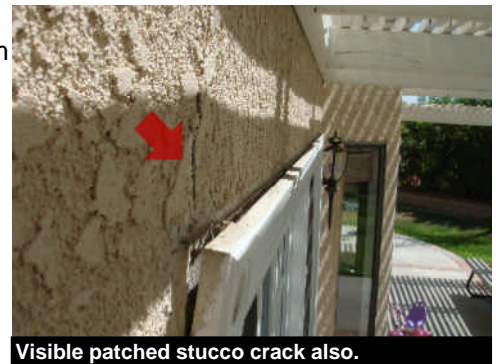
[CR] There is no metal flashing installed behind the siding and on top of the family room door trim /casing. This condition is conducive to moisture intrusion.

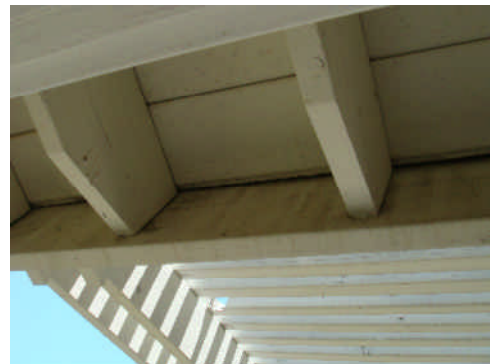
[FE] The rear left eave has moisture stains inside. This condition is typically from the tile roof underlayment has deteriorated and no longer is water proof.

This condition is typical due to the starter tiles are supported by the fascia boards fastened above the roof deck edge.

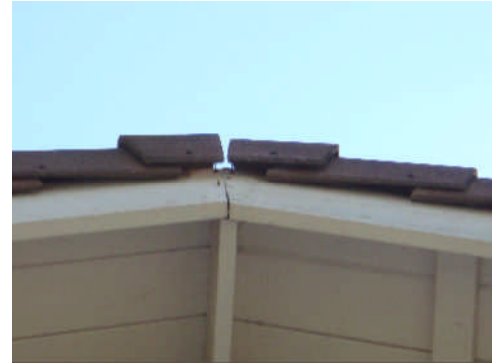
[CR] The fascia boards butt joints should be fastened properly, caulked and painted at the ridges.

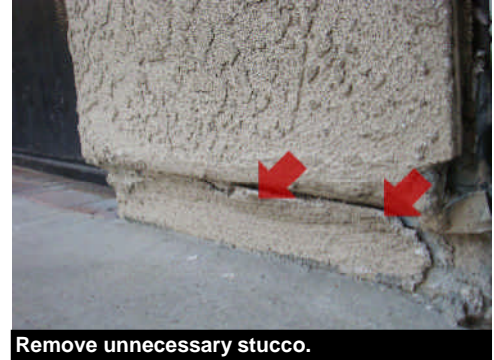
- 401 EXTERIOR** The stucco adjacent to the rear door is loose and should be removed from the foundation and stucco screed.

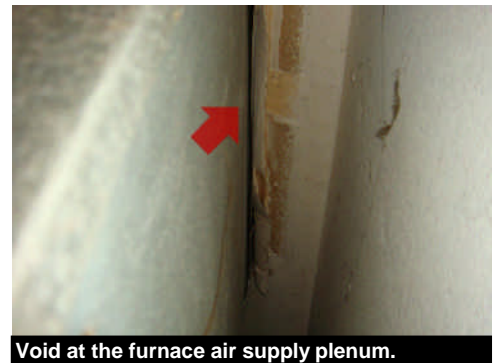
[SC] There are holes and voids in the fire separation walls /ceiling between the garage and joining living space.

Approved fire rated caulking is recommend at all of the penetrations /pipes.

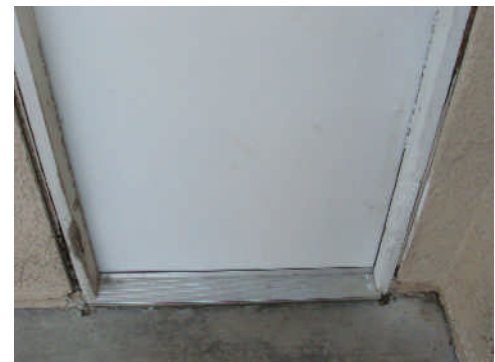
[CR] The garage door stucco molding has been removed and the door jambs have hungry dog damage.

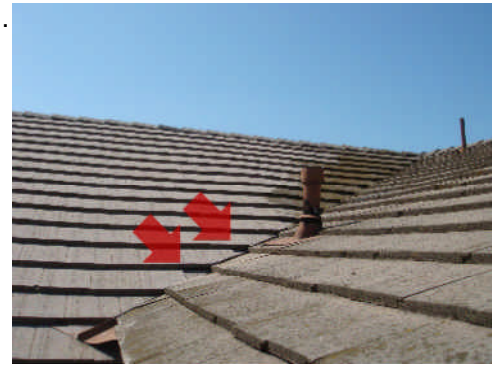
[FE] The front upper valley has discolored tiles. The home owner stated the area leaked and was repaired. The bedroom ceiling below has visible patching.

[FE] The tiles have small cut tiles in the valley. The small tiles laying in the valley could direct the water runoff laterally /improperly.

[FE] Moisture stains are evident on the living room ceiling.

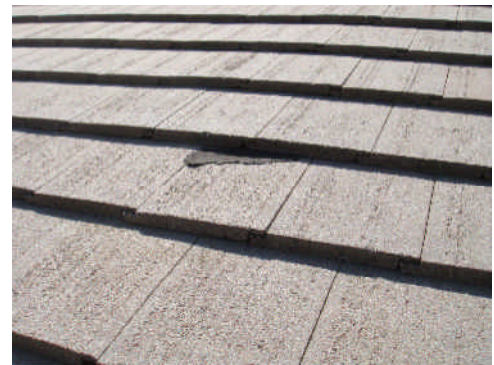
[CR] Patched broken tile at the front left.

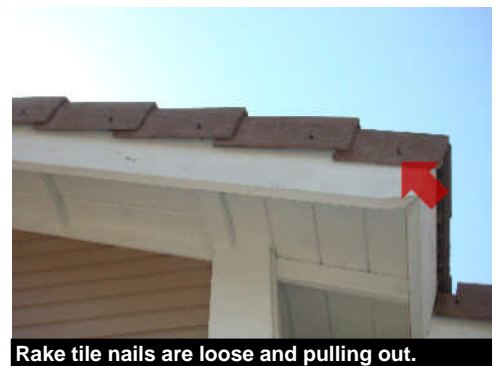
516 COMMENTS [CR] The rake or ridge tiles are missing at the left and right sides.

[FE] The rake tile fasteners should be evaluated due to rusting and pulling out.

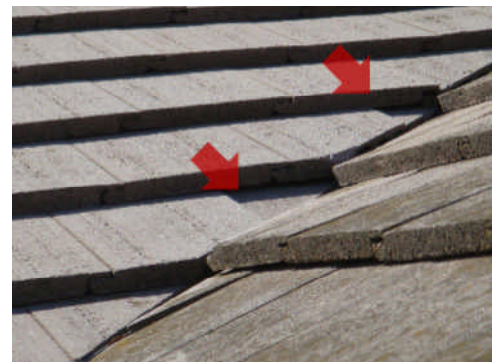
[CR] The valley flashings have small cut tiles in the valley.

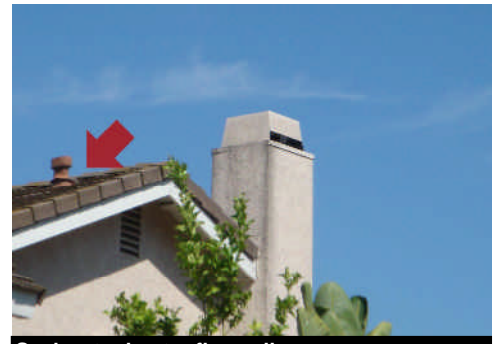
[CR] The right side water heater flue has water stains in the closet ceiling. The flue collar is not sealed.

Seal water heater flue collar.

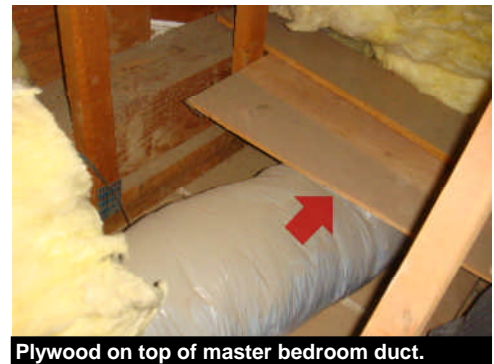
Plywood on top of master bedroom duct.

Remove the scrap plywood from the duct.

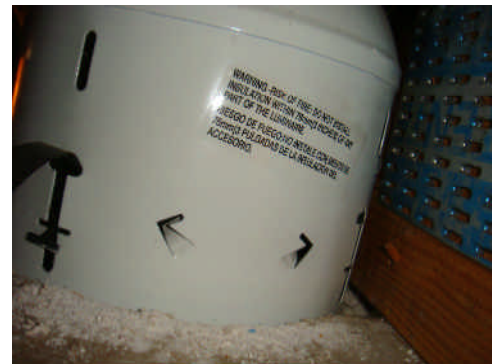
612 COMMENTS The added /updated hallway recessed can lights are not IC rated for insulation contact.

[RU] I recommend replacing the non-IC rated fixtures with IC rated can lights for energy efficiency.

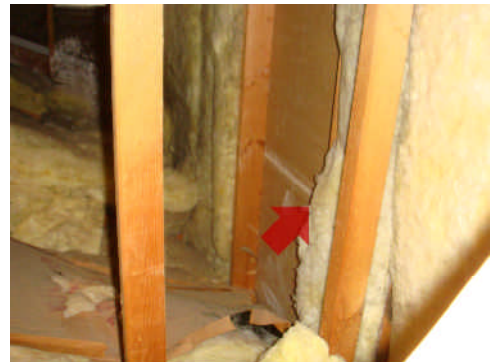
618 INSULATION [CR] The insulation is out of place/missing in areas. This condition minimizes the overall value of the insulation.

[CR] The master bedroom vaulted wall insulation is not secured in place and missing sections.

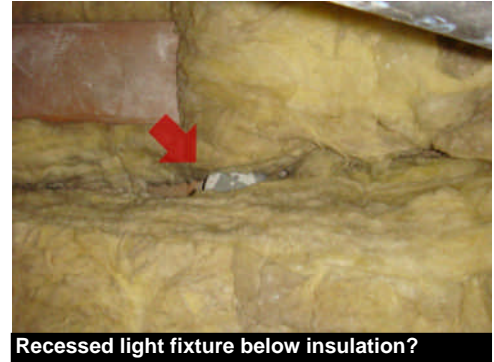
619 COMMENTS [FE] The insulation is in contact and covering the recessed luminaries [lighting fixtures]. It is unknown if the ceiling recessed light fixtures are "IC-rated for insulation contact. I recommend the trims and bulb be removed to expose the manufactures label to determine the rating.

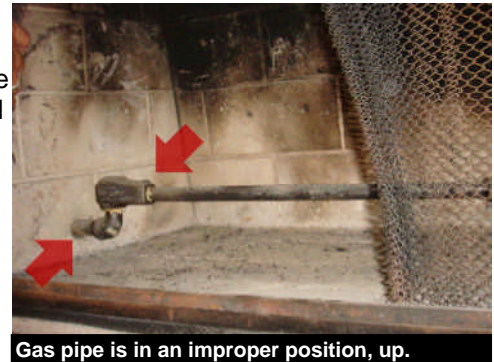
[SC] The gas pipe is not sealed properly at the wall where it enters the firebox. Sealed around with proper material.

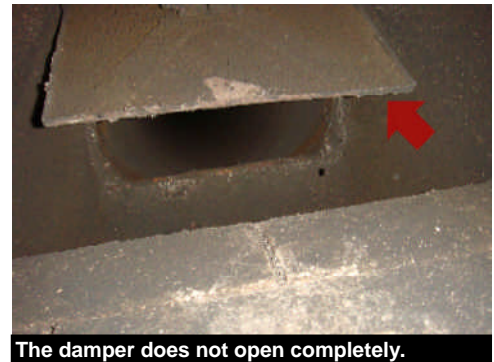
[FE] The top dome around the damper appears to be soiled or rusty, and the damper does not open completely.

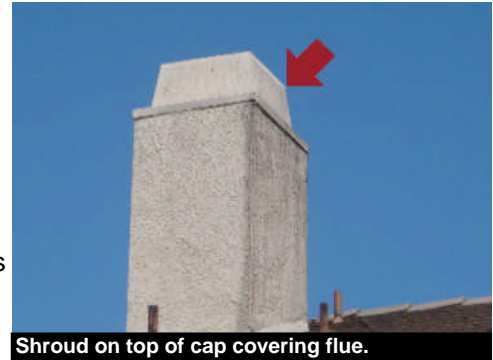
Shroud on top of cap covering flue.

I recommend an inspection by a qualified fireplace specialist. My inspection of the chimney flue is limited to the readily visible portion from the firebox and attic only. The inner reaches of the inner flue are inaccessible. A qualified fireplace specialist will remove the flue cap and use a specialized video camera as needed to evaluate the flue.

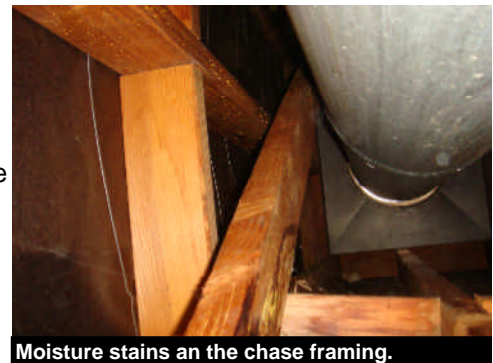
713 COMMENTS [FE] Moisture stains are evident in the flue chase. The chimney cap and collar should be evaluated for proper installation and maintenance.

[FE] The wood frame chase bracing clearance from the flue is suspect.

Moisture stains on the chase framing.

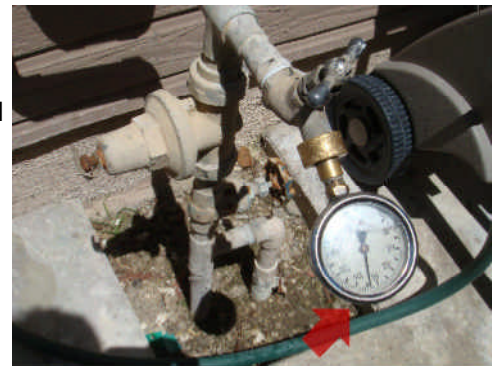
[CR] The static water pressure was measured at an exterior hose faucet and was 89 PSI. This condition can be conducive to plumbing leaks (pipes and faucets). I recommend installing, adjusting or replacing the pressure regulator to limit the water pressure to or below 60 PSI, or appliance design limits.

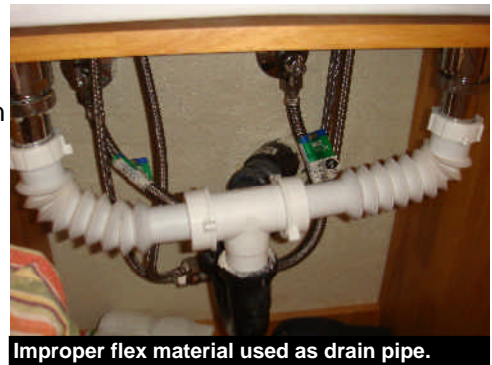
[CR] The kitchen sink drain leaks at the pipe to sink connection.

Improper flex material used as drain pipe.

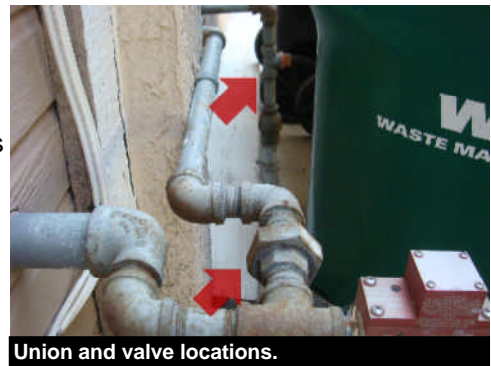
The valve should be before the union, to shut-off the gas if the union pipe connector leaks after seismic movement.

Union and valve locations.

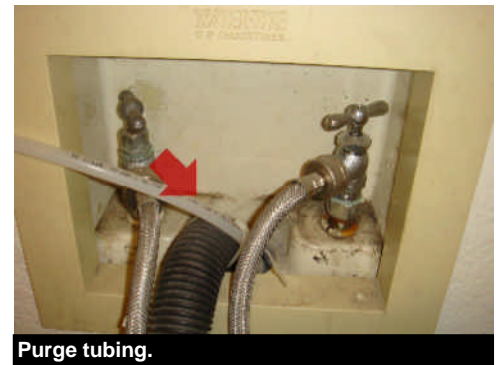
[CR] The purge tubing into the laundry drain pipe is lacking an air break /gap.

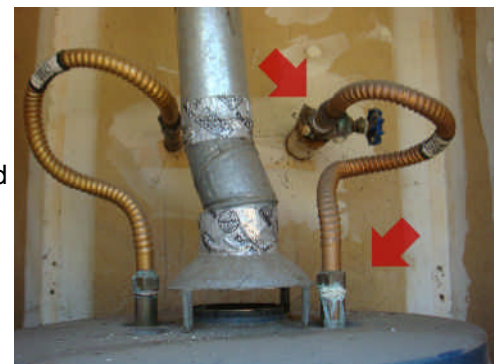
[RU] The water supply connectors are not insulated. I recommend insulating the exposed water piping to minimize heat loss.

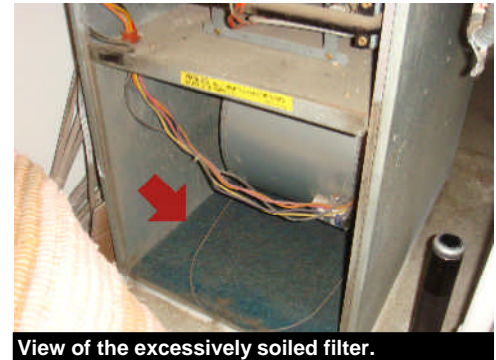
View of the excessively soiled filter.

The filter should be replaced with a pleated type filter every 6 mounts.

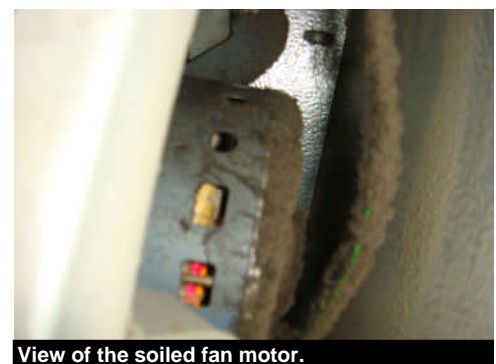
[CR] The blower compartment, blower and motor are dirty. This condition restricts the air flow and reduces the systems efficiency. I recommend having the system cleaned and serviced by a heating contractor /professional.

View of the soiled fan motor.

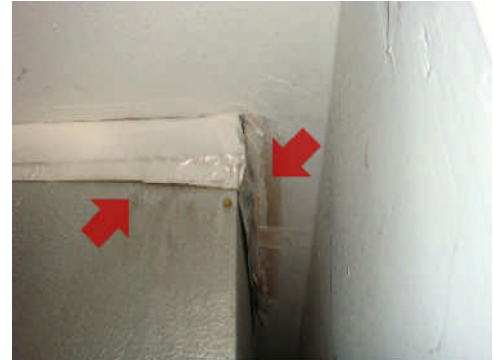
[SC] The plenum is not sealed at the ceiling. I recommend sealing with fire rated caulk.

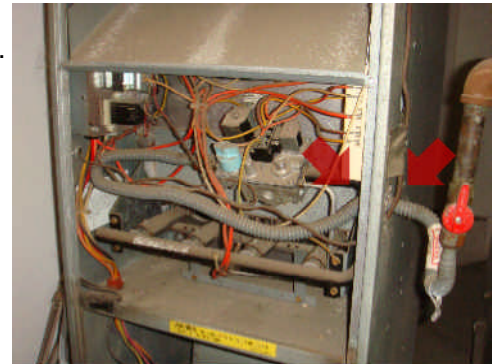
[CR] The furnace gas flex connector is not hard piped through the furnace housing.

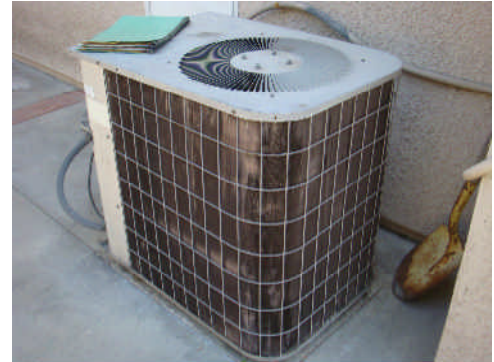
[FE] A number of the coil fins of the condensing unit are damaged/bent. This condition reduces the units overall performance.

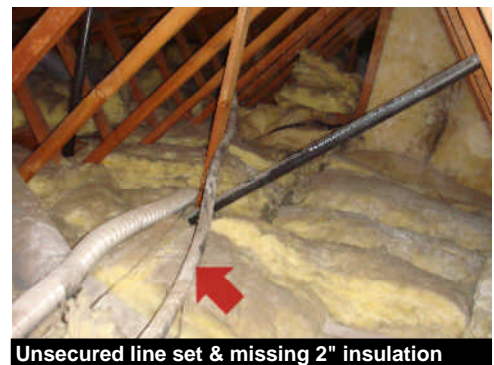
[CR] The coolant lines wall flashing is not sealed where they entered the building to prevent rodent access.

Unsecured line set & missing 2" insulation

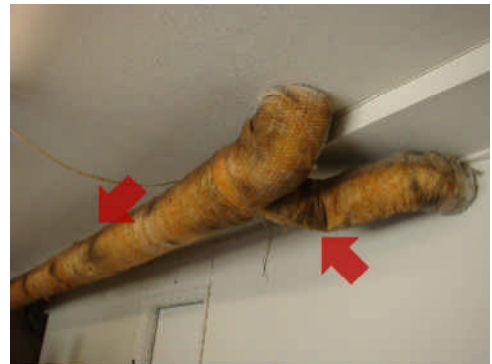
[FE] The garage duct connections are not sealed, the insulation is soiled at suspect connections.

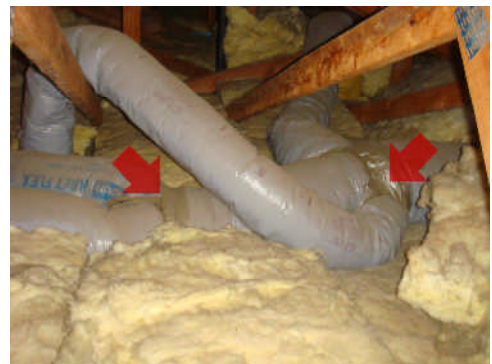
[FE] The boots are not insulated, and the connectors do not appear to be insulated properly.

I recommend insulating the duct boots and connectors for energy efficiency.

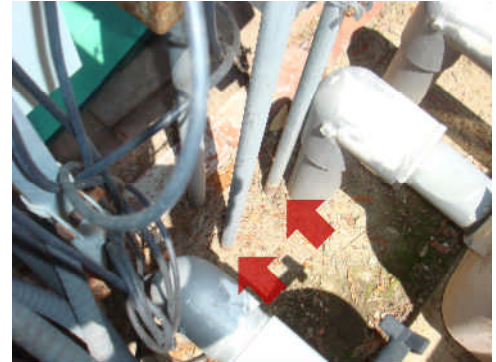
[SC] The panel box supports are rusted out, and should be replaced to support the box.

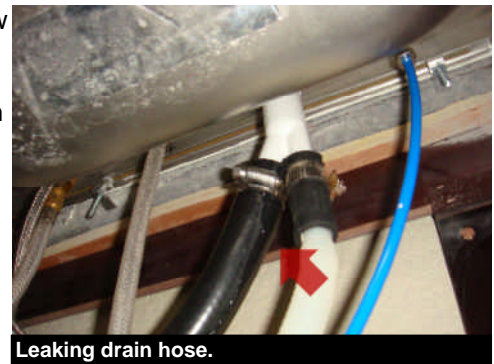
[CR] Water is draining out of the air gap when the unit is on the drain cycle. The drain hose, air gap or disposal may be plugged up.

Leaking drain hose.

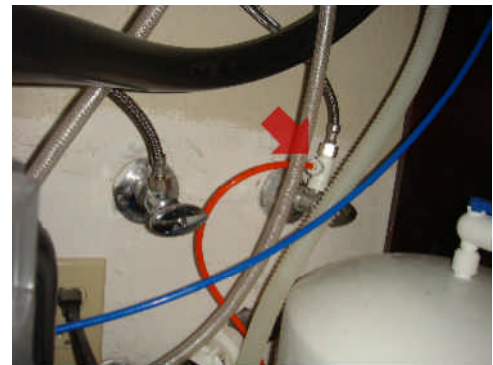
[CR] A saddle clamp fitting for the drinking water filtration unit is clamped onto the kitchen sink drain pipe improperly.

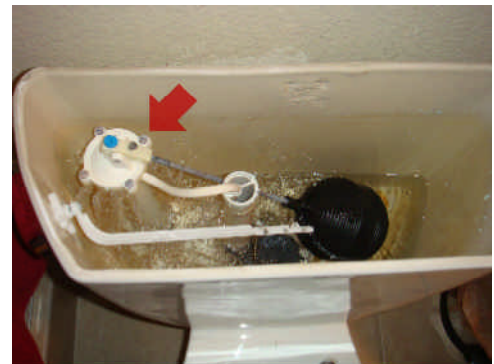
[CR] The first floor toilet tank fill valve leaks when filling, replace.

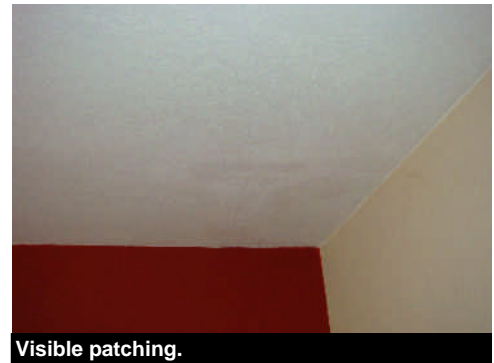
[FE] Moisture stains are evident on the living room ceiling.

Visible patching.

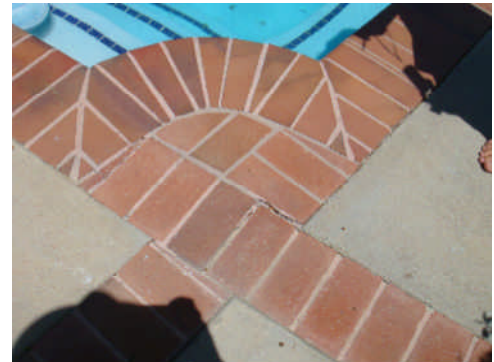
[CR] Cracks and settling between the spa decking and brick. This condition is conducive to moisture intrusion and lifting decks.

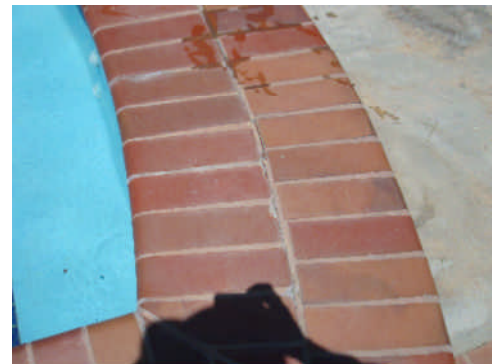
[CR] The grout between the coping and spa deck surface is cracked, deteriorated and missing. This condition is conducive to moisture intrusion into concealed spaces.

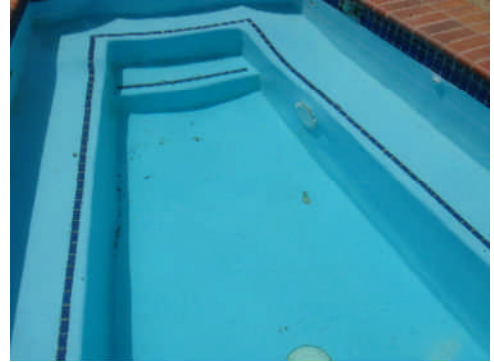
The plaster has been painted, and the paint is wearing off.

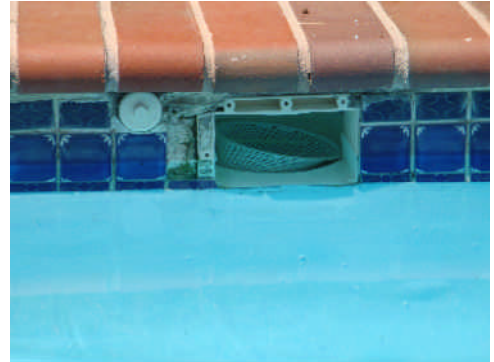
1620 WATERLINE TILES [CR] There were loose/damaged/missing water line tiles at the skimmer.

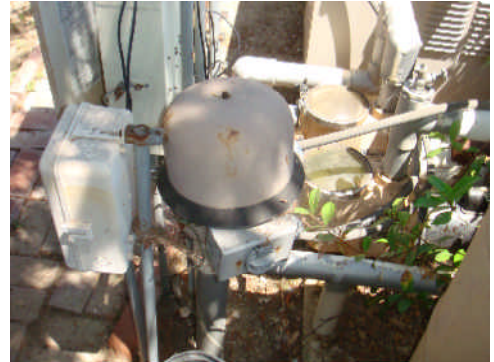
[FE] The blower cover is rusting a bit.

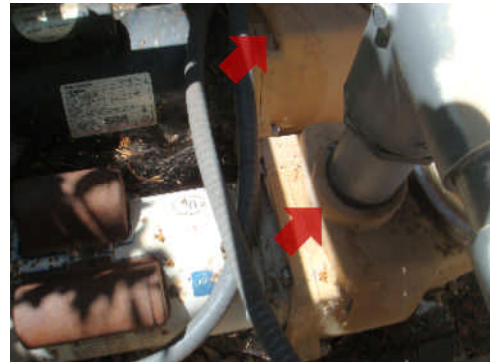
[CR] Leaking at the pump connections.

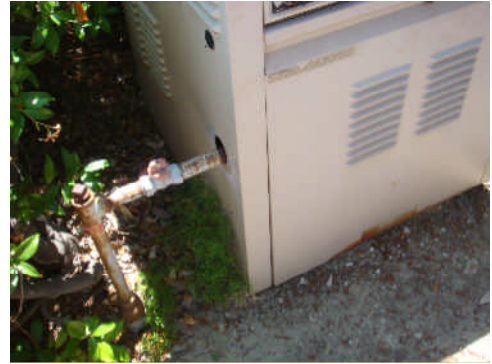
[CR] The heater is lacking proper separation from the grade and bushes.

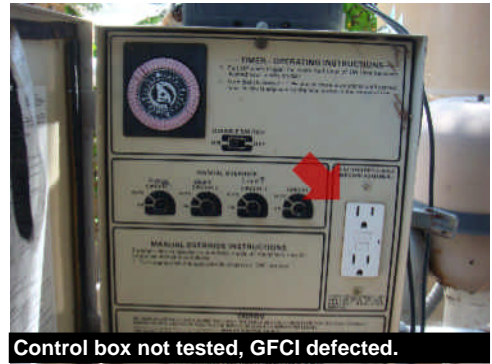
[SC] The GFCI protection device on the control panel failed to function.

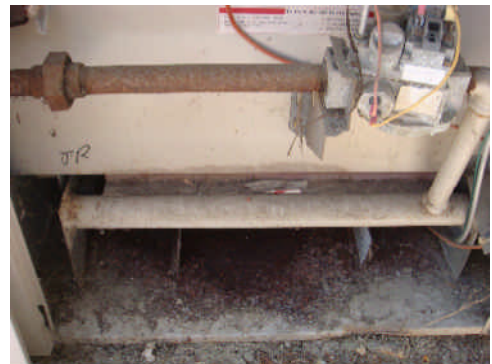
[FE] The heater should be cleaned on top and below /evaluated.

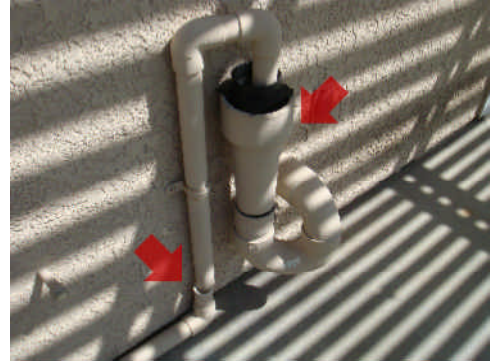
[CR] The back wash pipe is cut in half, and the grate is missing.
