Pre-purchase Building Inspection Report

Sample of a 3 year old 8,746 square foot never been occupied
Industrial Building

Building Inspection Report

Propose: Pre-purchase Building Inspection.

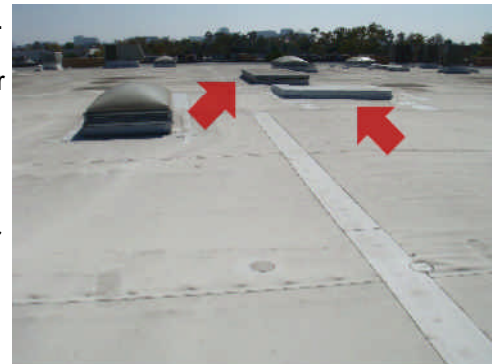
PHOTO # 2 View of the roof from the front to the rear area.
The skylight in the picture is located at the rear of the mezzanine.
A platform is provided for a HVAC unit.
The larger platform is located towards the rear right of the building, see pictures below.

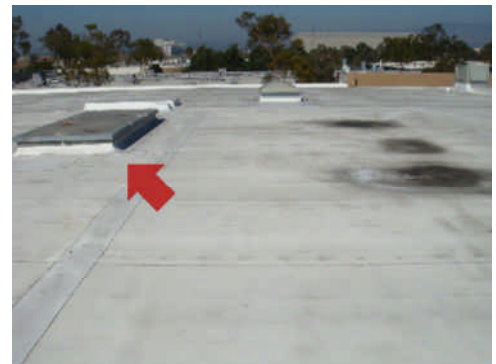
PHOTO # 3 View of the roof from the rear to the front.
The large platform has a metal cover, see pictures below.

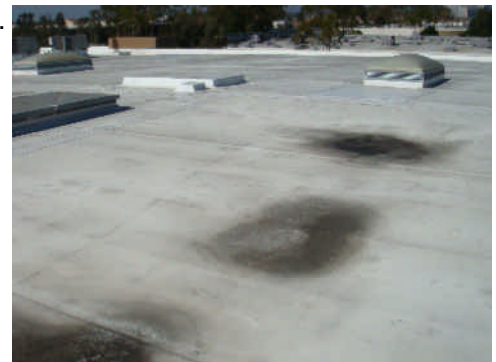
PHOTO # 4 The roof deck has low areas causing puddling.

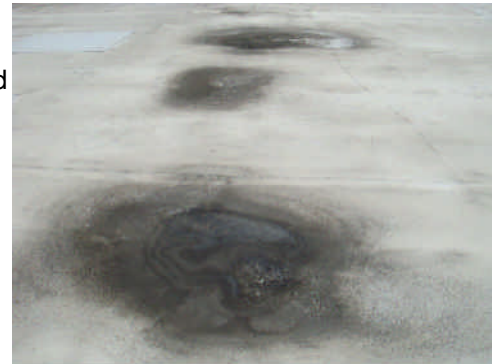
PHOTO # 5

Second picture of #4.

[FE] The puddling areas are soiled. The soiled areas may cause deterioration of the roofing membrane /material.

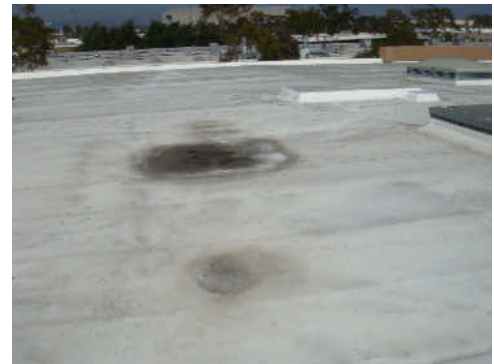
PHOTO # 6

Second area of puddling.

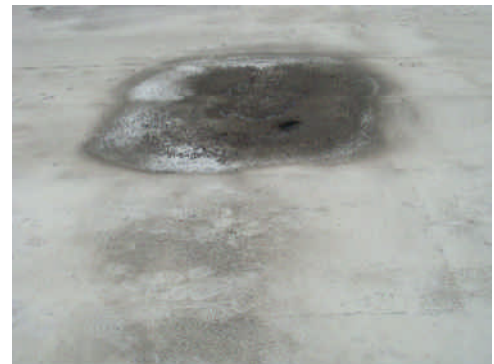
PHOTO # 7

Second picture of #6.

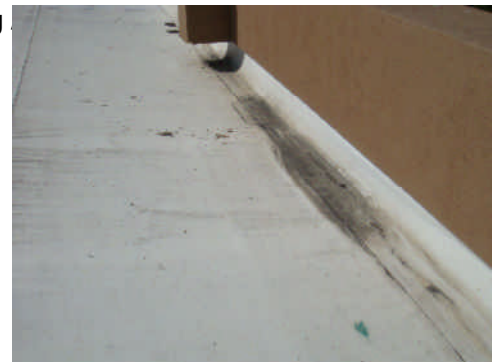
PHOTO # 8

[FE] Puddling noted at the front of the building unit at the left and right areas.

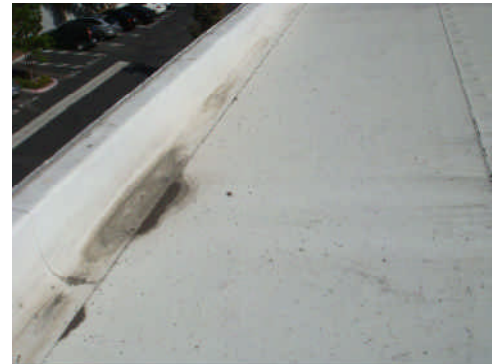
PHOTO # 9 Right puddling area.

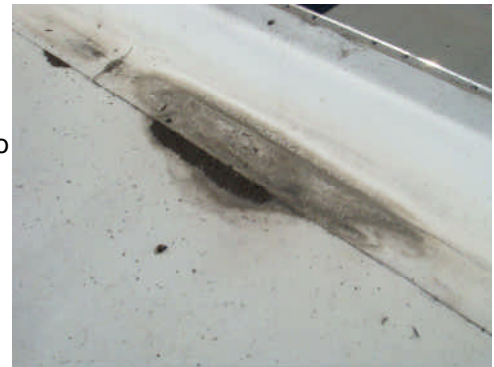
PHOTO # 10 [CR] Second picture of #9.
The complex building association should follow the roofing material manufactures maintenance instructions to prevent damage to the material and roof sheathing /framing system.

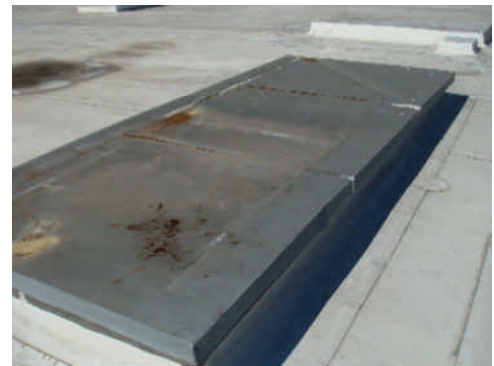
PHOTO # 11 [CR] The large platform metal cover is bent down and the seams are separated, causing apparent leaking /water staining to the roof framing below.

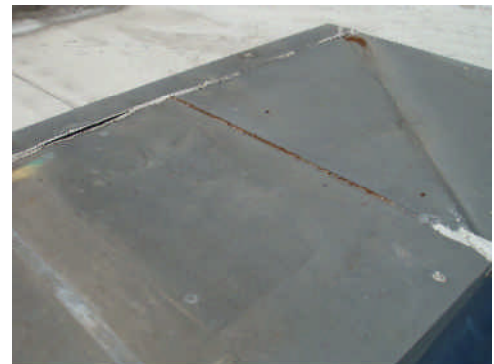
PHOTO # 12 Second picture of #11.

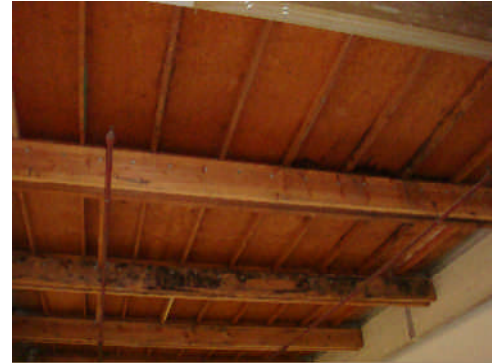
PHOTO # 13 View of the moisture stained suspected area below the platform metal cover.

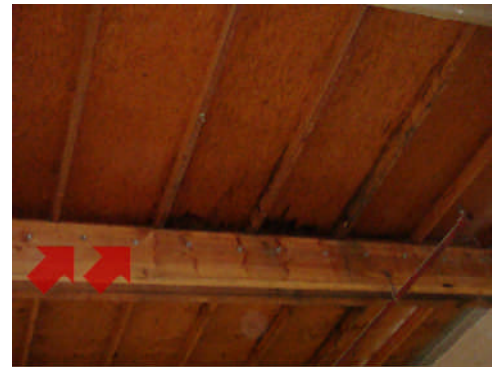
PHOTO # 14 [FE] Second picture of #13. The sistered framing members are lagged bolted without staggering the bolts.

Not staggering the bolts could cause the framing members to split on the bolt path.

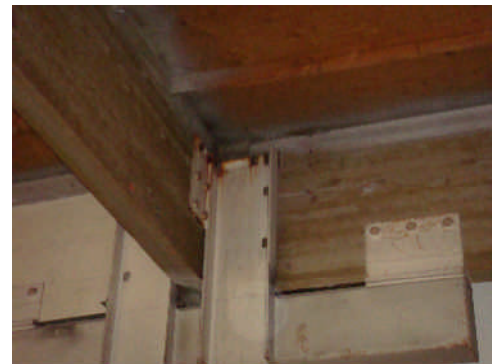
PHOTO # 15 [FE] Adjacent and to the right of the large platform metal cover is this structural hanger that is rusted at the top.

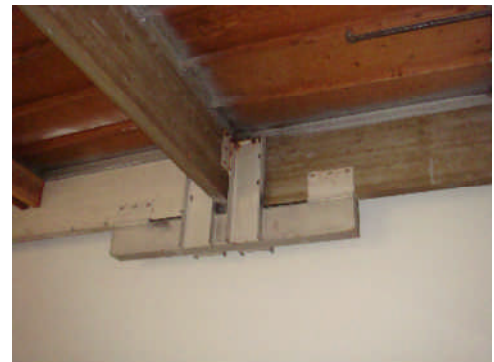
PHOTO # 16 Second picture of #15.

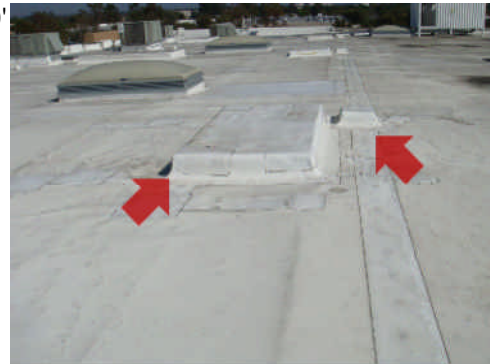
PHOTO # 17

The 4' X 8' HVAC platform is approximately 20' from the mezzanine skylight. A 16" X 16" platform is adjacent to the larger platform.

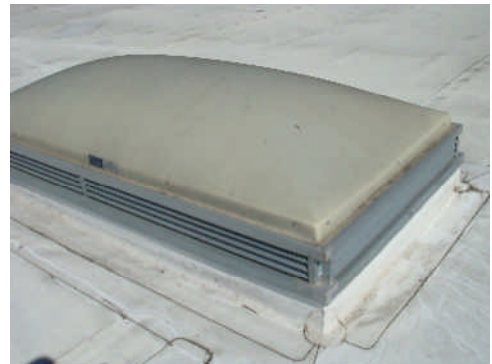
PHOTO # 18

View of the mezzanine skylight, one of two for the building. No defects evident at either skylight.

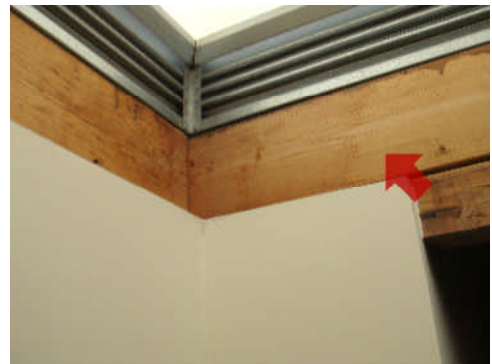
PHOTO # 19

Slight stain is evident below the mezzanine skylight wood frame and sheetrock below.

[FE] The stain appears to be from wind blowing moisture in from the skylight louvers.

The slight moisture will not cause damage to the materials. The moisture is minimal and will dry before damage could develop.

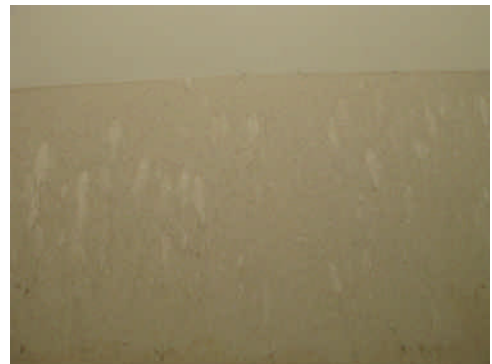
PHOTO # 20

Second picture of #19. Evidence of slight moisture drops on the sheetrock below the skylight.

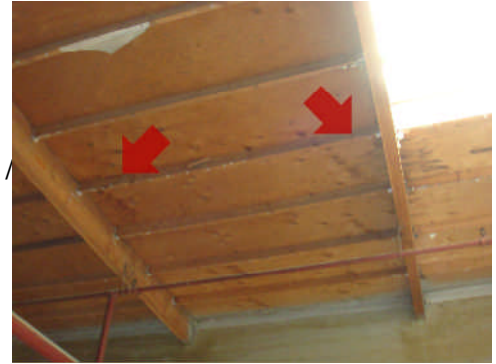
PHOTO # 21

[FE] Moisture stains are evident adjacent to the mezzanine skylight.

It is unknown if the suspected reclaimed plywood roof deck sheathing was already stained before the construction of this building / roof system.

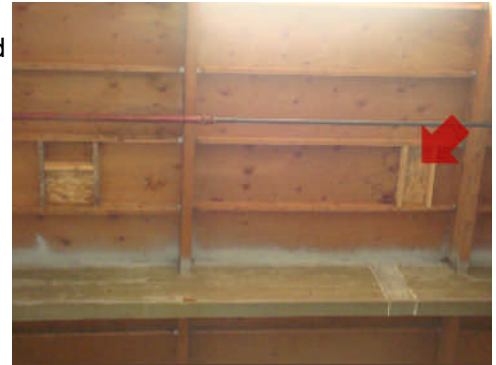
PHOTO # 22

The OSB patch in this picture is not moisture stained as is the suspected reclaimed plywood sheathing is.

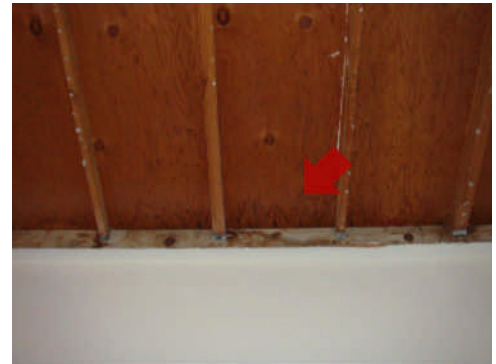
PHOTO # 23

[FE] Moisture stains are evident below the roof deck /framing at the front of the building.

Puddling areas are evident at the front of the building.

The fasteners /bolts and nuts should be protected from rusting.

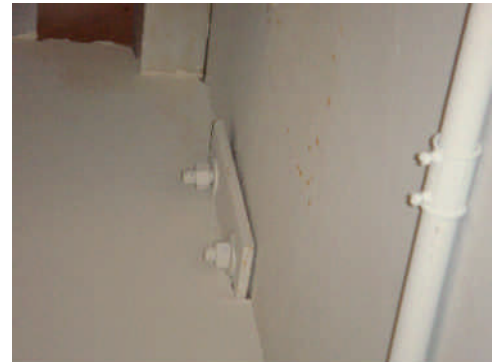
PHOTO # 24

[FE] The front upper right structural wall plate is not flush onto the wall and the securing bolt is bent.

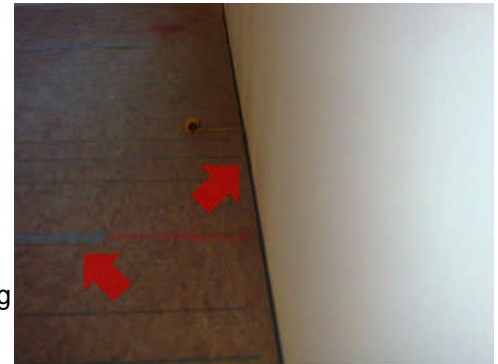
PHOTO # 25

The mezzanine floor sheathing is separated from the concrete building wall up to 3/4"

Concrete tilt-up building walls more often than not are not plumb or straight.

[FE] The floor sheathing at the front of the mezzanine has metal straps fastened to the framing below. The straps are separated from the wall over 1'. Without the approved building plans the straps function could not be determined due to the location of the straps.

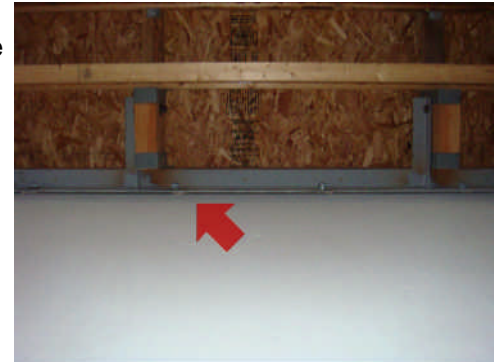
**PHOTO # 26**

[FE] View below picture #25. The metal frame fastened to the concrete wall is not flush onto the wall.

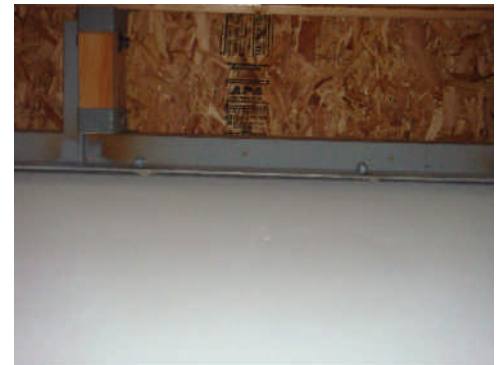
**PHOTO # 27**

Second picture of #26.

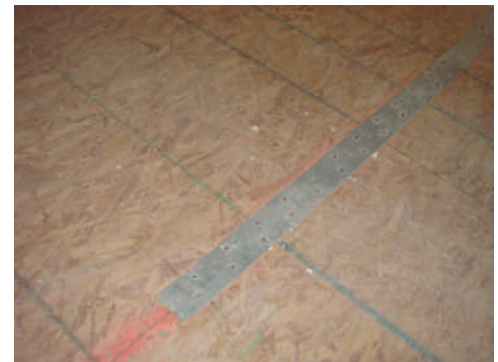
**PHOTO # 28**

[FE] Second picture of #25, of the straps fastening /nailing.

I recommend the unit approved building plans be reviewed for the function and installation of the straps.

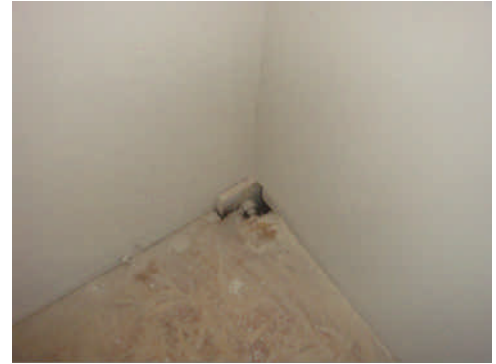
PHOTO # 29 [FE] Void /gap at the front left corner of the mezzanine OSB sheathing.

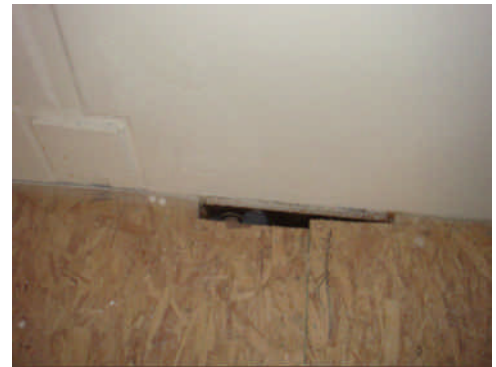
PHOTO # 30 [FE] Void /gap at the right front center of the mezzanine OSB sheathing.

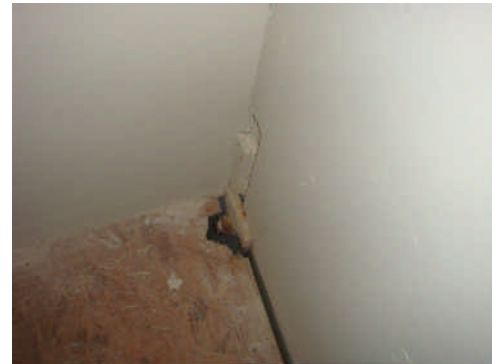
PHOTO # 31 [FE] Void /gap at the front right corner of the mezzanine OSB sheathing.

Depending on the building /unit usage these conditions may not be a concern other than flooring installation.

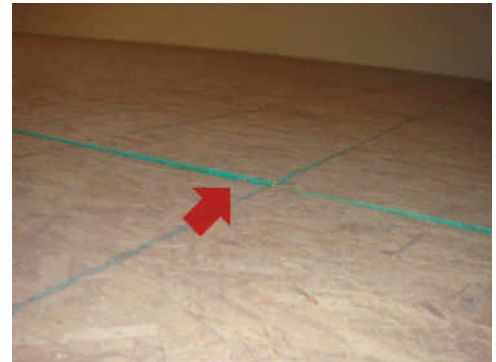
PHOTO # 32 [CR] The OSB sheathing is lifted /uneven up to 1/2" at the front right area.

[CR] Many of the sheathing fasteners are not flush onto the sheathing, with heads 1/4" above the sheathing.

[FE] The floor sheathing is creaky at areas when walked on.

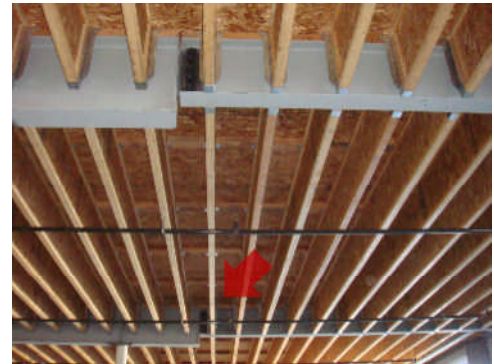
PHOTO # 33 The framing below could be the cause of the uneven floor sheathing.

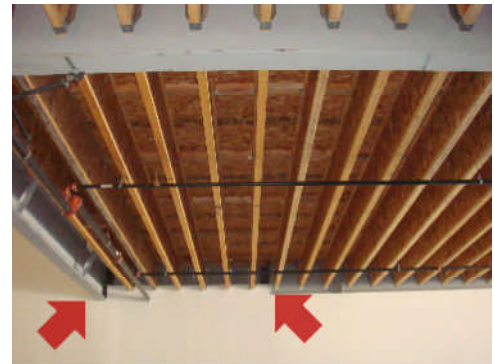
PHOTO # 34 [SC] Voids /gaps are evident between the building /units fire-resistive walls and floor metal frame.

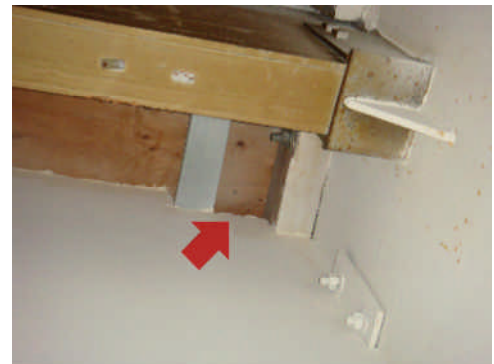
PHOTO # 35 [SC] Voids /gaps are evident between the building /units fire-resistive wall at the right side metal framing and roof.

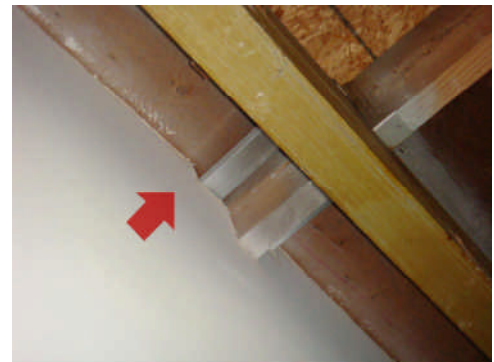
PHOTO # 36 [SC] Second picture of #35. All pipe penetrations should be sealed and fire caulked.

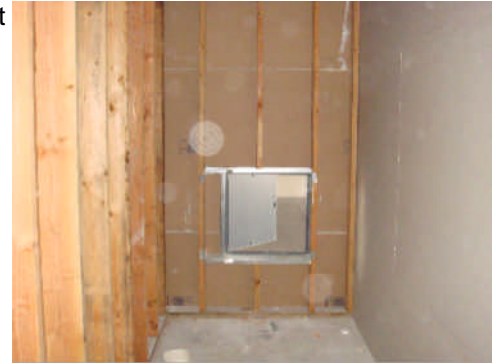
PHOTO # 37

View of the walls below the mezzanine fire exit stairs.

[SC] The unit walls are only have sheetrock installed on one side of the framing.

This is not a code compliant inspection, although fire life and safety is paramount.

[CR] The walls should have fire-resistive sheetrock on both sides of the walls.

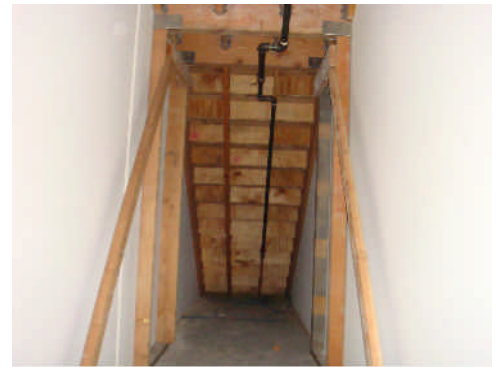
**PHOTO # 38**

Second picture of #37 below the fire exit stairs to the rear fire exit corridor.

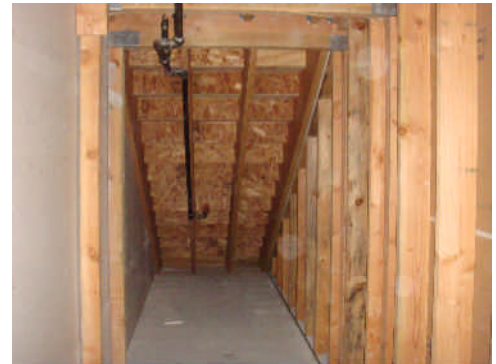
**PHOTO # 39**

[SC] View of the exposed wall framing and stairs below the mezzanine rear stairs.

See 1997 Uniform Building Code Volume1, section 1003.3.3.9.

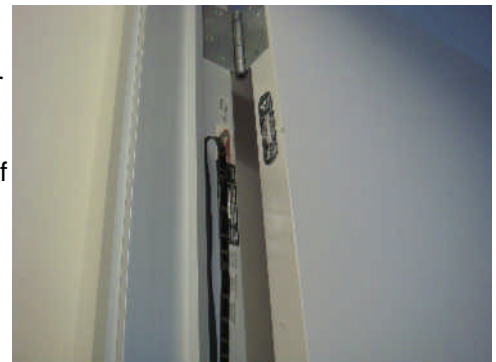
**PHOTO # 40**

[CR] The fire exit doors are lacking thresholds, and a section of the smoke /draft gasket is loose on the mezzanine fire exit door jamb.

The mezzanine and rear fire exit doors are self closing and latching as required.

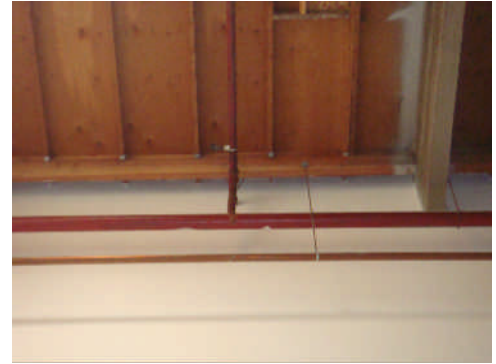
PHOTO # 41 [CR] A sprinkler fitting apparently leaked at the rear left of the building.

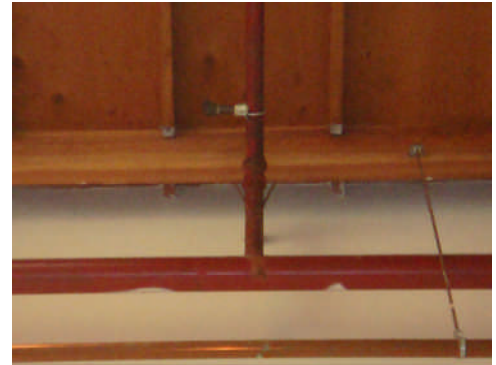
PHOTO # 42 Second picture of #41, of the rust stains.

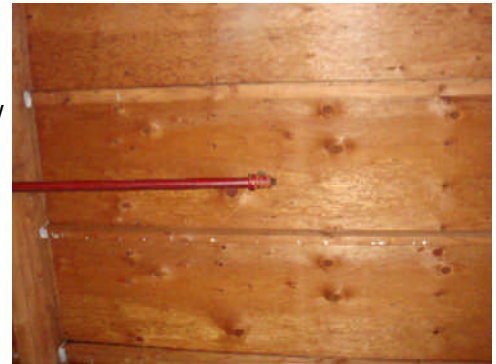
PHOTO # 43 [CR] A sprinkler fitting apparently leaked at the front of the building above the mezzanine.
Moisture stains are evident on the floors below the suspected leaking fittings.
[FE] All of the sprinkler fittings should be evaluated.

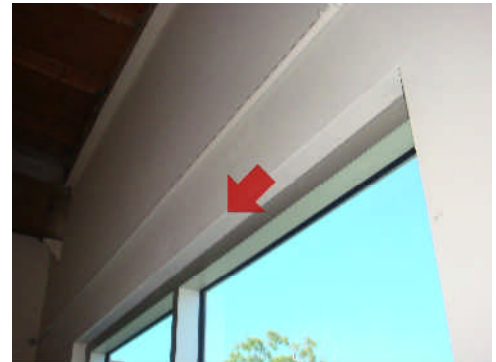
PHOTO # 44 [FE] The mezzanine front right window head / return has slight dark stains.

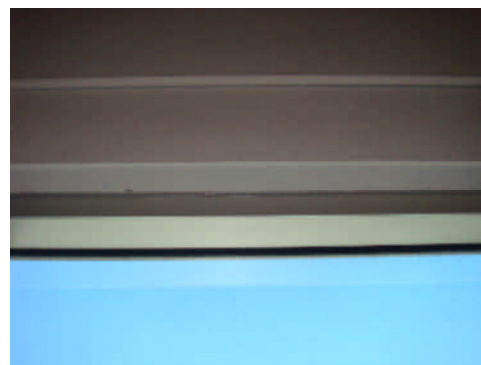
PHOTO # 45 Second picture of #44.

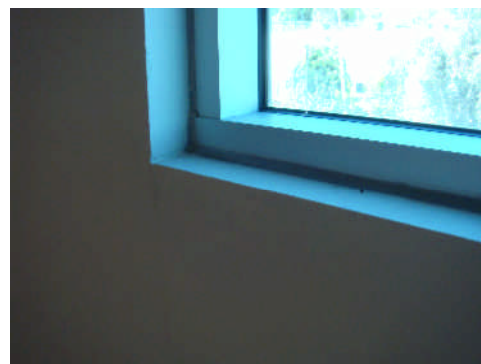
PHOTO # 46 [FE] Slight stain is evident below the front center mezzanine window corner.

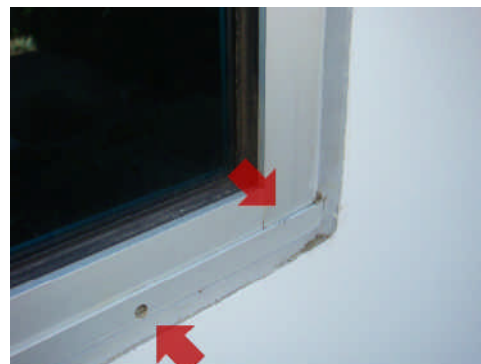
PHOTO # 47 The aluminum single pane tempered safety glass fixed windows appear to be functional, other than noted above.

The picture shows the window frame and weep hole at the exterior.

I recommend that the window manufactures instructions be reviewed for proper maintenance.

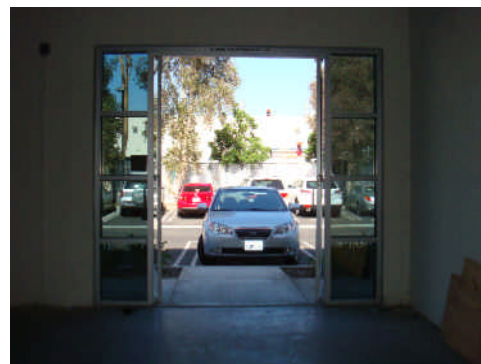
PHOTO # 48 The aluminum single pane tempered safety glass doors and windows were functional.

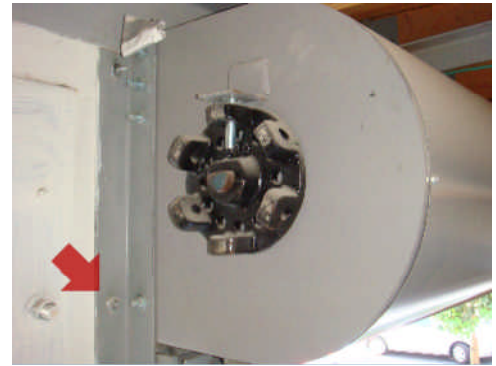
PHOTO # 49

The overhead roll-up door was operational, except;

[CR] One fastener bolt appears to be broken off at the top of the frame.

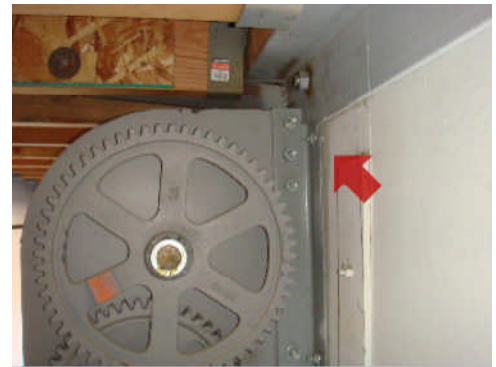
PHOTO # 50

[FE] The roll-up door frame is not flush onto the building wall at the top.

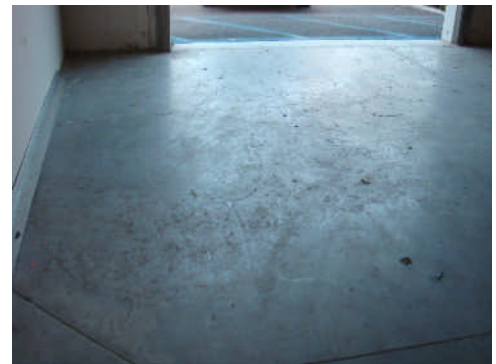
PHOTO # 52

[FE] Water intrusion staining /signs are evident on the slab adjacent to the roll-up door. Water may be seeping under the door.

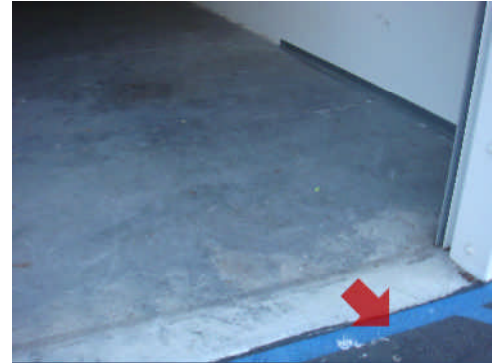
PHOTO # 53

[FE] The asphalt may not be sloped /placed properly at the interior slab intersection.

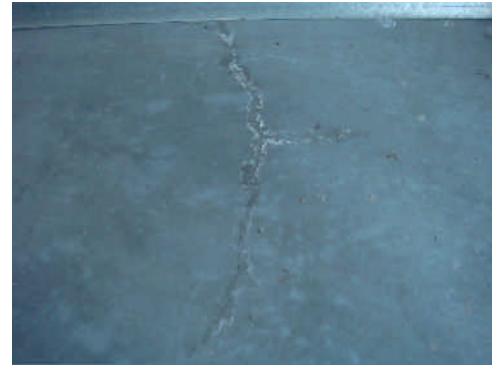
**PHOTO # 54**

[FE] The slab crack adjacent to the door has efflorescence from moisture and is in the area where water appears to puddle.

The unit concrete slab is functional with the exceptions of the conditions noted above, and a 2X4 chipped area below the stair landing.

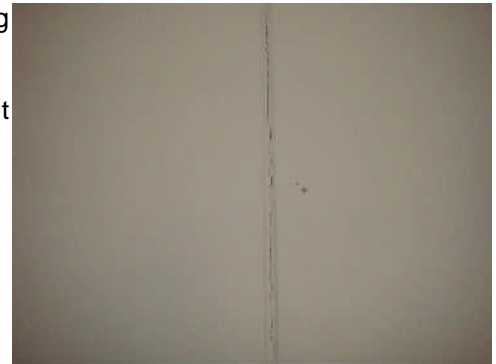
**PHOTO # 55**

[FE] The building wall joint material is cracking on the interior.

Slight concrete building wall cracks are evident at areas.

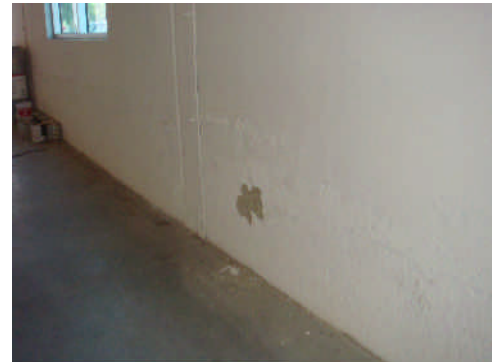
**PHOTO # 56**

[FE] The building concrete wall at the front has an irregular finish 3' up from the slab.

This condition appears to have been caused during the placement of the concrete wall.

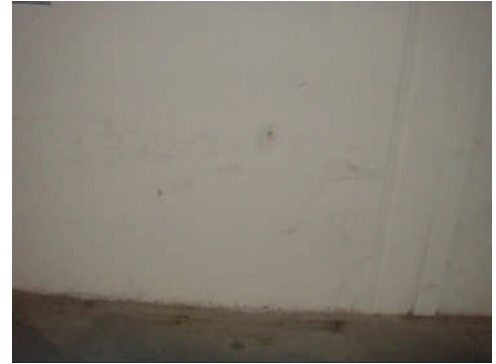
PHOTO # 57 Second picture of #56.

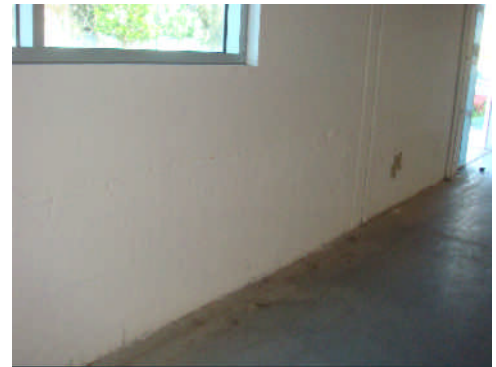
PHOTO # 58 Third picture of #56.
