Pre-purchase Home Inspection Report

Sample of a 4 year old 2,500 square foot house with pool & spa

Steve Garcia Inspections

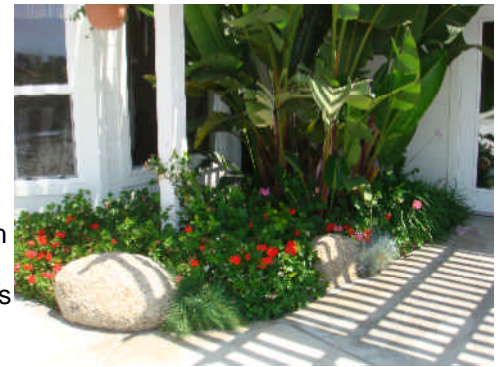
[CR] Outside of the BK nook /master bedroom the siding is below or marginally above the exterior grade /soil. I recommend modifications in this area to maintain a minimum of 4 inches clearance between the earth and wood siding and wall framing.

The grade at this area is not adequately sloped away from the foundation. It is important that surface grade be sloped away from the foundation.

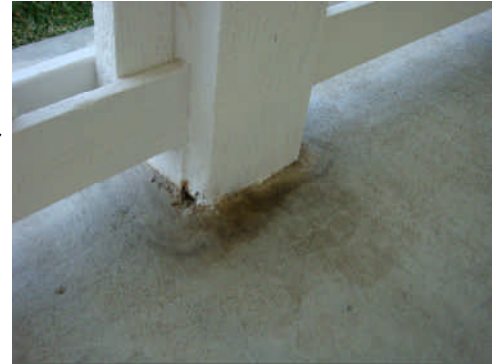
[CR] The patio /perimeter wraparound porch cover and lattice support posts /metal hold downs are improperly in contact /below the patio slab, and may be in contact with the planter soil outside of the BK nook and master bedroom. These conditions are conducive to moisture damage.

[CR] There is evidence of conditions that require further evaluation and repair by a pest control operator.

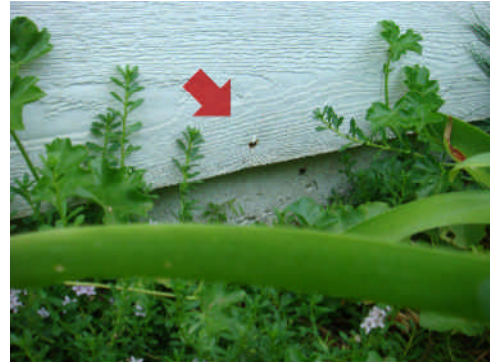
[CR] The manufactured siding lacked adequate clearance from or are buried in the ground outside of the BK nook. This condition is conducive to moisture intrusion/deterioration.

[CR] The sprinkler spray may be hitting the front garage wall, or the roof water runoff may be splashing onto the siding causing moisture damage, and rust to the fasteners.

Before painting the siding caulk the fasteners that are recessed into the siding to seal the siding surface.

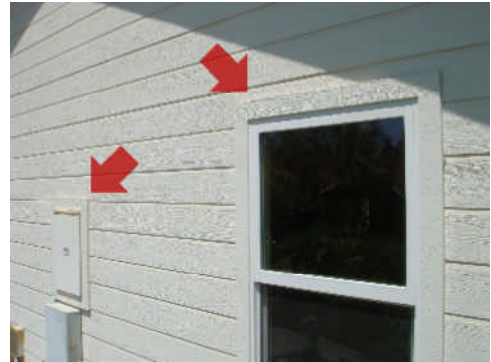
[FE] There are no visible metal flashings installed at the top of the doors and window trims. This condition could be conducive to moisture intrusion/deterioration.

I recommend the exposed head trims be maintained with caulking and paint.

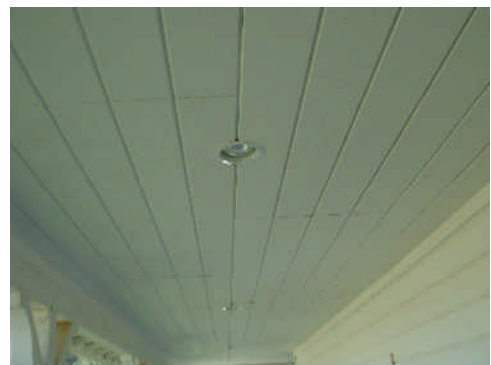
321 COMMENTS [FE] The wraparound porch ceiling wood paneling seams appear to be separating.

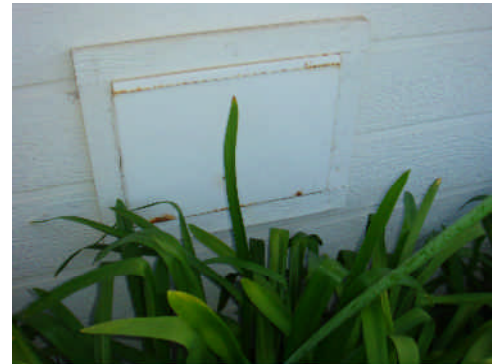
The metal cable box at the front of the garage is rusting. The box should be painted.

Any siding butt joints and cut siding like at the right side electrical box, caulk and paint.

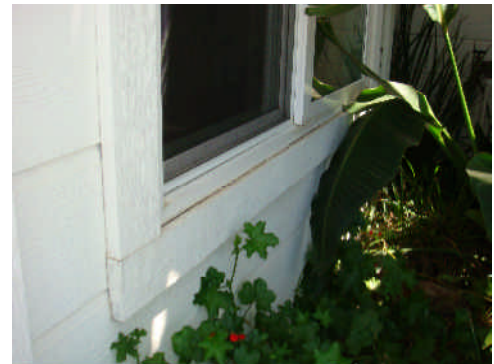
The sprinklers may be spraying this area.

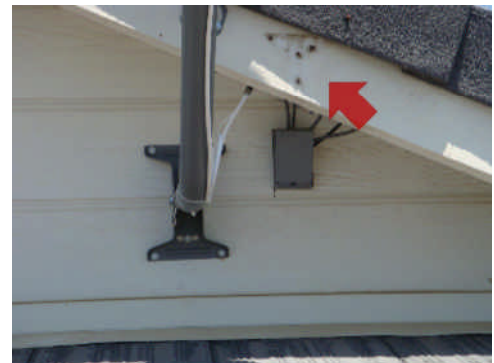
[CR] Holes in the fascia at the right side should be caulked sealed and painted.

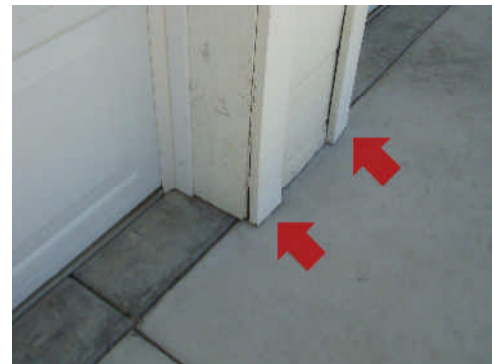
[CR] The siding trim materials should be cut back from the concrete to prevent moisture damage.

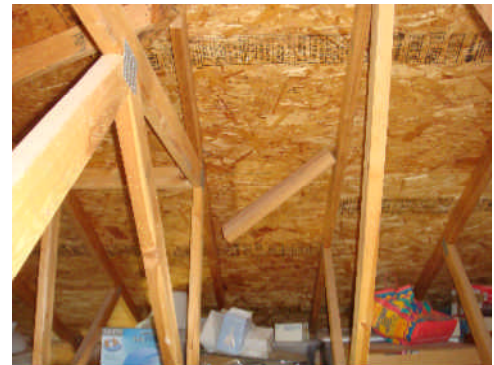
One framing truss block is separated.

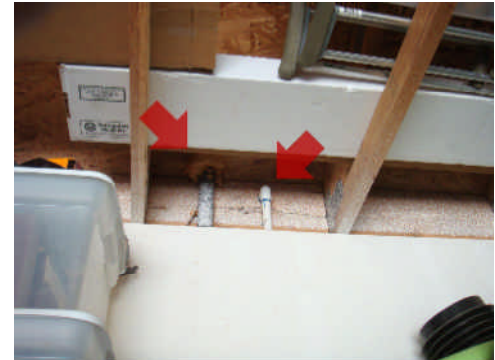
[SC] The fire-resistive wall is sealed at pipe penetrations with a suspected improper non-rated foam material, and plastic PVC is through the wall.

[CR] Approved fire rated caulking is recommend at the penetrations /pipes.

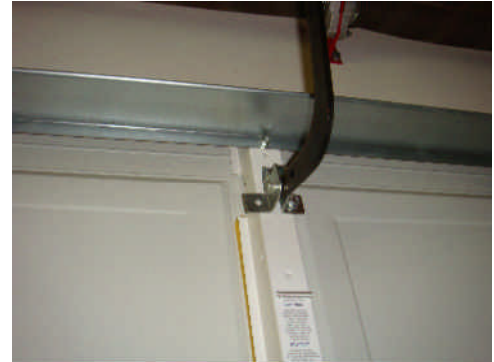
[FE] The rail arm is secured to the garage door without blocking /proper fastening.

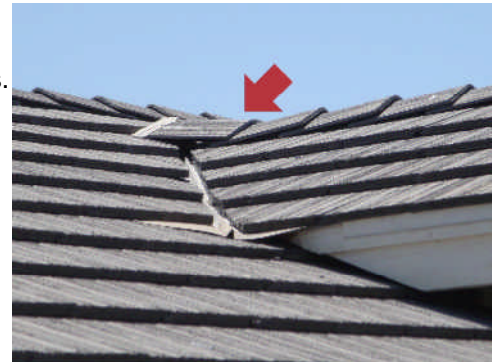
[CR] The ridge tiles have voids at a few areas. The fastening and weather blocking should be evaluated at these ridge tiles.

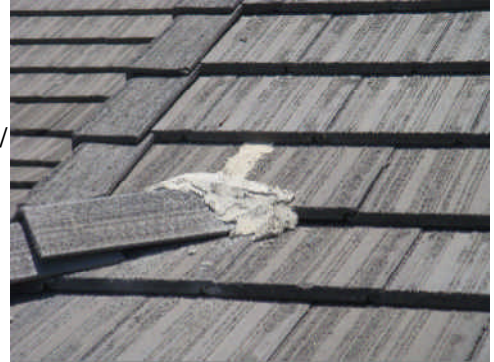
[FE] Mortar has been used at the field tiles and hip tiles intersection in place of metal pan / channel flashings.

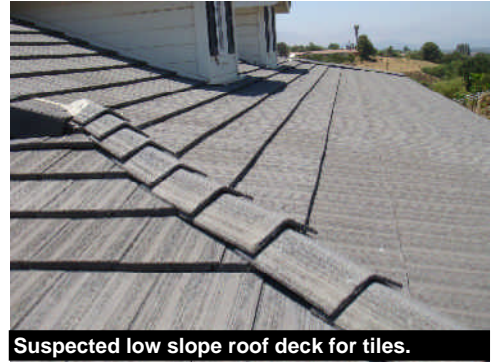
[FE] Due to the suspected low sloped roof deck /area around the house, a low slope roofing material may have been required to be placed onto the roof deck before the tiles were installed.

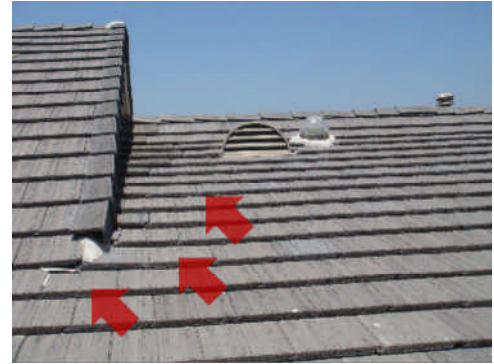
[FE] The wall rake pan /channel flashing is crushed and the mortar material is irregular at this location.

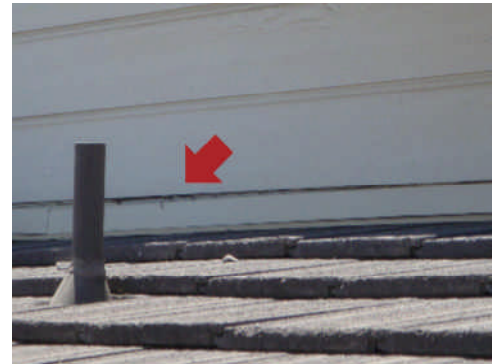
519 INSPECTOR RECOMMENDS [CR] The wall flashing appears to be loose, and should be corrected.

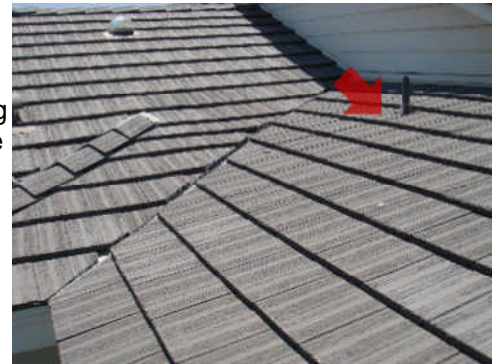
[FE] I recommend evaluation the the plumbing vent jack flashing installation at the front of the house.

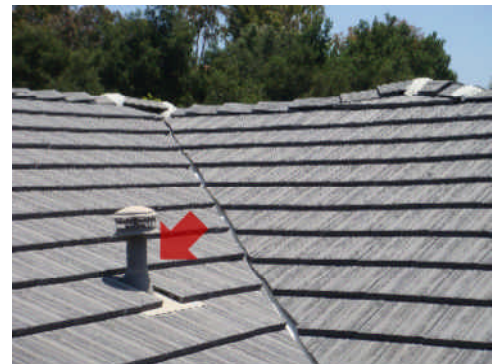
[CR] The two gas exhaust flue pipes are lacking storm collars.

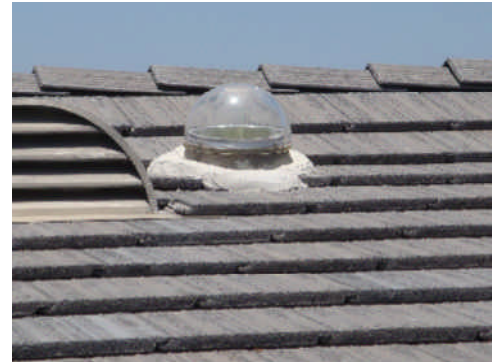
[FE] The tube skylights do not have visible flashings, only mortar fill.

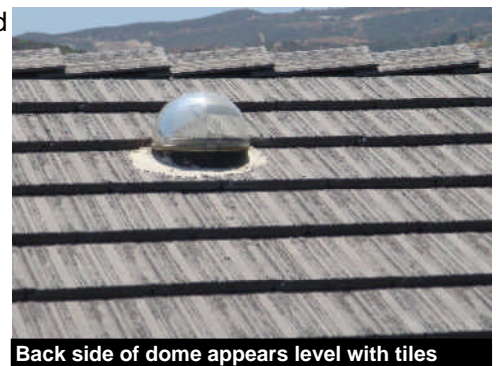
[FE] Evaluation is recommend for flashing and proper installation of the tube skylights.

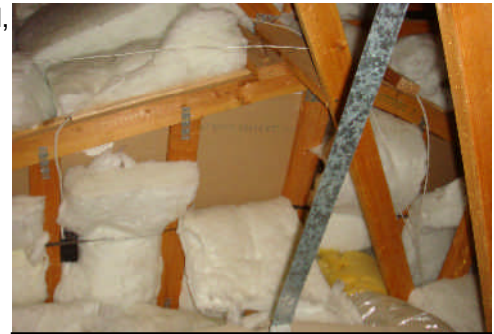
Living room wall.

[CR] The insulation is out of place/missing from the living room wall.

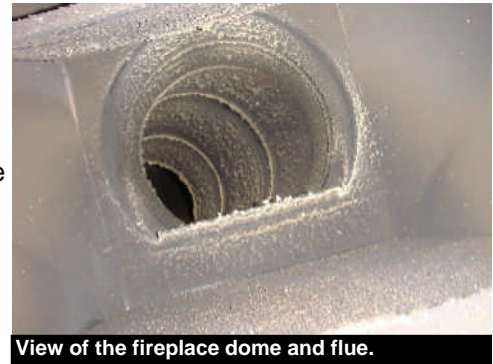
[FE] The visible areas of the flue is a bit soiled. I recommend the flue and related components be cleaned by a certified fireplace specialist.

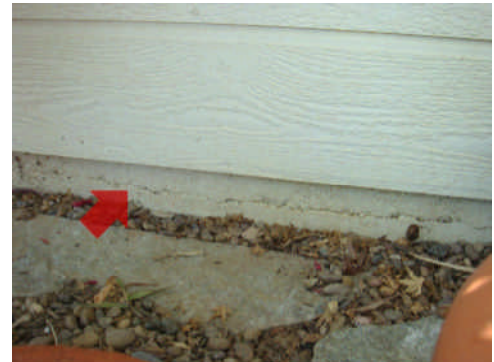
Horizontal cracks or separations known as cold joints are evident in the foundation. This condition appears to have been caused from the placement /installation of the foundation and slab.

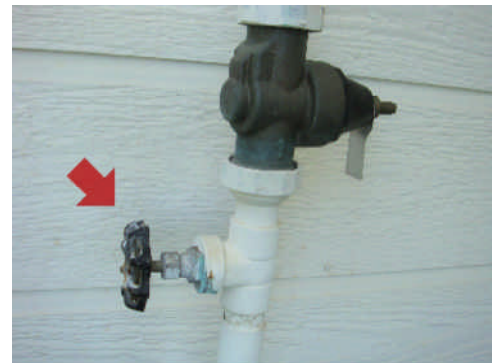
Older /original main water shutoff valves are not shutoff to test, to prevent the valve from breaking or leaking.

[RU] I recommend replacing the main water supply valve with a 1/4 turn ball valve.

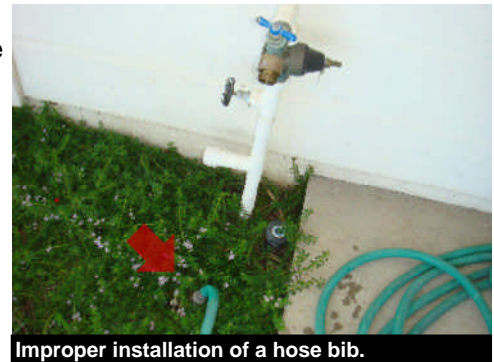
[CR] In front of the main water supply line is a hose bib in the soil improperly. The bib water supply appears to be part of the sprinkler water supply.

[RU] There are no anti-siphon backflow preventers on the landscape hose faucets / bibs. I recommend installing these devices to prevent water in the hose from entering the building water supply.

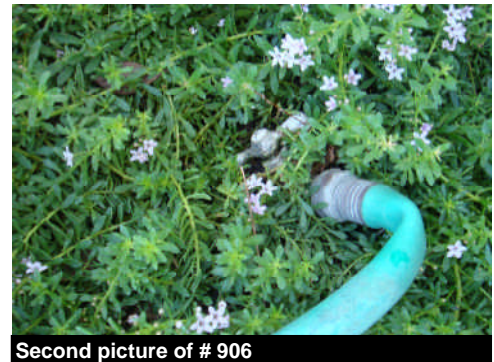
907 INSPECTOR RECOMMENDS [FE] The sprinkler water supply should be evaluated for required backflow preventers and anti-siphon valves.

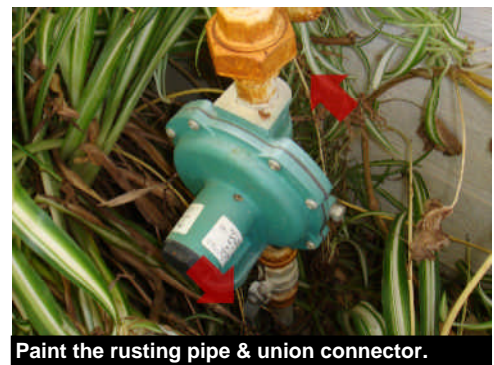
A main gas shut-off ball valve is located at the left side of the house. The pipe union connector should be evaluated for leaking after seismic movement.

Paint the rusting pipe & union connector.

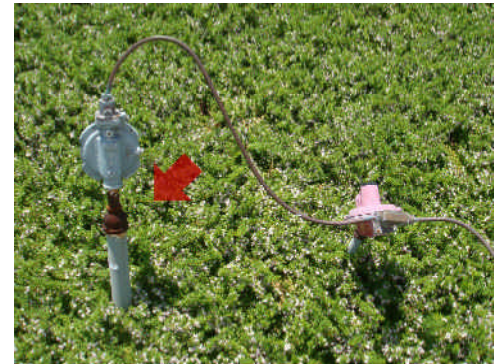
[FE] Rust is evident at the main gas supply pipe fittings adjacent to the tank.

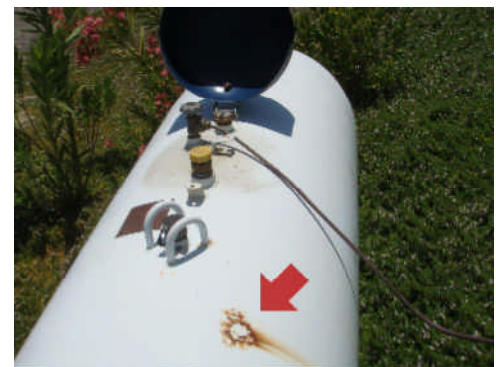
[FE] The tank has a rusty area. The tank should be secured and evaluated.

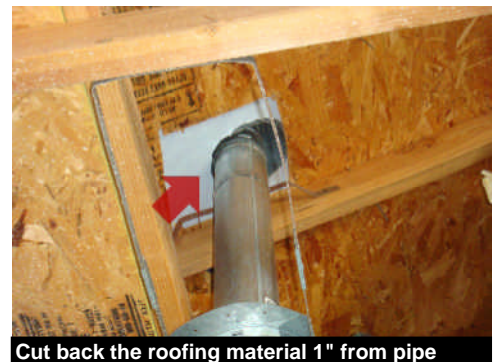
[SC] The flue vent piping is close to combustibile materials, cut back the roofing underlayment.

Cut back the roofing material 1" from pipe

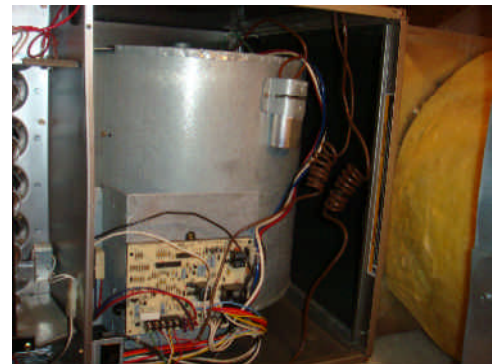
[FE] Irregular vibration when the unit /fan is operating. The fan may be out of balance.

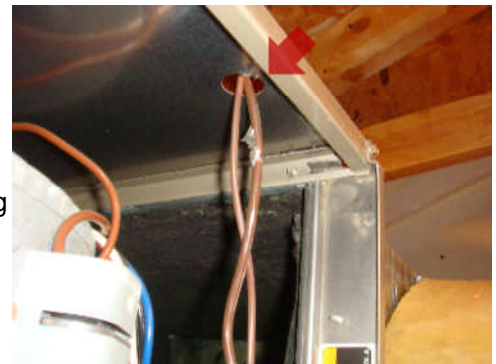
[RU] The fan cabinet is not insulated with insulation board.

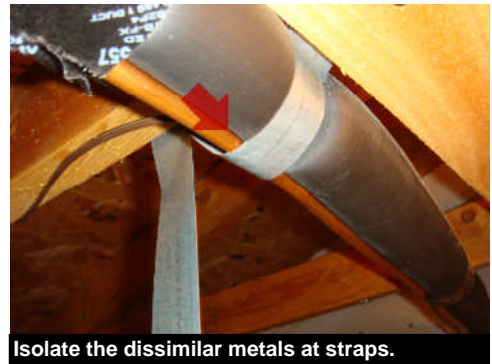
[CR] The refrigerant line is in contact with the metal straps improperly.

Isolate the dissimilar metals at straps.

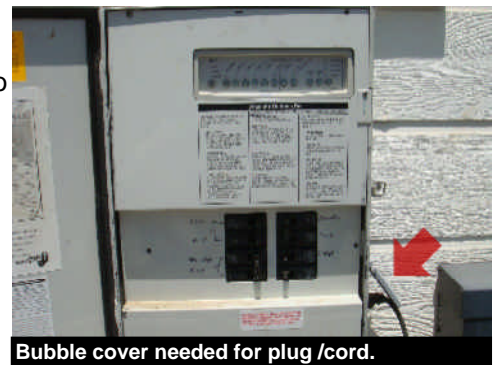
[CR] Screws are missing from the front panel cover.

Bubble cover needed for plug /cord.

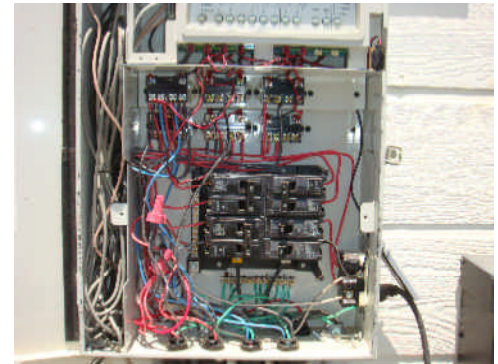
[CR] Red wire connected to the neutral terminal.

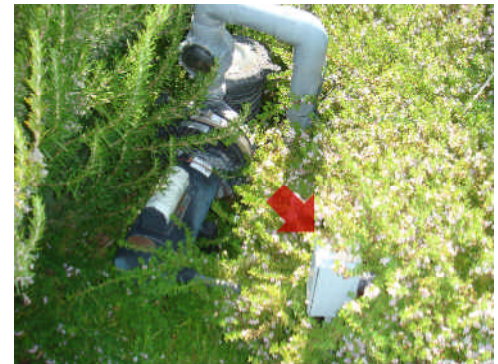
[CR] The pool pump power supply junction box at the rear left of the pool is only supported by the plastic conduit.

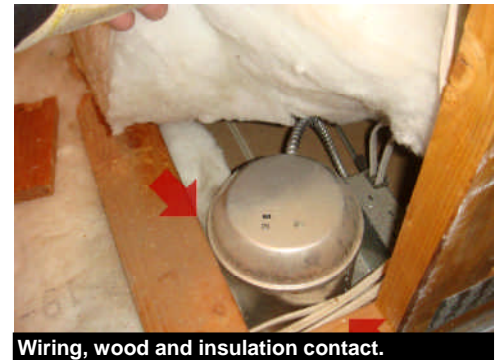
[FE] It is unknown if the ceiling recessed light fixtures are "IC-rated for insulation contact, and combustible materials. I recommend the light fixture trims and bulbs be removed to expose the manufactures label to determine the rating.

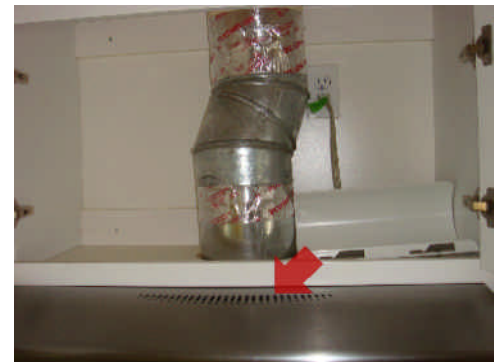
[FE] Air came out of the top of the hood vent. This hood vent should vent all of the air to the exterior.

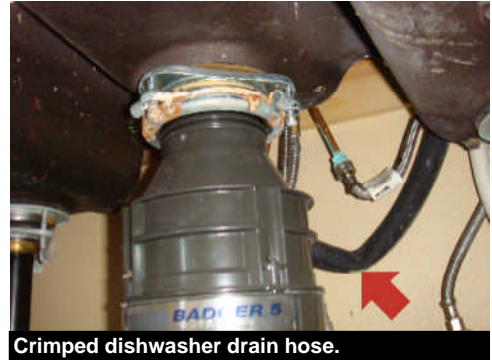
The garbage disposal functioned, no leaks.
Some corrosion is evident at the disposal connection.

Crimped dishwasher drain hose.

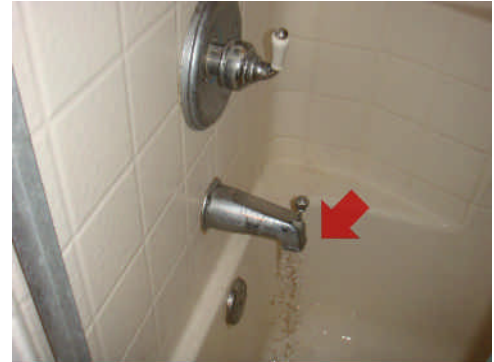
[CR] The tub spout shower diverter failed to fully divert all water to the showerhead.

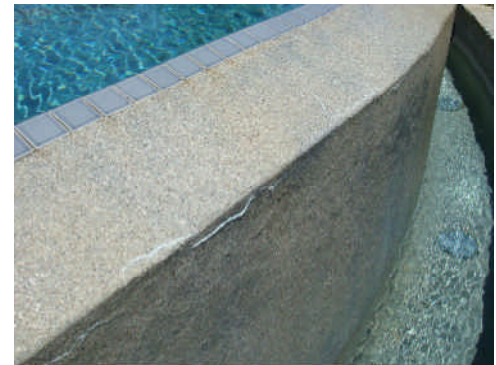
[FE] Calcium /mineral deposits are evident at the water spill surface.

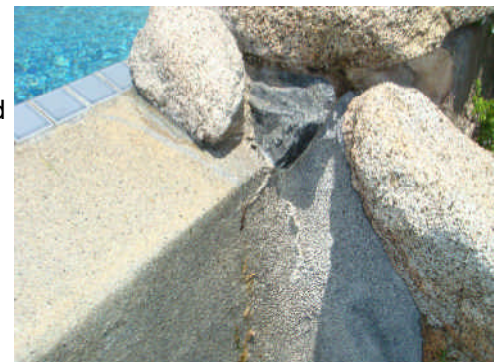
[FE] Calcium /mineral deposits and suspected moisture intrusion evident at /in the stone and spill wall.
