# *Pre-purchase Home Inspection Report*

Sample of a 51 year old 1,600 square foot house

***Steve Garcia Inspections***

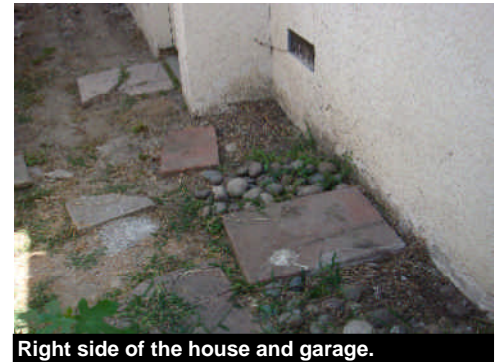
Right side of the house and garage.

[CR] The grading at the right side is not adequately sloped away and to the street. It is important the surface grade be sloped away from the building to prevent moisture accumulation next to the foundation, which may effect the foundation.

[RU] The addition of surface drains, or concrete is recommended to collect and remove excess water at the right side.

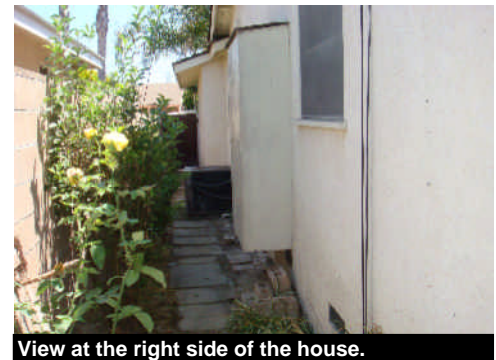
View at the right side of the house.

The exposed areas of the surface drainage appeared functional, with the exception of the grading noted above.

[RU] Roof gutters and downspouts are not provided to control roof water runoff. I recommend installing roof gutters and downspouts routed away from the house and directed to the street or into a drainage system.

The site should be evaluated during or after a heavy rain, for grade corrections and gutter installation /downspout location.

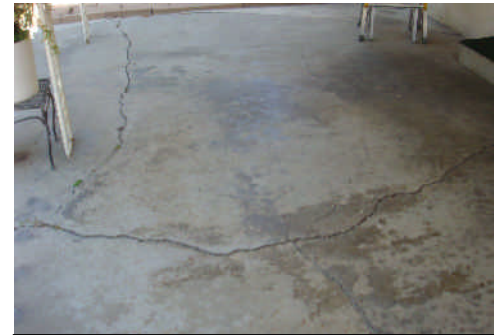
[CR] The concrete is cracked and uneven up to 3/8".

[CR] Broken /loose blocks are evident at the corner /edge.

Expansion joints were not installed.

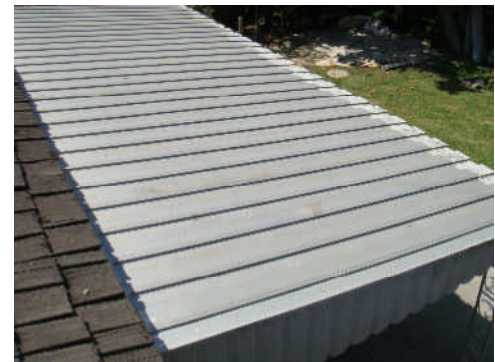
[FE] Moisture stains are evident below the cover connection.

[FE] The metal support posts are rusting.

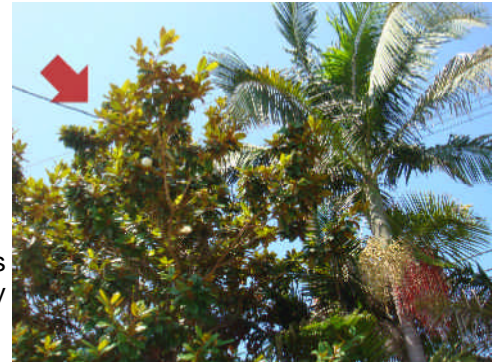
[CR] The rear left tree appears to be planted too close to the block wall and fence. The electrical service conductors are improperly in the tree. I recommend considering removal, as the tree continues to grow in size damage may occur to the wall, and the service conductors are in the tree.

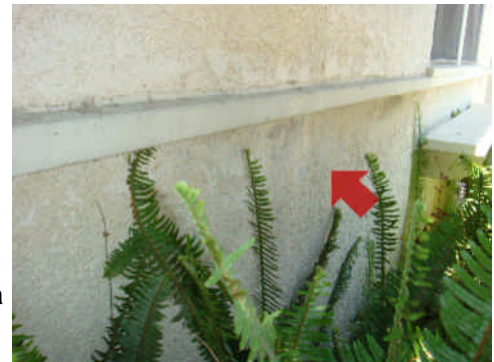
[FE] The stucco color coat is worn off at the front left.

This building was constructed in an era before weep screeds were installed at the bottom edge of the stucco siding, to separate the stucco from the grade /soil. The stucco lacks a drainage plane. This condition does not allow moisture to dry, causing the stucco to blister and flake off. I recommend minimizing moisture around the building to help protect the

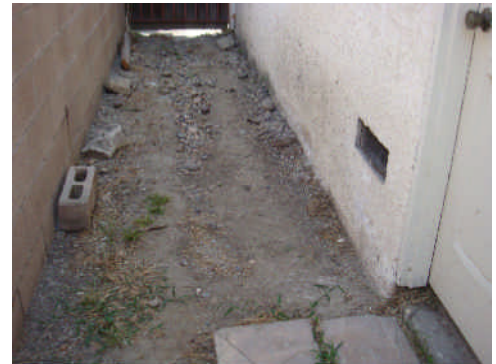
[FE] The stucco siding at the base has moisture stains at the right side. Roof gutters should be installed to prevent water from splashing onto the stucco wall.

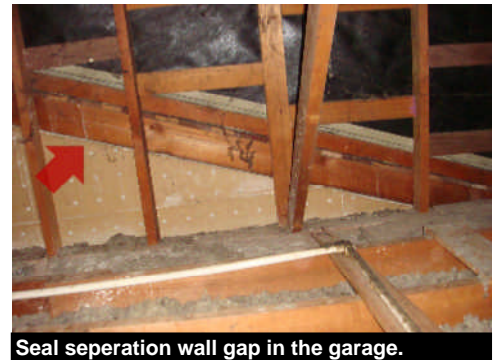
[CR] Gap at the top of the wall should be sealed, visible day light from the attic space is evident.

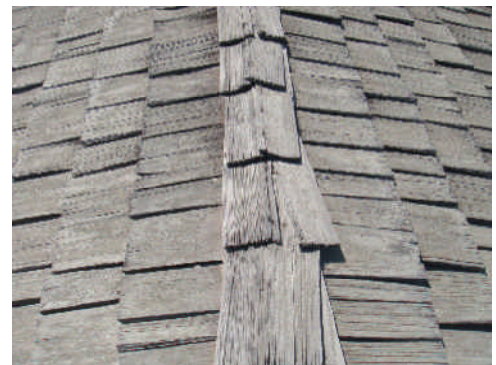
[CR] The roof ridge is separated and damaged.

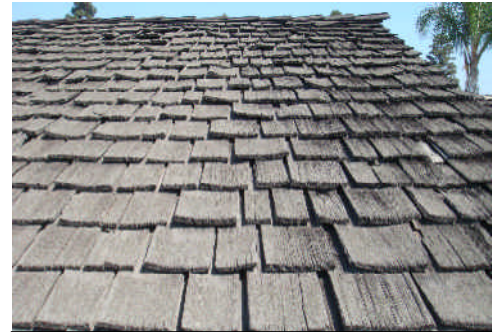
Front south facing side.

[FE] The roof appeared to be old and showed signs of advanced deterioration. It appeared to be at the end of, or extended beyond its useful life.

[CR] [RU] There are a number of wood shakes that are damaged, deteriorated through, slipped out of place, wrapped and exposed underlayment is evident. These conditions are conducive to roof leaks.

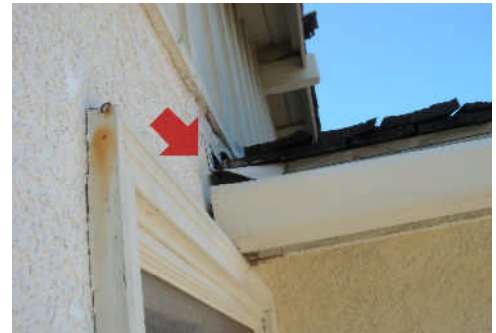
[RU] Kick-out flashing is lacking at the front above the window. It is important to divert water away from the wall.

Install kick-out flashing.

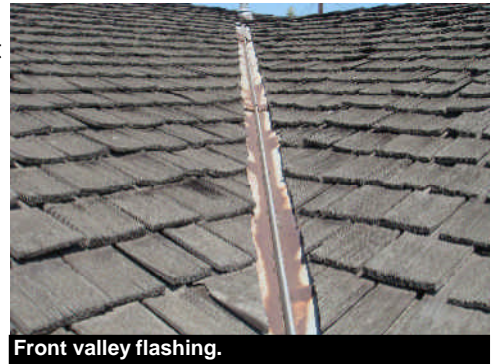
**518 FLASHINGS** Some of the flashings are rusty. I recommend they be cleaned, painted with an oil based rust inhibitor and/or replaced as needed.

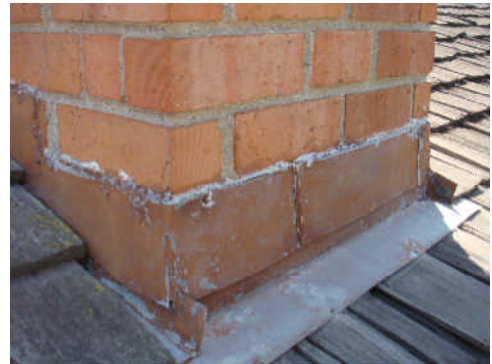
**519 INSPECTOR RECOMMENDS** Recommend re-caulking and maintain the chimney flashing.

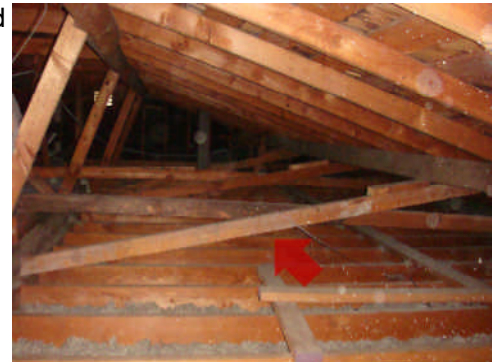
[FE] The rear perlin support struts angle are over 45 degrees.

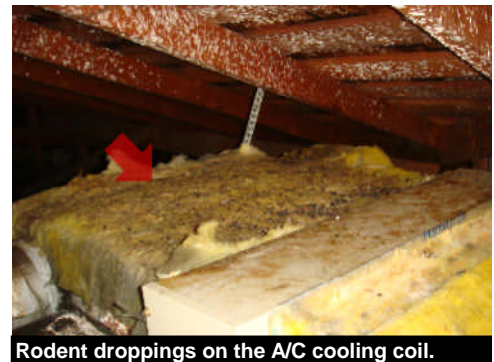
**611 INSPECTOR RECOMMENDS** [SC] [CR] The rodent condition is a health concern. The rodent droppings should be removed by a certified abatement company.

Rodent droppings on the A/C cooling coil.

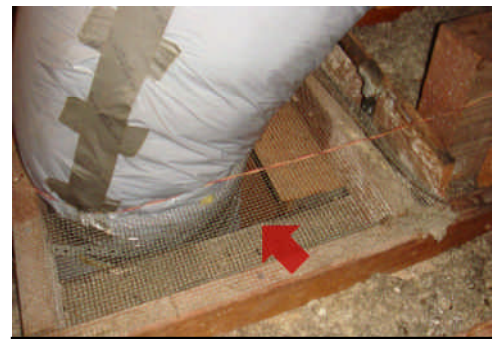
[RU] The furnace return air duct chase is not sealed with insulation. The screen appears to have been installed to keep rodents from entering the interior.

Return air duct chase not sealed/insulated

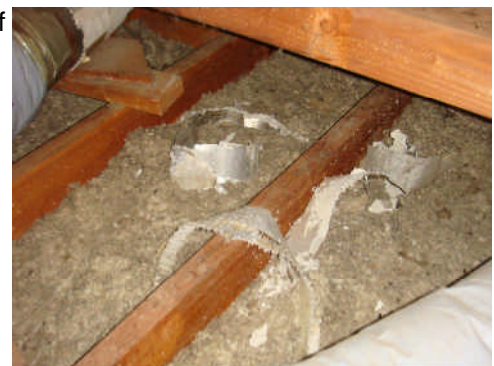
[FE] Suspect asbestos duct material is torn off the ducts and laying on the attic insulation.

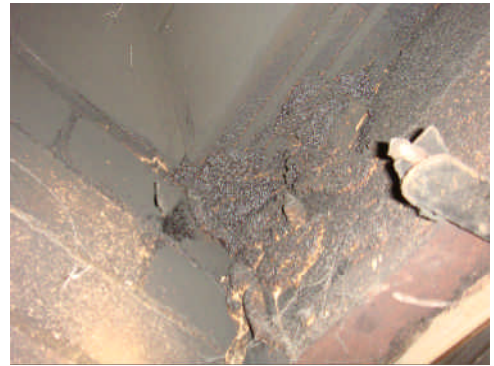
**[CR]** The upper inside front corners of the firebox are soiled. I recommend cleaning and parg coating for a smooth surface.

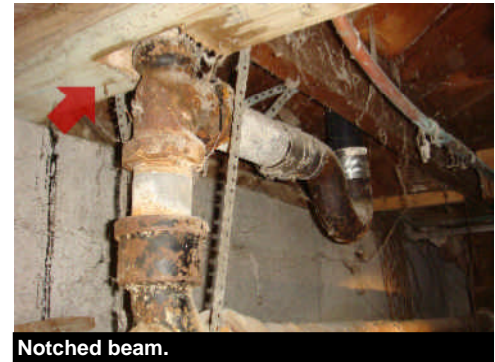
[RU] The beams are in acceptable condition other than noted above. However no gussets or mechanical connectors were installed on the post-to-beam connections at the time of construction. I recommend the installation of mechanical connectors as a seismic upgrade.

Notched beam.

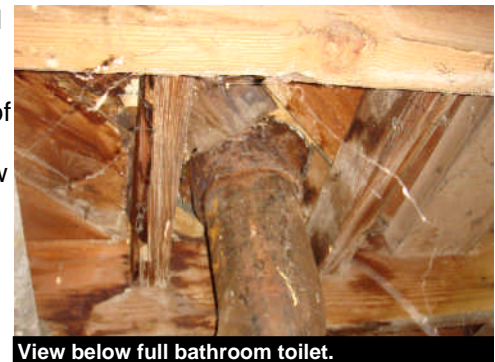
[FE] Moisture stains with some deterioration of the sub floor below the full bathroom. Suspected plywood sheathing is evident below the toilet.

View below full bathroom toilet.

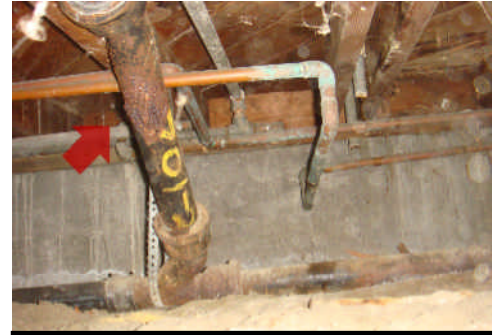
View below kitchen. Corroded cast iron.

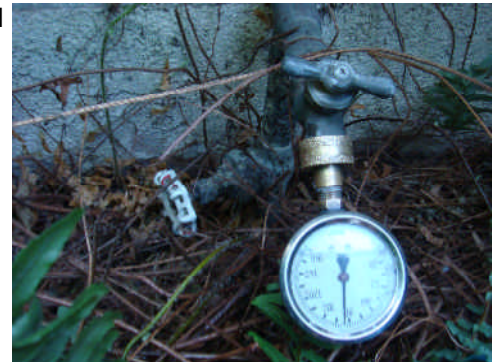
[CR] The static water pressure was measured at an exterior hose faucet and was 84 PSI which exceeds the 80 PSI maximum. This condition is conducive to plumbing leaks (pipes and faucets). A pressure regulator should be installed as required to limit the water pressure to or below 60 PSI, or appliance design limits.

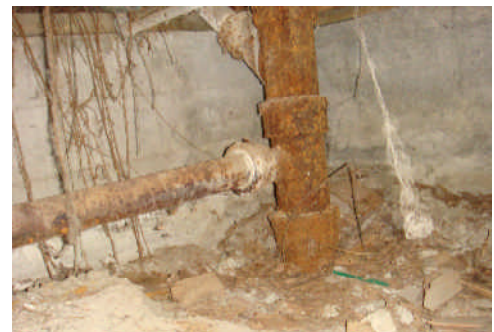
Rusted drain pipe below the 3/4 toilet.

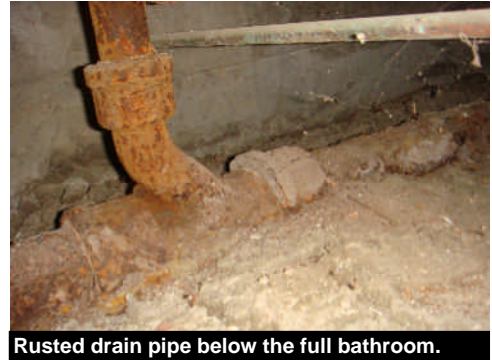
**Rusted drain pipe below the full bathroom.**

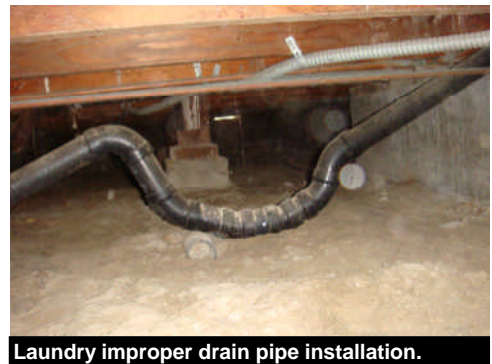
[CR] The laundry drain pipe in the craw space is improper. The drain trap and venting should be identified and evaluated. The drain pipe should be corrected for proper draining.

**Laundry improper drain pipe installation.**

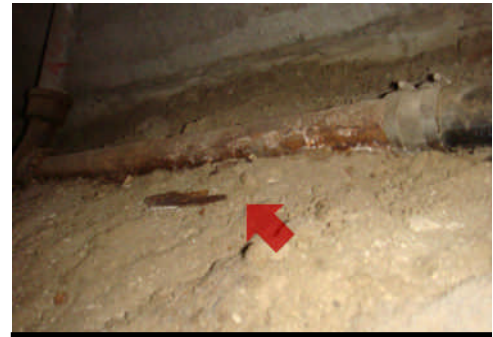
[RU] The cast iron pipes are apparently at the end of life. I recommend replacing the corroded and rusted pipes.

**Metal is breaking off the cast iron pipe.**

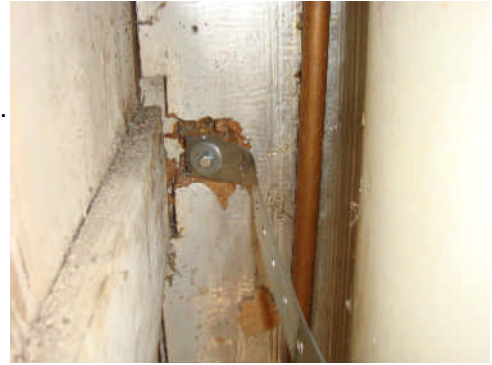
[CR] The straps should be fastened properly and installed one third from the top and bottom. The top strap is loose could be pulled out of the wall with the hand. Tanks are filled with water and very heavy.

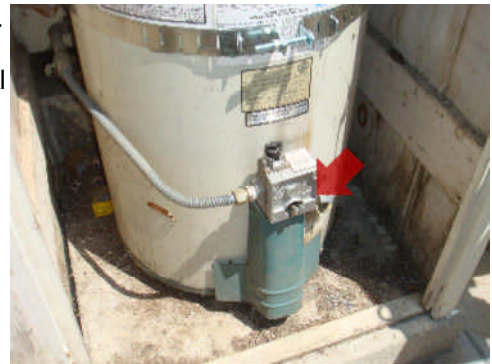
[CR] The temperature control knob is missing. The temperature control was set in the "normal range" and the water at the faucets is warm/hot.

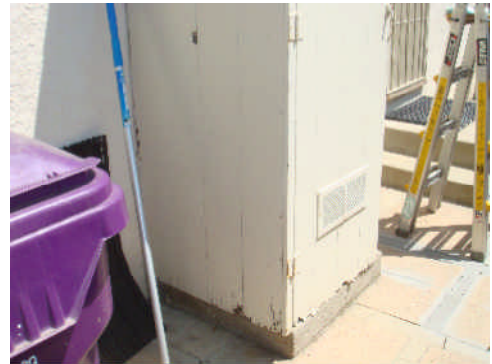
[CR] The enclosure is not secured to the wall and has moisture /insect damage.

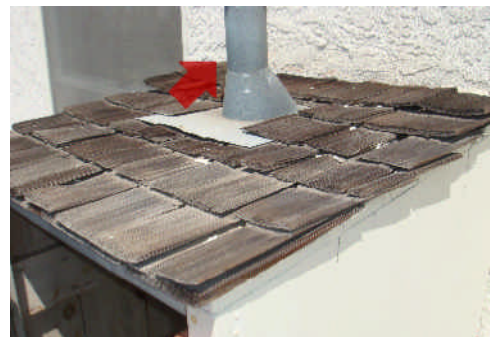
[CR] The wood shake cabinet roof is damaged and an improper material for the cabinet top slope.

View also of the single wall vent flue.

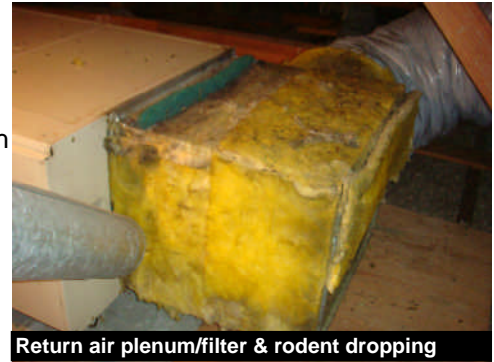
[SC] The filter cover is missing, the filter is soiled, and the plenum /insulation is soiled with rodent droppings. This condition is a health concern.

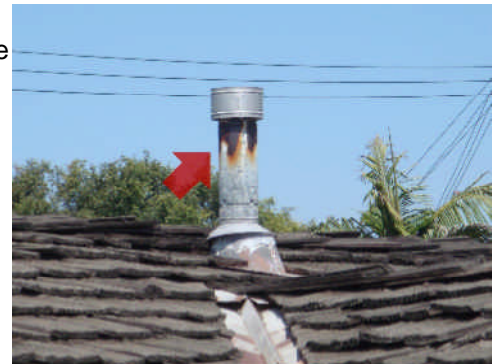
[FE] The metal vent flue is rusted below the cap above the roof. The vent system should be evaluated due to this condition.

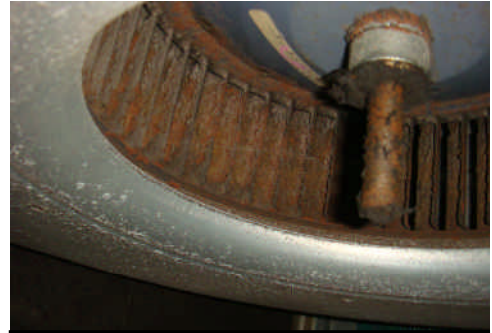
[SC] Dust /debris is built up on the fan, motor and in the fan compartment. I recommend having the fan removed and cleaned by a heating contractor /professional for health.

View of the soiled fan blades.

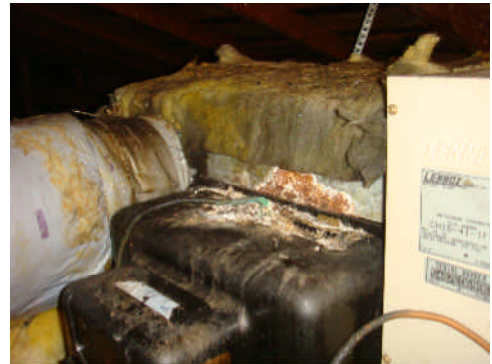
[CR] [RU] The air supply metal is damaged, corroded and soiled from the added humidifier and rodents. The plenum should be replaced.

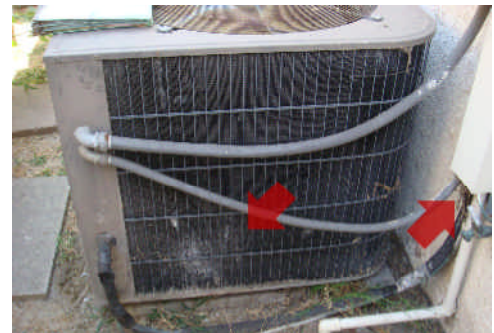
Visible coil damage.

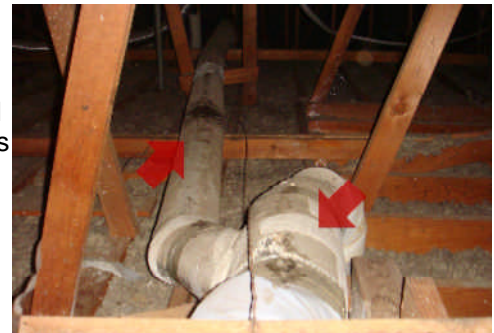
[SC] [RU] The original ducts are manufactured with a material that may contain asbestos. This duct material is like cardboard, and are damaged from rodents. Rodents appear to have eaten into the ducts.

Soiled ducts from rodents. Health concern.

[SC] [RU] The ducts /system should be replaced for health, due to the conditions and rodent damage /contamination.

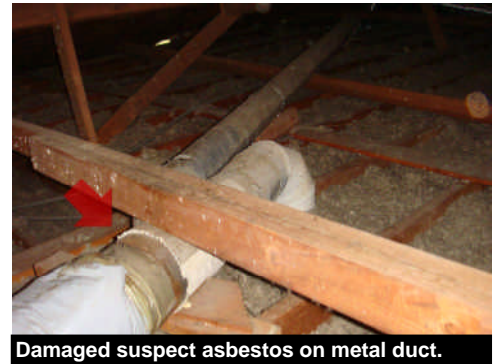
Damaged suspect asbestos on metal duct.

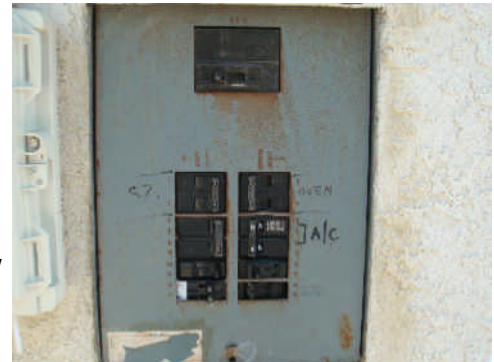
[CR] A number of the circuit breakers are not labeled or labeled properly. The circuit breakers should be accurately labeled to allow individual circuits to be shut off for maintenance or emergency needs.

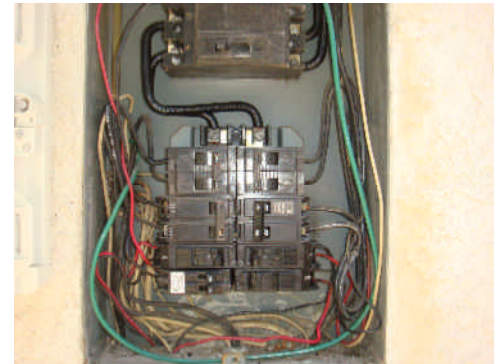
**[SC]** Breaker amperage exceeds wire capacity. Install proper size breaker.

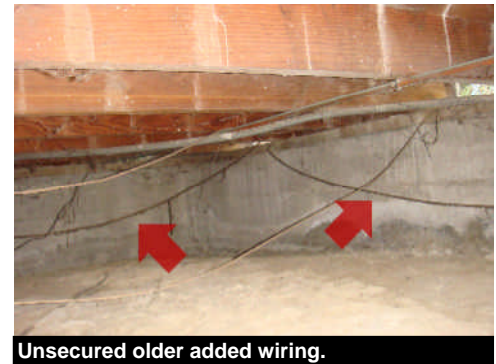
**[CR]** The cloth insulated wiring in the craw space is feeding the rear right bedroom and not secured.

**Unsecured older added wiring.**

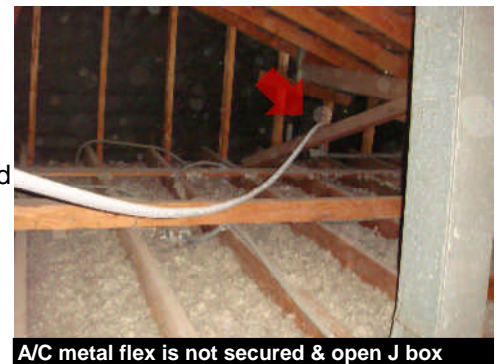
**A/C metal flex is not secured & open J box**

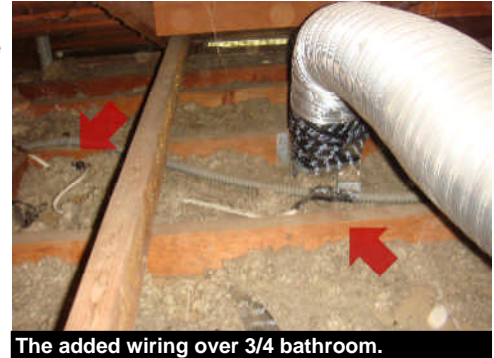
**[SC]** Improper exposed wiring splicing above the 3/4 bathroom should be corrected, and the added fan wiring /installation evaluated.

The added wiring over 3/4 bathroom.

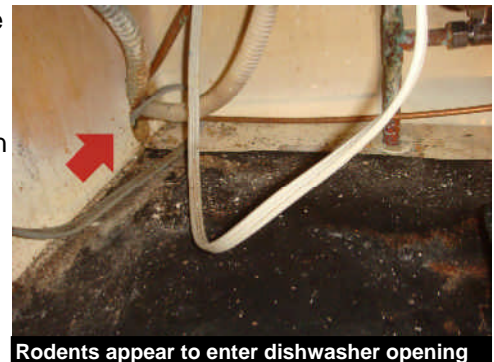
**[SC]** Rodent droppings are evident below the sink. Rodents appear to be entering the hole in the cabinet behind the dishwasher. This condition is a health concern.

Rodents appear to enter dishwasher opening

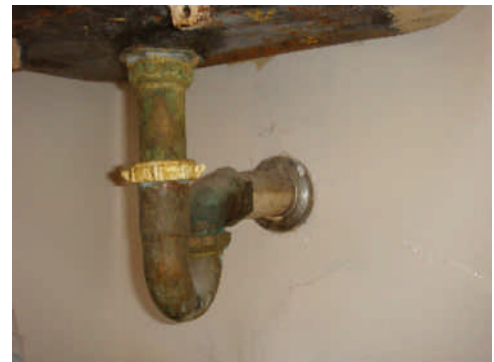
[CR] The sink drain is corroded and rusted.

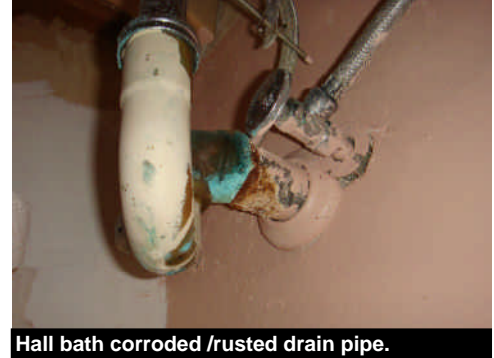
Hall bath corroded /rusted drain pipe.

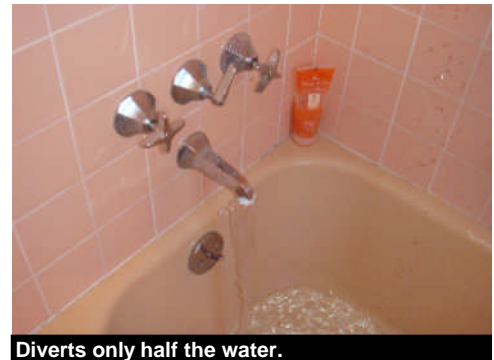
Diverts only half the water.

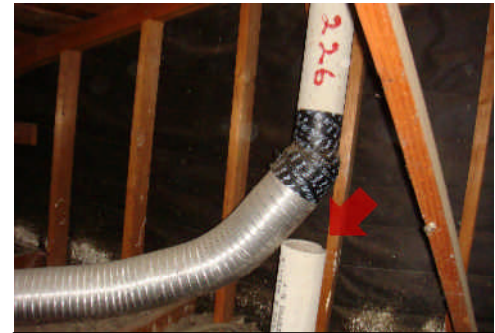
Broken in half transite pipe is asbestos.
