Building Inspection *Photo Documentary Report*

12 Journey, Aliso Viejo, CA. 92656

Steve Garcia Inspections

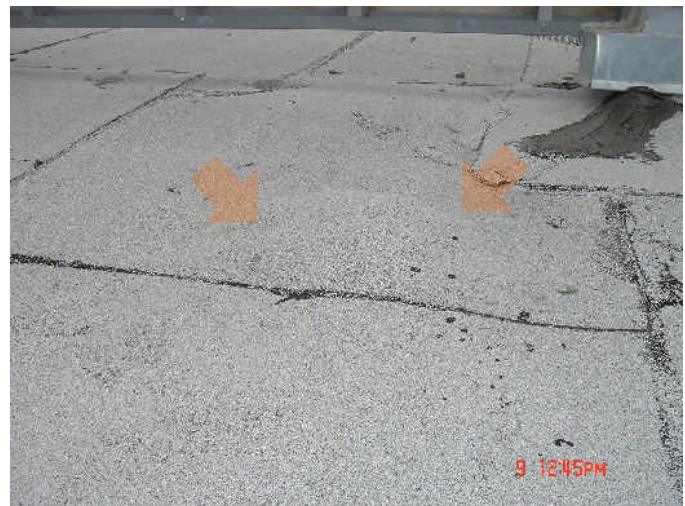
PHOTO # 16

Blister evident at the north center roof area. This blister should be repaired before it is stepped on and broken. [CR]

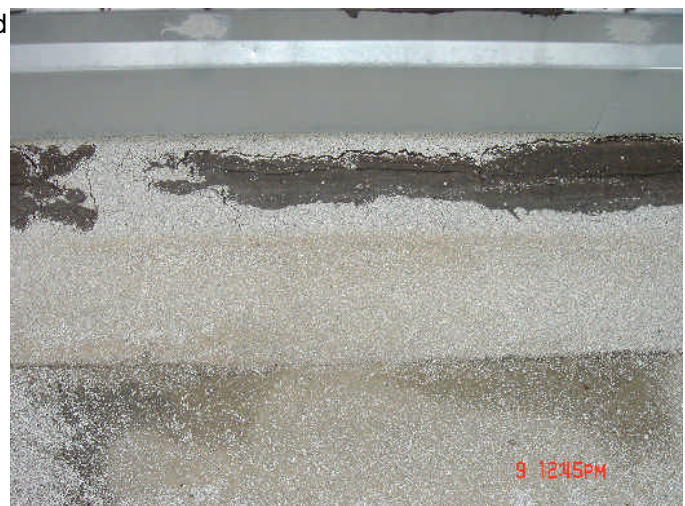
PHOTO # 17

The added mastic has damaged the roofing material at the roof perimeter. [CR]
Mastic should not be used as a repair, we recommend using a single ply torch down material.

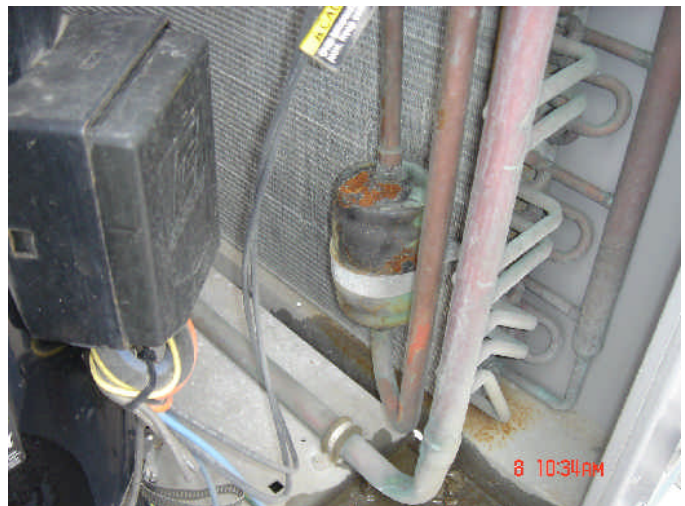
PHOTO # 30

Close up of the compressor with uninsulated evaporator line, dripping condensation onto the platform creating rust. [CR]

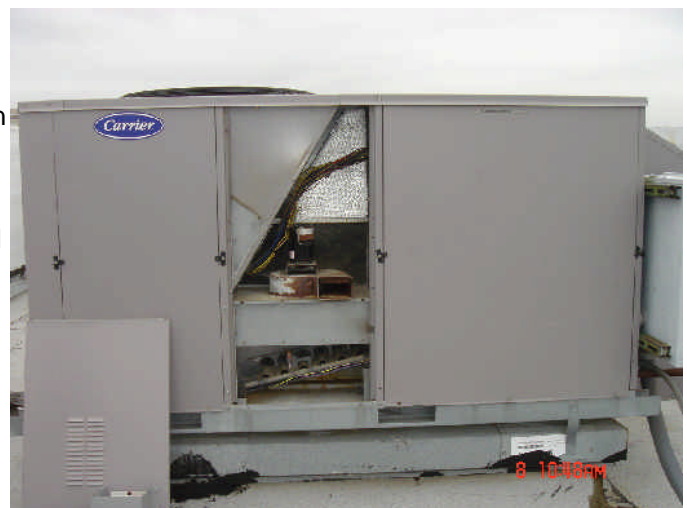
PHOTO # 36

Close up of the rusted induced blower motors. [FE] [CR]

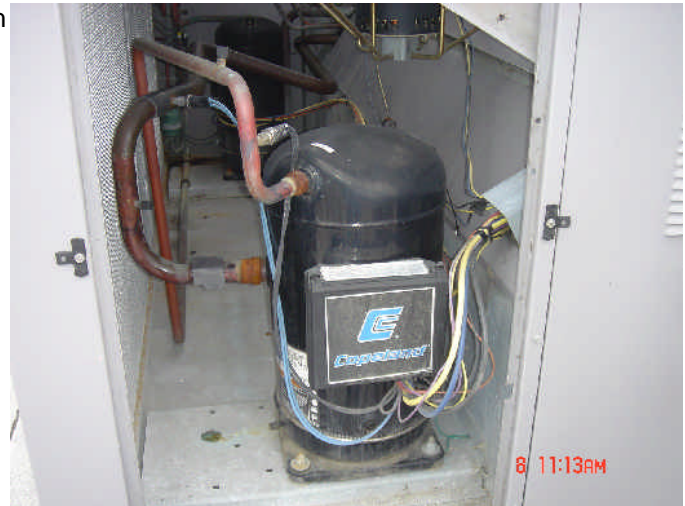
PHOTO # 43

Second compressor in the same unit with the similar condition. [CR]

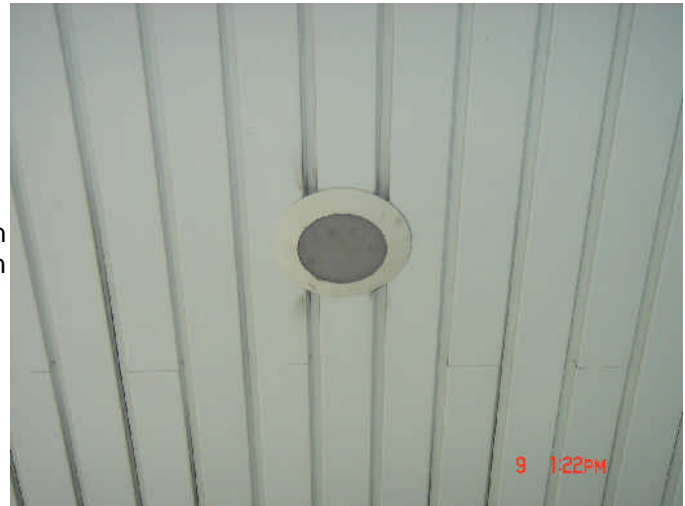
PHOTO # 49

Another example of improper pressurization seen in the same area. [FE] [CR]

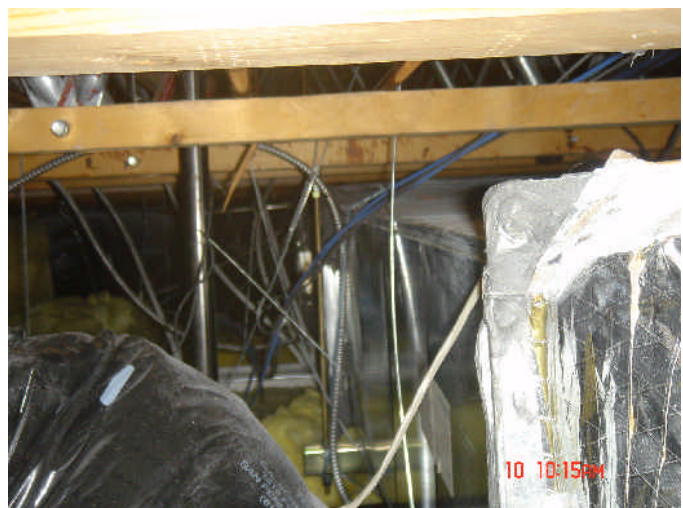
PHOTO # 54

Air leak at the corner of the duct located above the second story, occupied office space, very cool air space above the ceiling.
[FE] [CR]

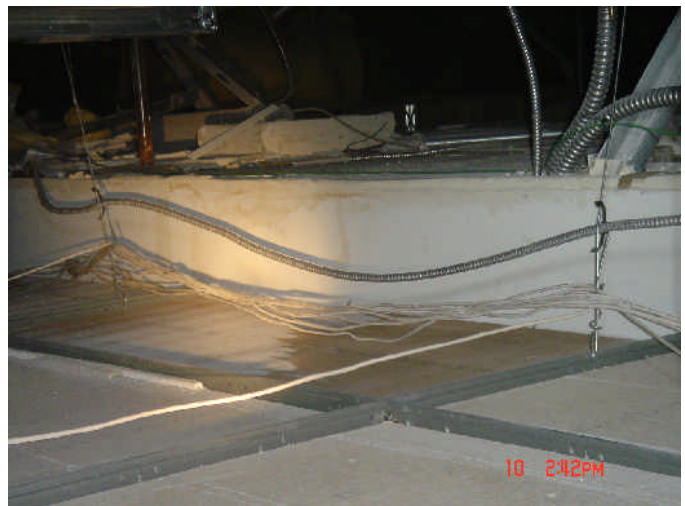
PHOTO # 57

Improper duct connection, ducts were not touched for inspection, the entire duct system should be evaluated before the close of this real estate transaction. [FE]
[CR]

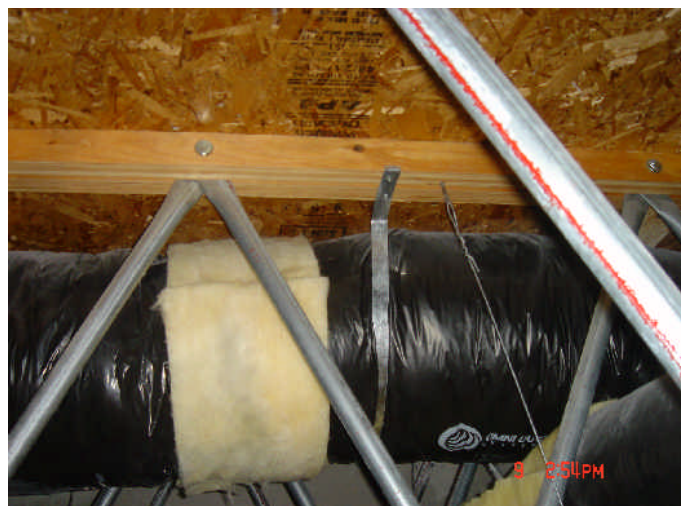
PHOTO # 60

Diffuser securing and seismic straps installation appears improper. [FE] [CR]

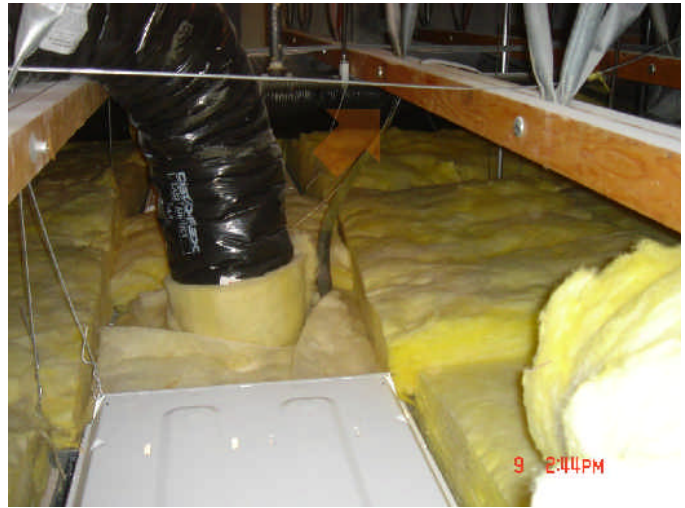
PHOTO # 61

Loose insulation on metal duct connector. [FE] [CR]

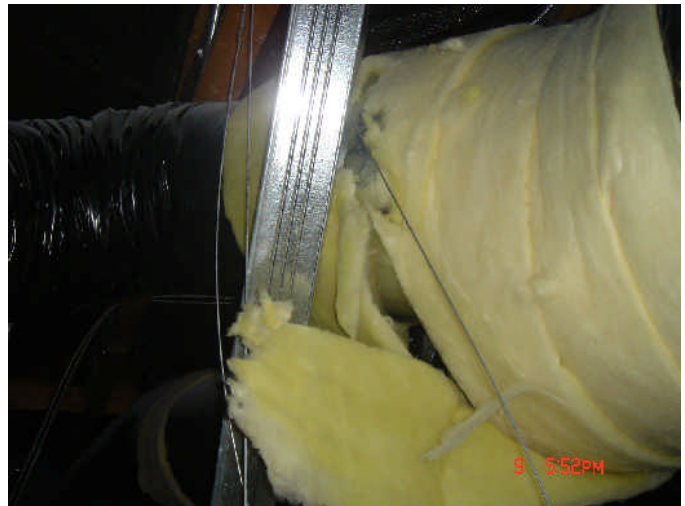
PHOTO # 62

Water stain on the ceiling below this exposed metal duct connector, at the second floor occupied office. [FE] [CR]

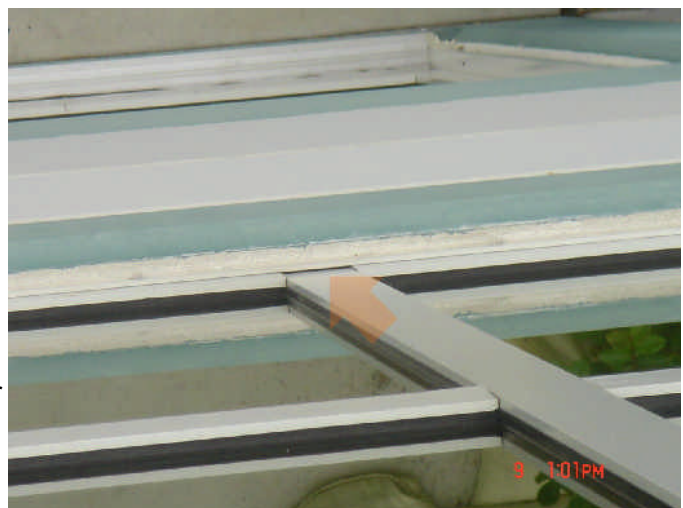
PHOTO #126

View of the second story south side window frame separation, opening /void and deteriorated caulking. [FE] [CR]

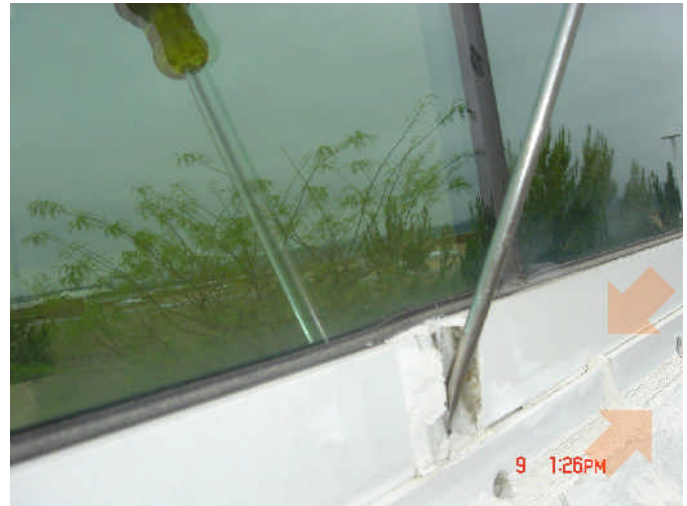
PHOTO #127

Second picture of #126.

Drain holes appear to have been drilled into the bottom of the window frames after the windows were installed, for water to drain out due to this type of frame configuration. [FE]

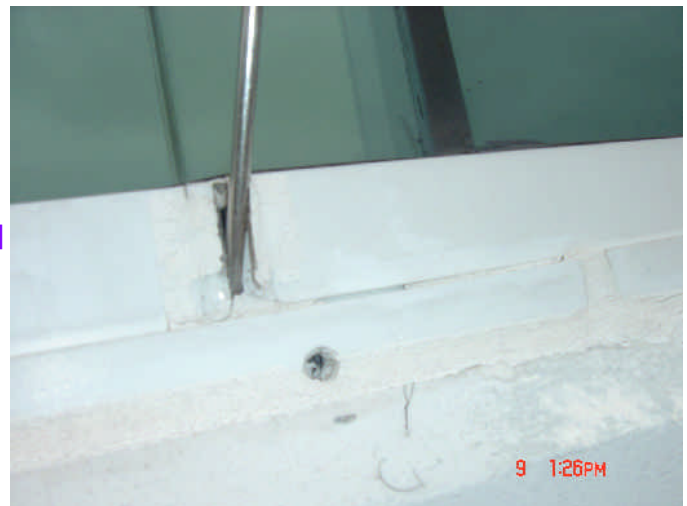
PHOTO #128

Cause of stains are unknown. [FE]

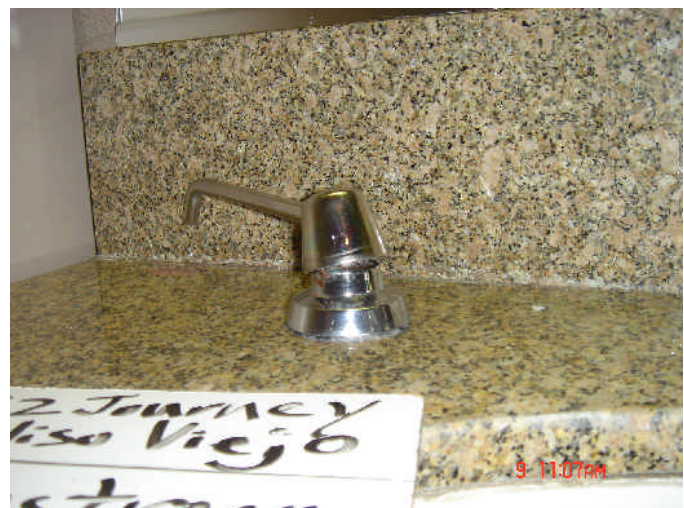
PHOTO #141

Signs of leakage under the restroom countertops at the fixture cut-outs typical throughout the bathrooms. [CR]
