Pre-purchase Home Inspection Report

Sample report of a 6 year old 4,400 square foot house

Steve Garcia Inspections

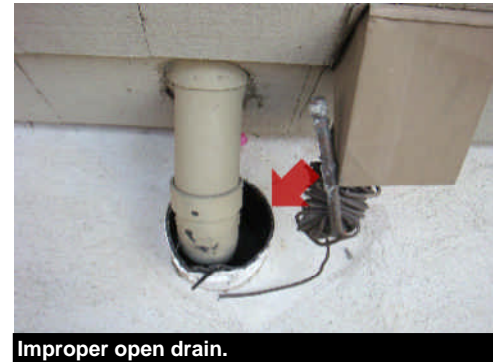
[CR] The landscape drains and roof downspouts have been connected improperly with the drains open.

I recommend installing proper downspout / drain connectors, or cutting back the drains and downspouts and install drain grate / screens to prevent any debris from entering the drainage system.

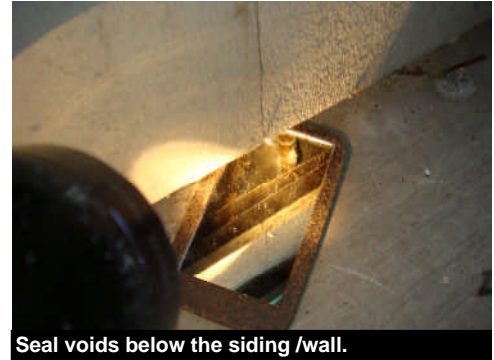
[CR] A void is evident below the wall outside of the kitchen where the plumbing is located. I recommend sealing all voids to prevent rodents, insects and air from entering.

Seal voids below the siding /wall.

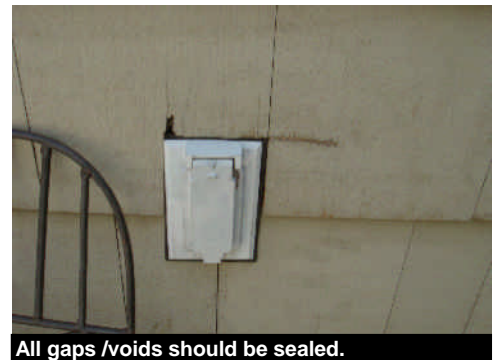
[CR] There are gaps between the shingled siding and adjacent materials /pipe at the left side.

All gaps /voids should be sealed.

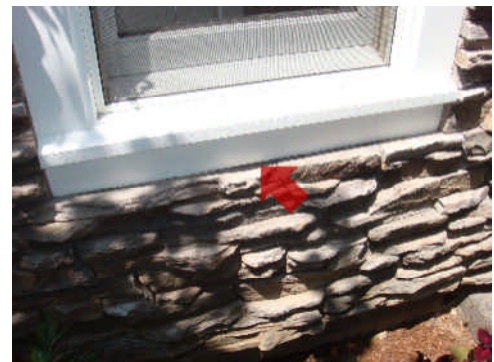
[FE] The stone termination /base is lacking a drainage plane flashing.

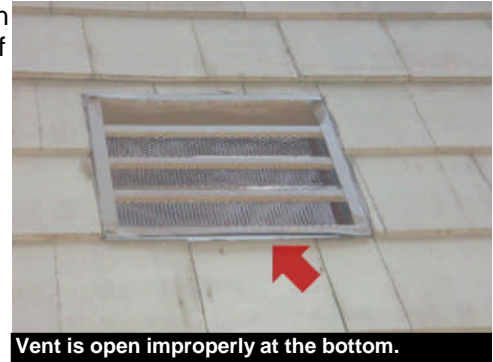
321 COMMENTS [CR] The laundry room metal wall vent is open at the bottom over an 1/4" and is bent inside of the room and out.

I recommend consulting with the home owner as to this condition.

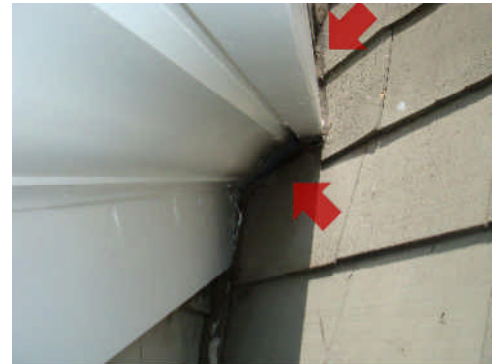
322 INSPECTOR RECOMMENDS [CR] At the front center of the house a gap / void is evident between the soffit and wood shingles. The void should be sealed properly.

[FE] Caulking is evident above this area. No flashing separating the shingles and soffit.

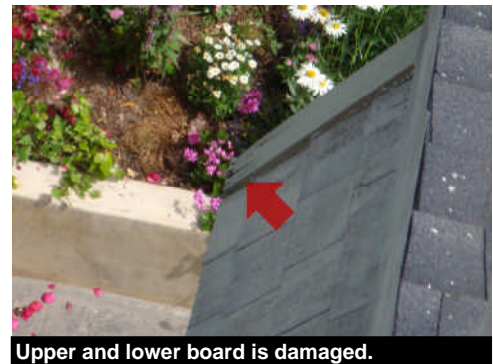
[FE] The rear left trim board is damaged/ deteriorated.

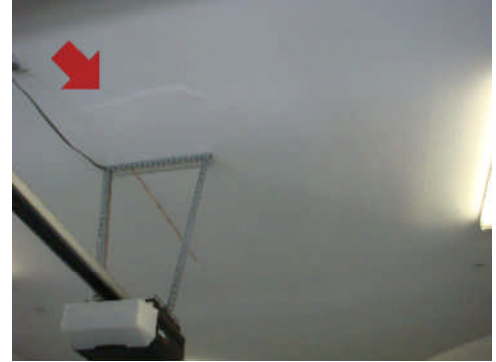
[FE] The ceiling board is fractured adjacent to the door opener.

[FE] It is unknown if the fractured ceiling board has compromised the required fire-resistive /separation.

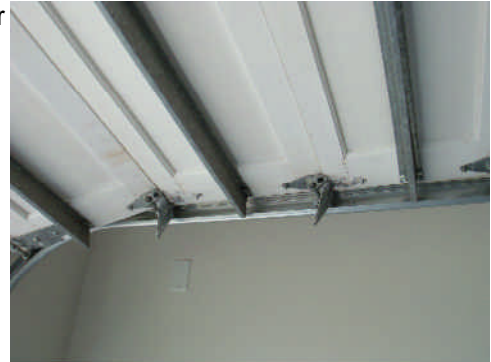
[CR] The garage door hardware /hinges are loose and missing securing nuts.

[CR] The rubber sill is loose at the bottom of the door.

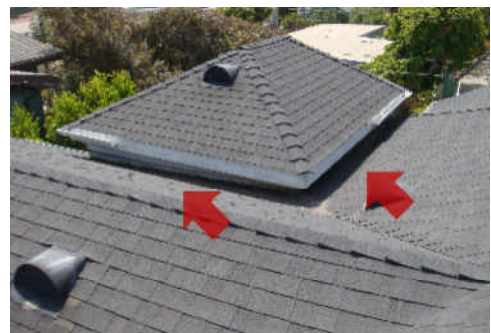
Low slope area has roofing material.

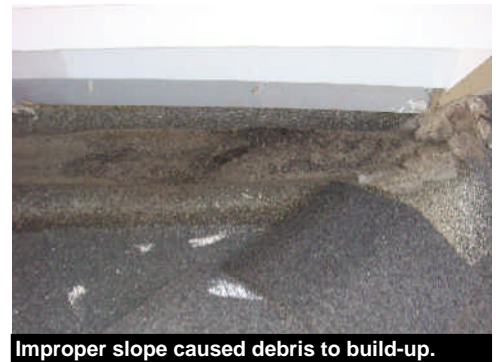
[CR] Picture # 500 above has arrows pointing to an area with roofing material in place of metal flashing /cricket to prevent debris from collecting and allow proper water to runoff.

[CR] Debris has collected due to improper slope above the front left bedroom where moisture stains are evident in the closet.

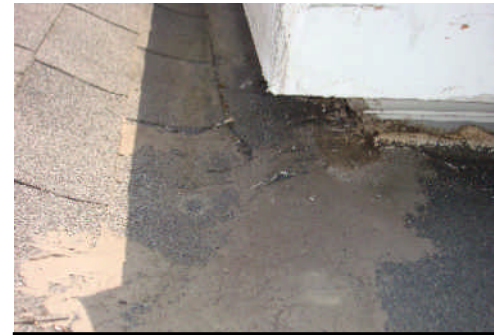
Patching will not correct the condition around the upper bedroom roof to wall intersection.

Patching will not correct conditions.

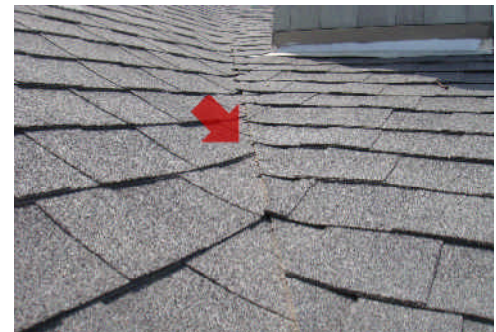
[CR] The rear valley shingles are not cut back from the center of the valleys properly like the front valleys are.

Debris & moisture becomes trapped.

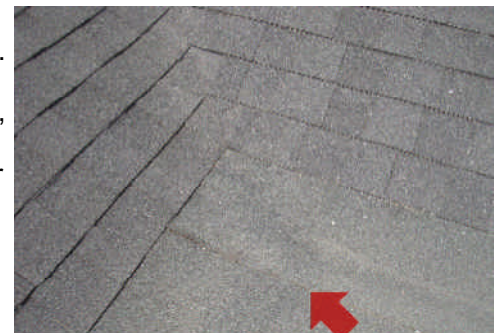
[CR] The roofing material appears weathered, the seams are not properly sealed, and the material is lacking proper backing at the upper slope area below the shingles.

Suspect leak area, no bond to deck.

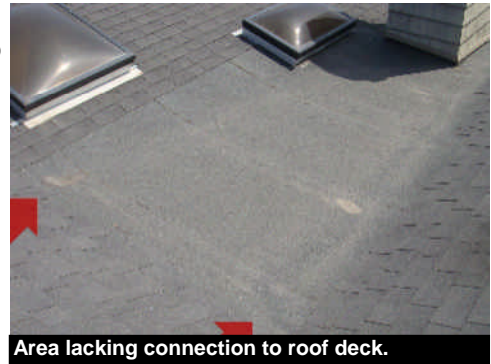
516 COMMENTS [CR] Mastic /tar patching is evident at the upper area that is lacking proper connection to the roof deck. The moisture stains in the hallway appear to be below this area.

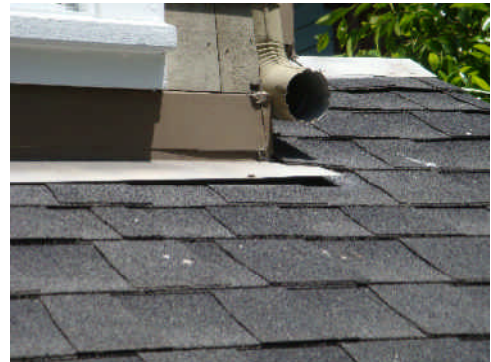
[FE] The visible rear edge flashing is improperly over the underlayment /felt.

[CR] The front right lower roof to wall flashing and fastener is lifted and unsealed.

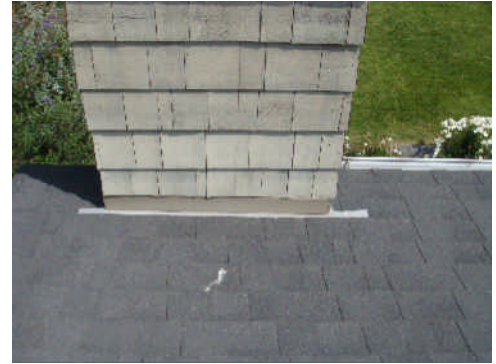
522 COMMENTS [FE] The rear left 36" wide chimney is lacking a cricket. No evidence of puddling water or damage to the shingles.

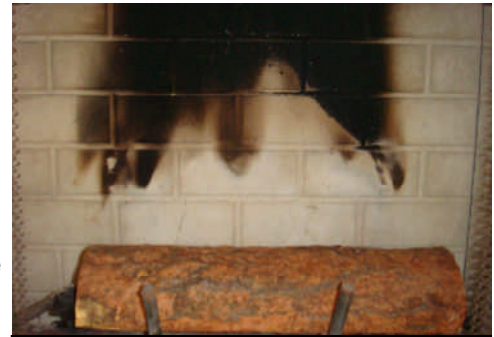
Family room firebox rear wall panel.

The family room firebox rear ceramic panel has small cracks that are not a defect at this time.

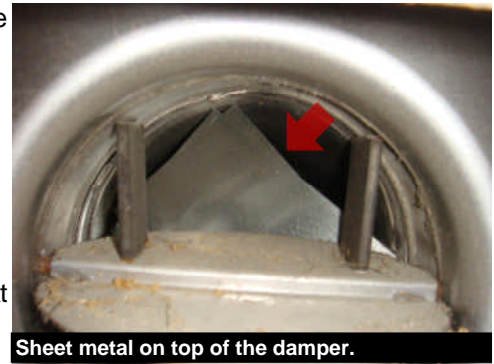
Sheet metal on top of the damper.

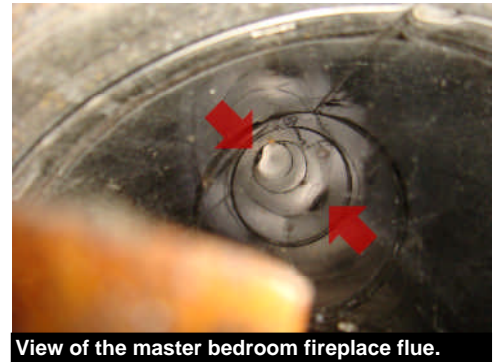
[SC] The master bedroom flue metal is bent at the connections. This fireplace should not be used until the flue is evaluated. See #710 picture below.

View of the master bedroom fireplace flue.

I recommend an inspection by a qualified fireplace specialist. My inspection of the chimney flues is limited to the readily visible portion from the fireboxes only. The inner / upper reaches of the flues are inaccessible. A qualified fireplace specialist will remove the chase and flue caps, use a specialized video camera as needed to evaluate the flues.

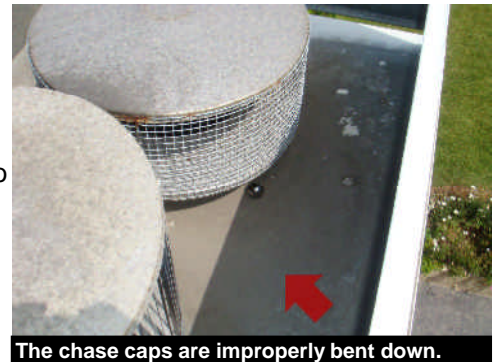
The chase caps are improperly bent down.

I recommend painting the caps with an oil based rust inhibitor.

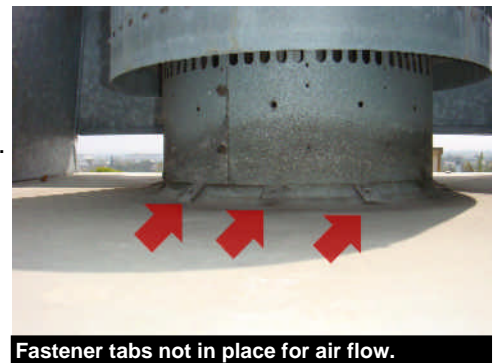
[FE] The outer flues installation appears improper. This type of installation may not allow proper air flow for cooling the inner flues.

Fastener tabs not in place for air flow.

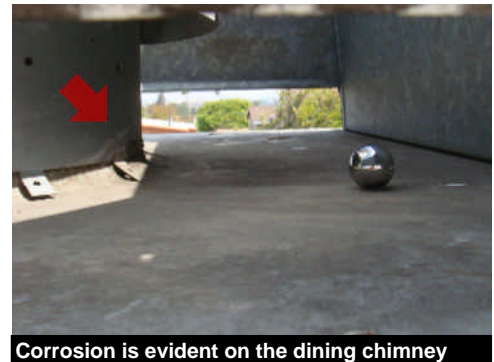
713 COMMENTS [CR] Due to the poor chase cap installation the irregularly installed outer flue is corroding at the dining /living room chimney.

The manufactures installation instructions should be reviewed for proper installation of the chimney flues.

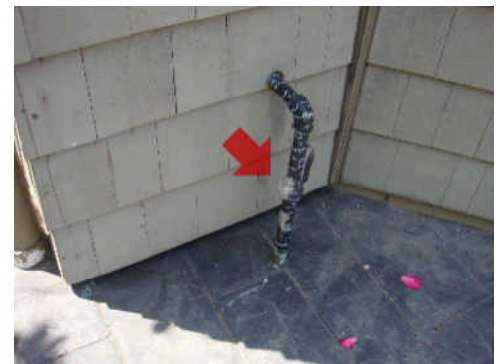
[SC] Improper use of gas pipe union connector for the rear yard BBQ supply pipe. The supply pipe is also lacking a shut-off valve.

[FE] The gas supply pipe appears to have been spliced from the kitchen. The pipe installation is irregular and should be evaluated.

The gas pipe installation should be on the approved and stamped building plans.

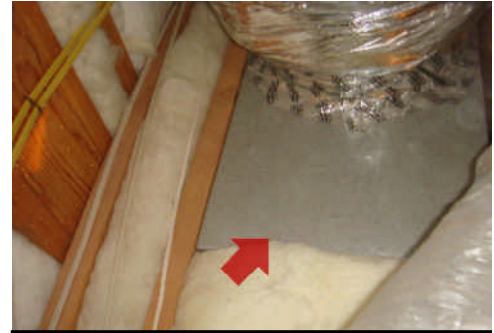
If an A/C condenser is installed and used the return air filter plenum should be insulated.

Un-insulated return air filter plenum.

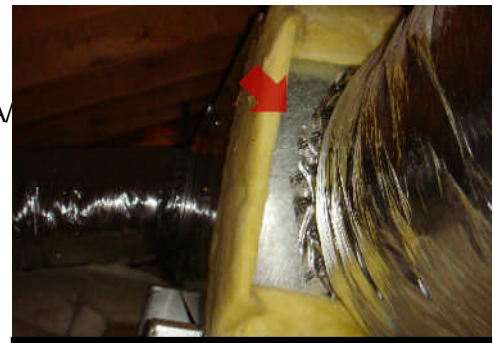
The cabinet is not completely insulated. If an A/C condenser is installed and used the cabinet should be insulated.

Un-insulated area of the cabinet.

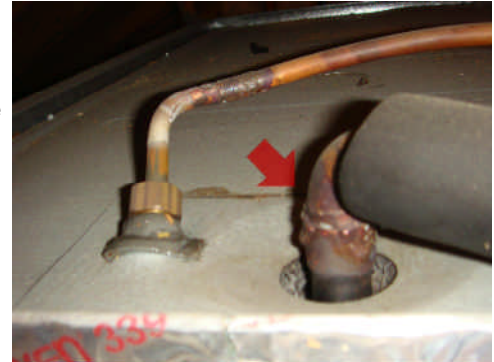
A bushing and line insulation is missing, conditioned air is escaping.

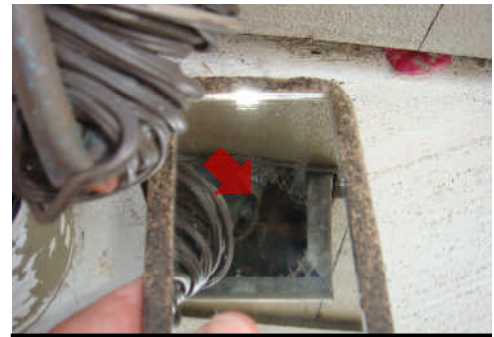
[CR] The refrigerant lines are provided and in place. The wall flashing is not sealed below to prevent rodent access.

Seal void at the line set wall flashing.

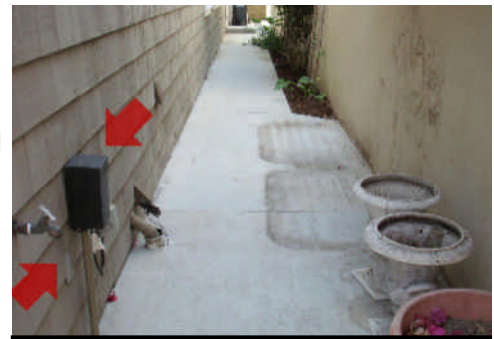
An electrical disconnect has not been installed at the location for the condenser. A junction box is evident at this area, the cover was not opened to prevent breaking the seal on the box cover.

Covered J. box & low voltage light timer.

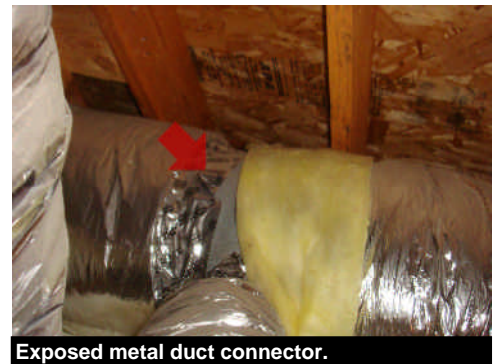
[CR] The main air supply metal duct connector is lacking insulation in the attic. The connector should be insulated if A/C is installed and used.

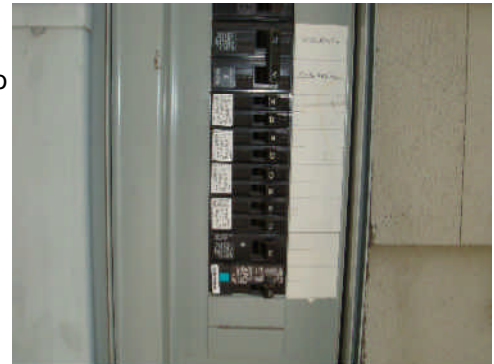
[CR] A number of the circuit breakers are not labeled. The circuit breakers should be accurately labeled to allow individual circuits to be shut off for maintenance or emergency needs.

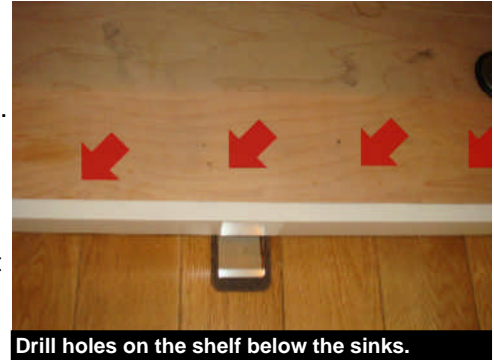
[FE] Below the island sink spider webs are evident. This condition is caused from moisture. The slab vapor barrier may have not been sealed around the under slab pipes / penetrations.

I recommend installing sheet vinyl on the bottom shelf below the sinks, and sealing around the penetrations.

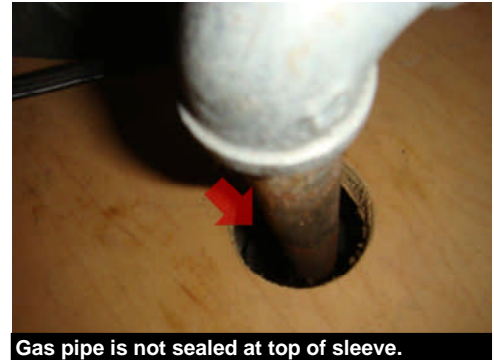
[FE] The gas supply pipe sleeve is not sealed at the top below the cabinet shelf.

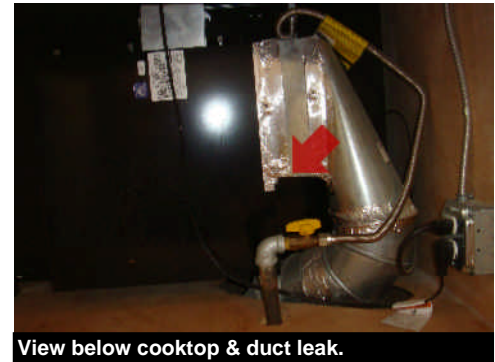
View below cooktop & duct leak.

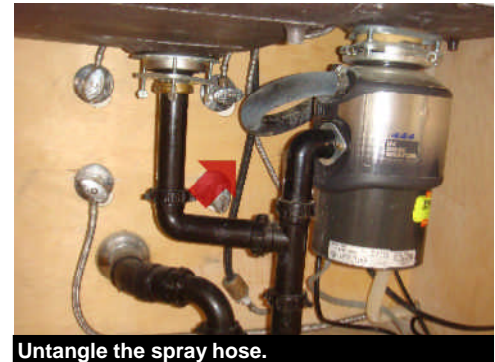
The main sink faucet spray head does not retract properly. Untangle the hose, or add an additional weight.

Untangle the spray hose.

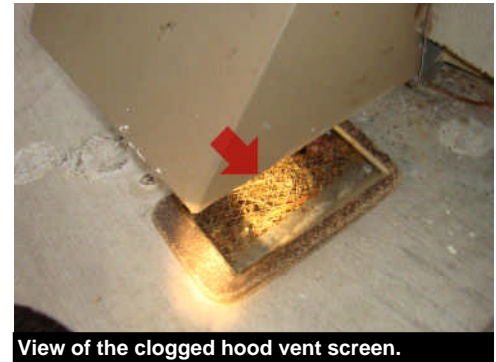
[CR] The exhaust termination hood at the exterior has a screen that is clogged with debris. It is unknown if a back draft damper is installed.

View of the clogged hood vent screen.

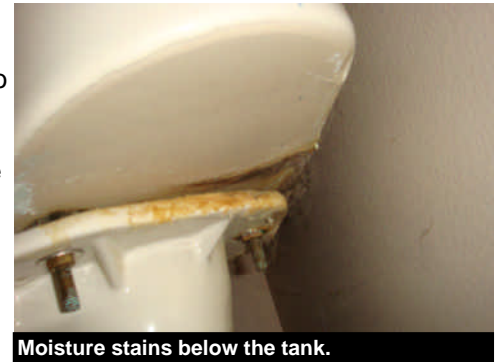
Moisture stains below the tank.

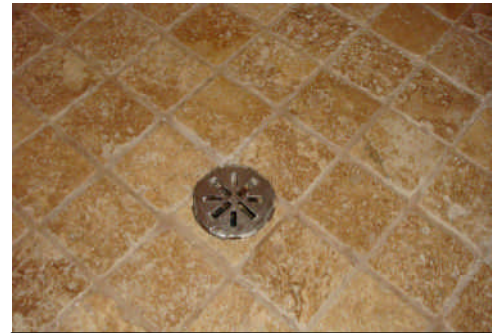
[CR] The second floor 3/4 bath shower stall drain screen is not secured and loose.

Second floor 3/4 shower loose drain cover.

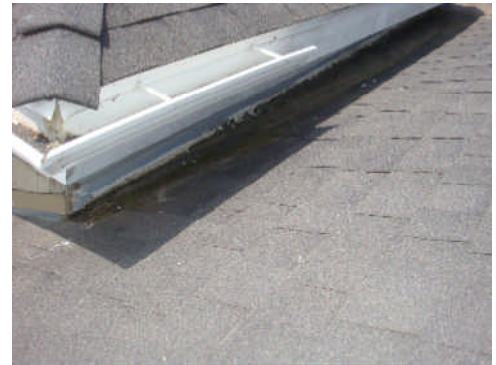
PHOTO # 1 This area is the rear right of the bedroom with the same conditions.

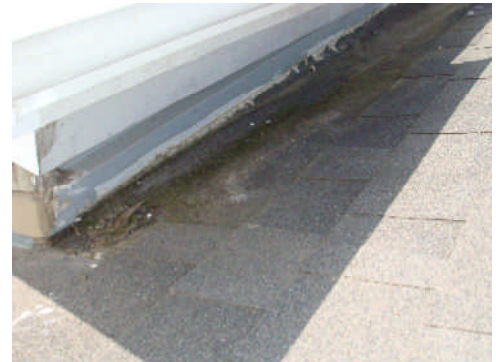
PHOTO # 2 Second picture of #1.

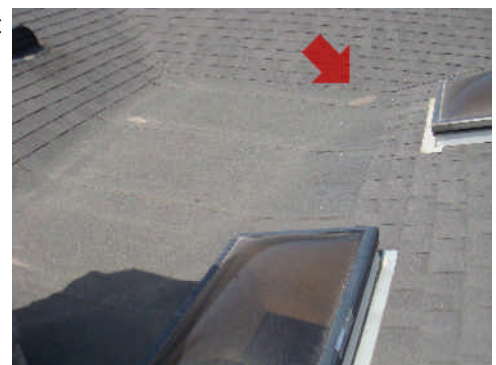
PHOTO # 3 Mastic /tap patching at the roof area that is not connected to the roof deck.

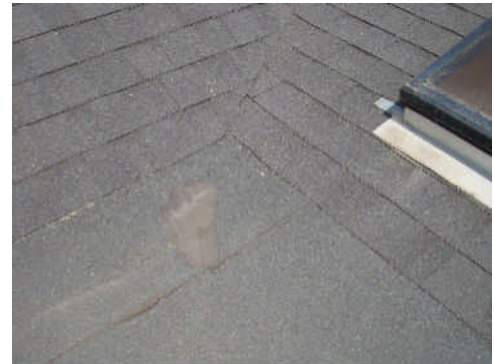
PHOTO # 4 Second picture of #3.

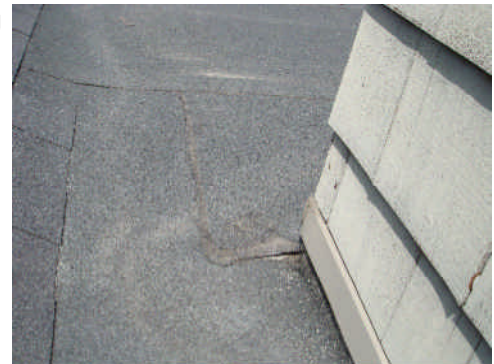
PHOTO # 5 Open lap adjacent to the chimney. The roofing material appears to be a inexpensive product.

This roofing material should be removed and re-roofed with proper connection to the deck.

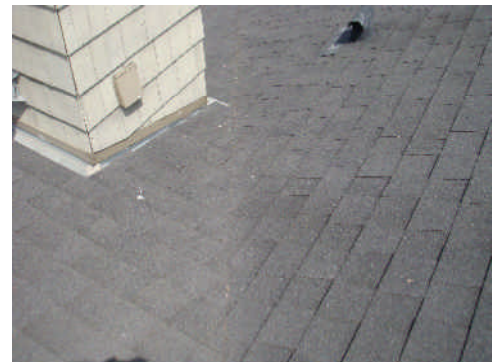
PHOTO # 7 Second picture of #6.
