Pre-purchase Pool /Spa *Inspection Report*

Shady Canyon, CA.

Steve Garcia Inspections

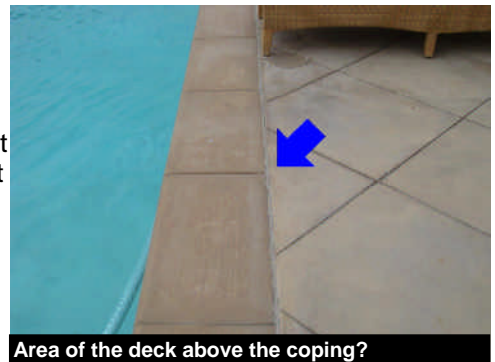
[FE] The deck is 1/4" above the coping at the front center area of the pool, and slight separation of the mastic sealant is evident between the coping and deck.

Around the spa and small pool is what appears to be fastener connectors for safety covers.

Consult with the home owner pertaining to the connectors /covers.

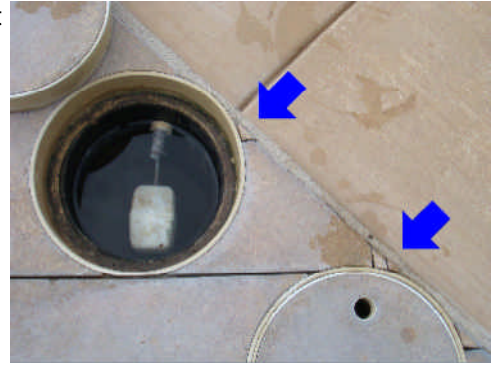
DECKING

[CR] Cracked /broken concrete decking at the left skimmer and fill valve.

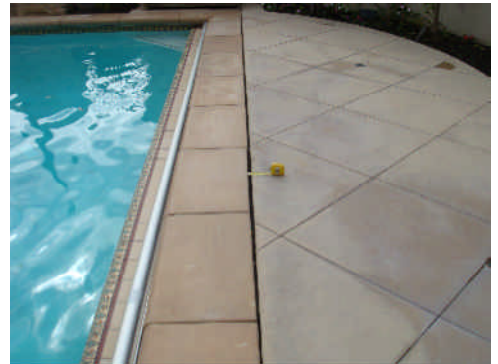
1009 COPING

[FE] The coping sections at the right side above the pool cover appear to be loose, and has a 3/4" separation from the deck.

[CR] Below the rear left corner of the coping is a loose pool cover track fastener.

[FE] The pool cover and equipment is not in the scope of this inspection. I recommend a pool cover manufacture approved installer inspect the cover and systems.

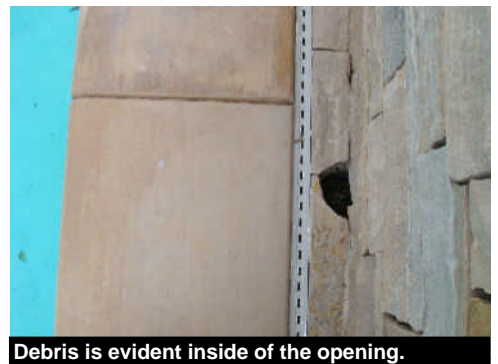
1010 DRAINAGE

[FE] Below the right side waterfall is an opening without a cover /great. The function of the opening is unknown.

[CR] Drain at the rear of the stone wall is missing a great.

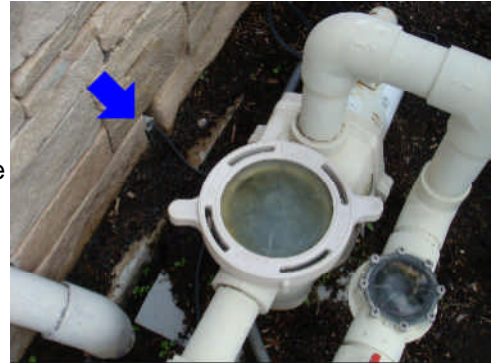
1011 COMMENTS

[FE] At the backside and base of the waterfall stone wall is plastic PVC pipes with low voltage wires and water seeping out.

[CR] Loose stones on the wall.

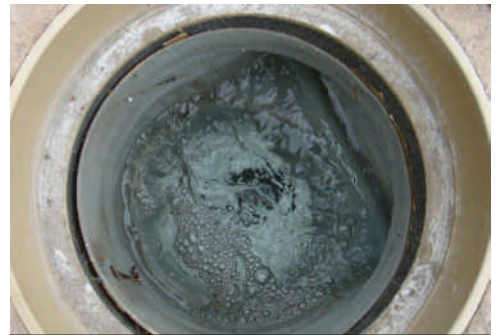
1014 SKIMMER(S)

The front skimmer basket was missing. It appears to have been removed for the creepy crawler /cleaner hose.

Skimmer basket missing.

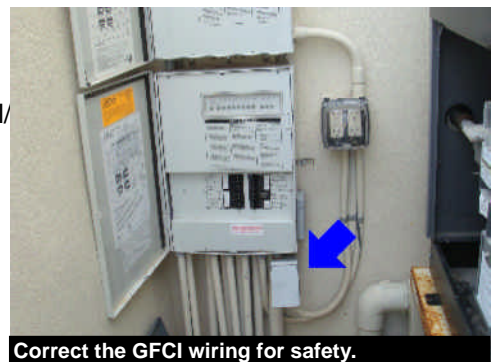
1015 POOL LUMINARIES [LIGHT(S)]

[SC] One of the GFCI receptacles below the equipment electrical box was found to have reversed polarity connections.

Correct the GFCI wiring for safety.

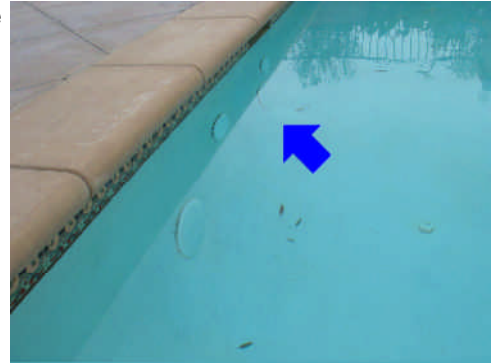
1016 POOL DRAIN(S)

The drain cover(s) are the anti vortex type and appeared to be functional.

[FE] The drains on the pool wall angle is unusual.

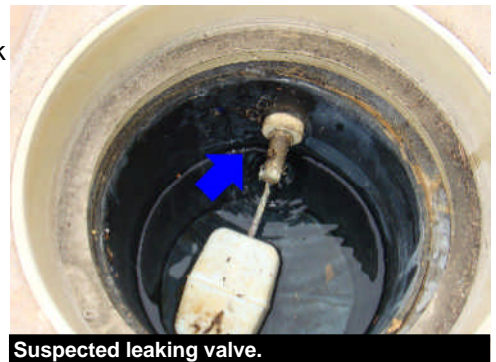
1017 COMMENTS

The pool water supply /level is controlled by auto fill valves located on the pool deck at the left and front areas.

[FE] The front valve appears to be leaking.

[FE] It is unknown if a backflow prevention device /valve is required with the auto fill valves.

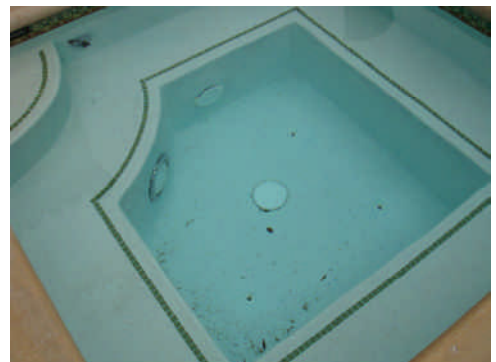
1024 WATER JETS

Water flow was evident from at the jets.

[FE] Nozzles are lacking at the bottom of the spa?

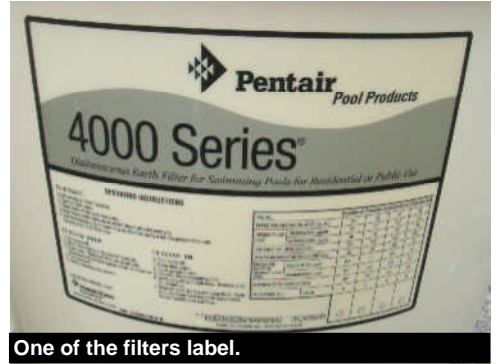
One of the filters label.

Two diatomaceous earth filter units with back wash systems for the pool and spa.

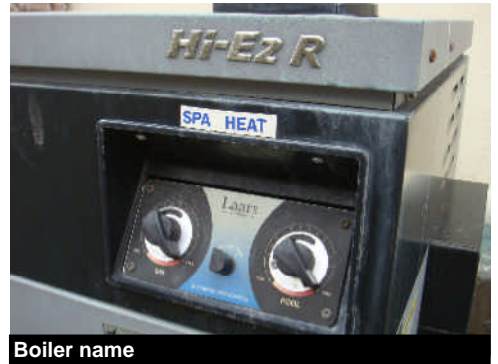
Boiler name

350,000 Natural gas boilers for the pool and spa, are between 6 & 7 years old.

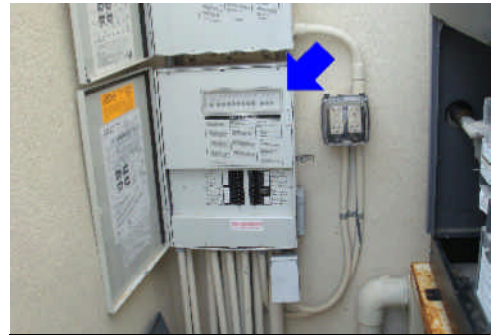
**1035 PANEL/
CONTROLS**

Remote electronic controls at the equipment and interior of the house.

The lower & house panel were only operated

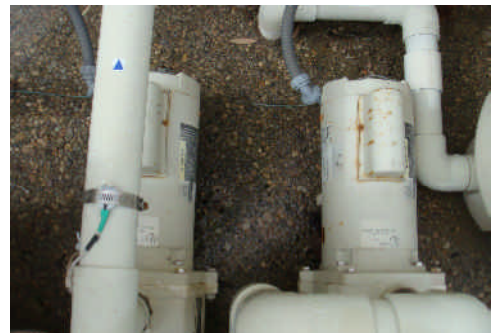
1036 FILTER PUMP

[FE] Suspected leaks were noted at the spa pumps.

One or two pumps suspected leaks.

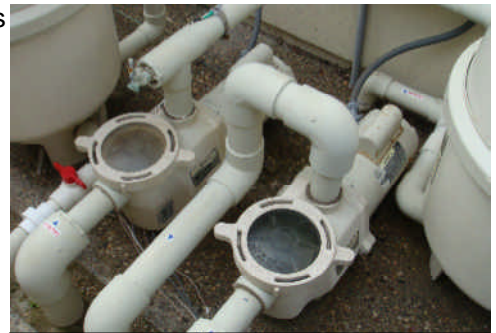
1037 BOOSTER PUMP

Spa booster pump and filter pump.

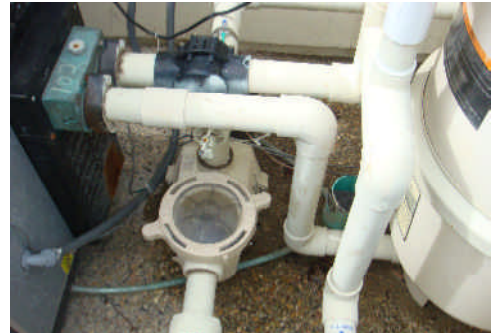
1038 SWEEP PUMP

The pool creepy crawler is operated from the pool filter /skimmer pump.

Pool filter pump.

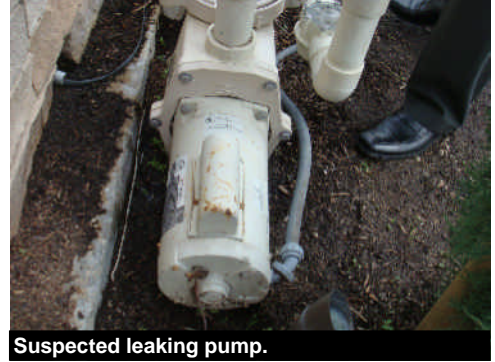
1039 FEATURE PUMP

[CR] The three pumps working access is improper and inaccessible.

[FE] One of the pumps at the backside of the wall appears to leak.

[CR] The platforms for the pumps at the backside of the wall are not supporting the pumps properly. The pumps have improper clearance from the grade.

Suspected leaking pump.

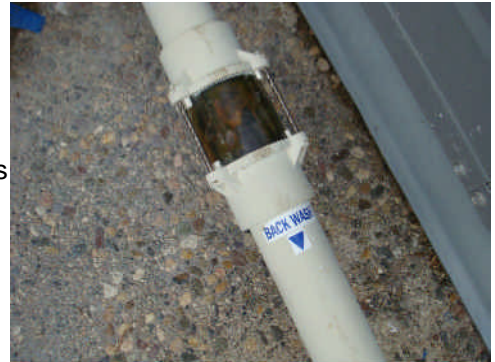
1041 WATER FILTER(S)

[FE] The spa backwash line glass appears to be filled with debris.

[FE] I recommend the filters be opened and the grids be cleaned and evaluated. The pool filter gauges was at 36 PSI during operation.

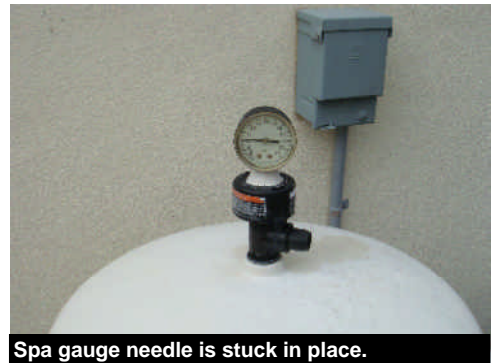
1042 PRESSURE GAUGE

[FE] The pool pressure gauge was at 36 PSI during operation. The filter should be cleaned.

[CR] The spa filter gauge was not functional.

Spa gauge needle is stuck in place.

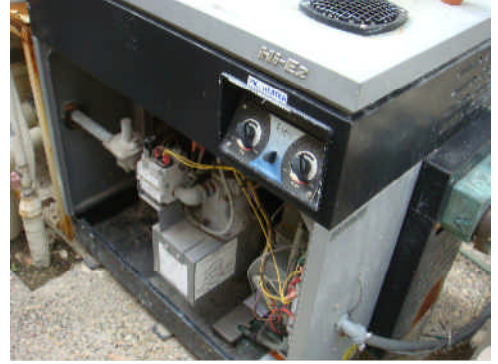
1044 BOILER

[FE] The boilers were functional, one was not secured to the ground.

[FE] The boilers metal housing is rusty.

[CR] The metal platform is rusted.

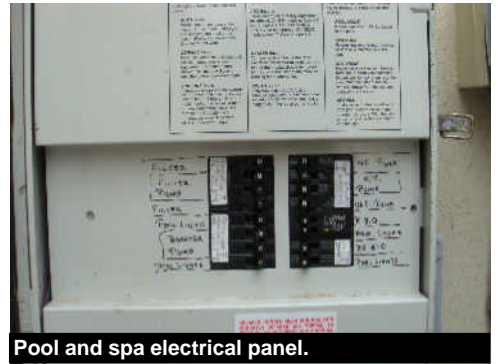
1047 PANEL/ CONTROLS

[FE] The circuit breakers in the panel at the equipment were labeled. The accuracy of the labeling was not verified.

Pool and spa electrical panel.

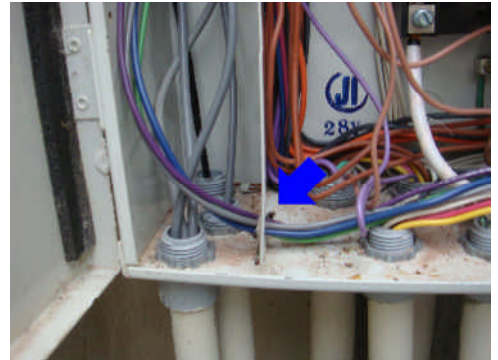
ELECTRIC PANEL

[SC] Improper double lugging was noted on one of the circuit breaker(s) in the panel.

[SC] There was improper wiring through the panel altered partition.

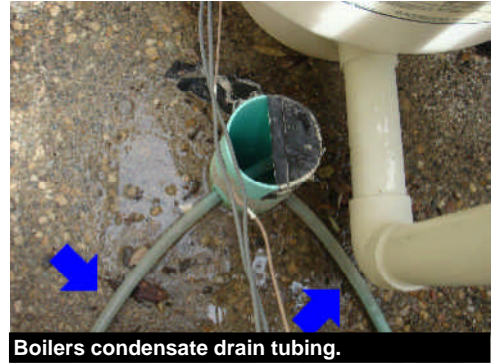
1048 COMMENTS

The equipment area surface drain is open and not finished.

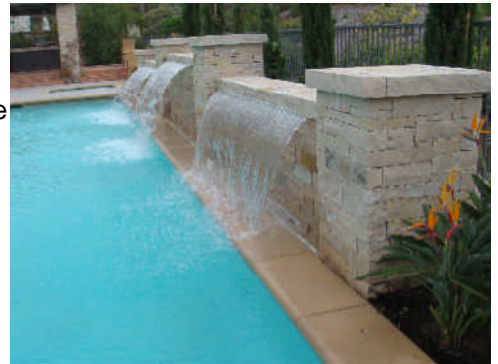
COMMENTS

[FE] The right side waterfall water does not enter the pool.

[FE] The waterfall did not operate after the equipment control panel was switched back to the house control panel.

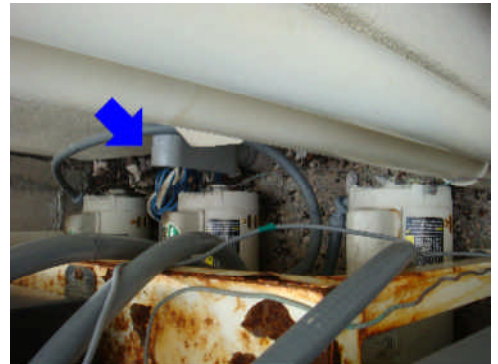
[CR] Exposed low voltage wires at the rear of the three water fall pumps are not accessible, and the conduit elbow is open.

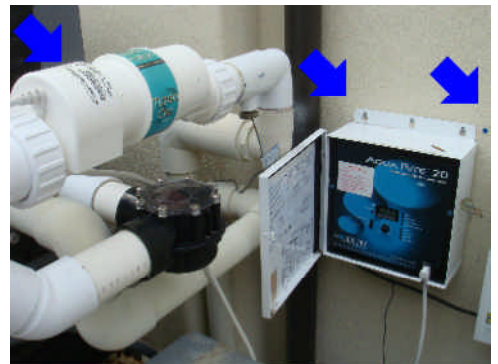
1052 CHLORINATOR

[FE] These units are outside the scope of the inspection and are not inspected.

I recommend a full evaluation by the appropriate specialist.

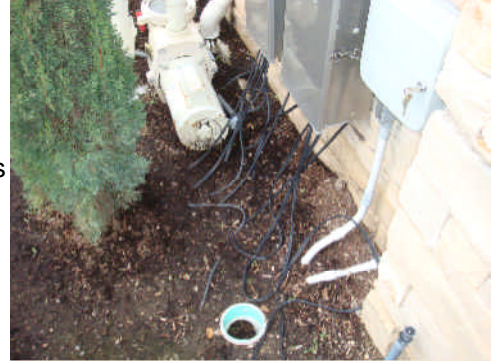
1053 COMMENTS

[CR] The landscaping lighting plastic conduit at the rear of the waterfall stone wall is the only support for the junction boxes.

[SC] The receptacles in the junction boxes are not GFCI protected, and the conduit / wiring is not all visible to the junction boxes or waterfall pumps.
