Pre-purchase Home Inspection Report

23 year old 2,500 square foot house with spa

Steve Garcia Inspections

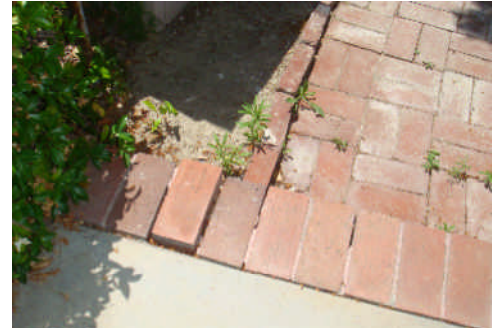
[SC] There is improper /uneven rise on steps/ stairs. This condition is a trip concern.

Loose bricks & missing mortar at spa.

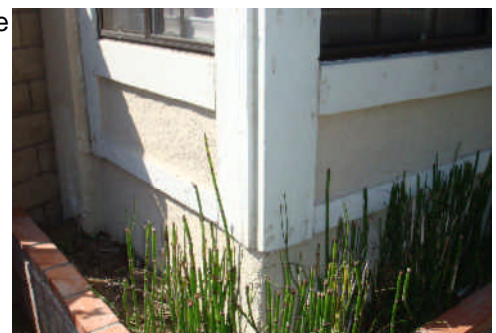
[CR] A raised planter enclosure has been added up onto the front living room wall, above the interior slab /foundation. This condition is conducive to moisture intrusion into the wall and deterioration /damage of the wall materials.

Soil above the interior slab /flooring.

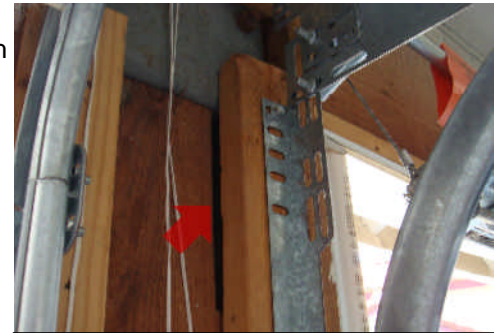
[FE] The door track fastening block is suspect at the large door right side.

No backing behind the support block.

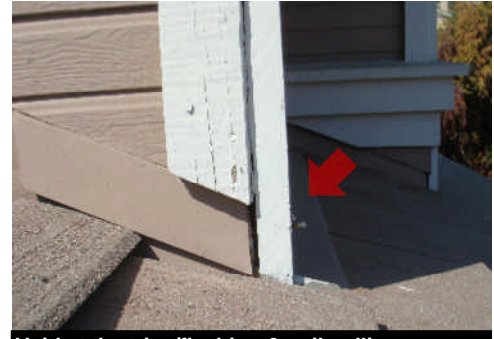
Void at the trim /flashing & nail pulling.

[CR] The wall flashing should be caulked and sealed at the wood trim /siding.

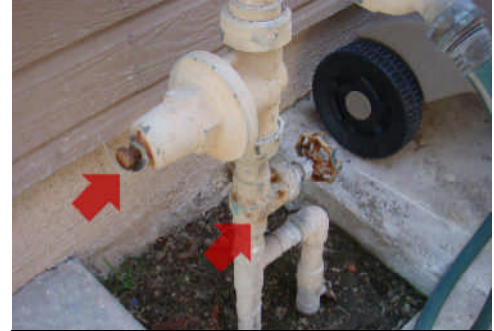
[CR] The main water shutoff valve is corroded. I recommend the valve be replaced with a 1/4 turn ball valve.

Pressure regulator and rusty valve.

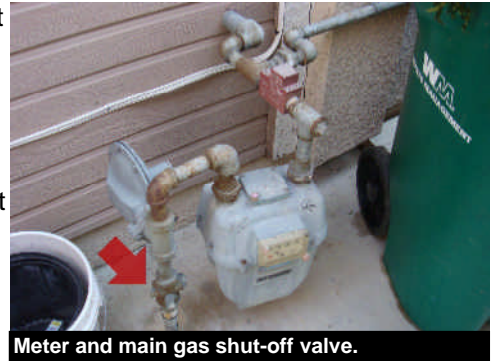
[CR] There is an added seismic automatic shut off valve. The valve has been installed improperly, unlevel and not supported properly.

Meter and main gas shut-off valve.

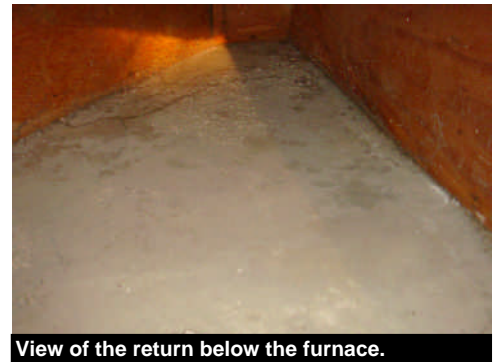
The return air plenum could be cleaned below the furnace.

View of the return below the furnace.

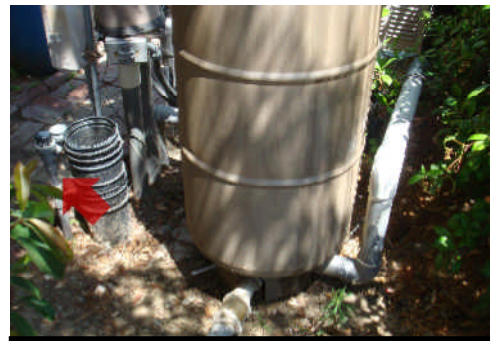
Valve may be spa fill valve. Not tested.
