Pre-purchase Home Inspection Report

Sample of a 4 year old 2,500 square foot house with pool & spa

Steve Garcia Inspections

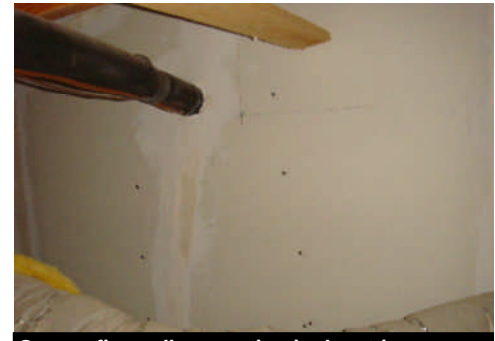
Garage fire wall separation in the attic.

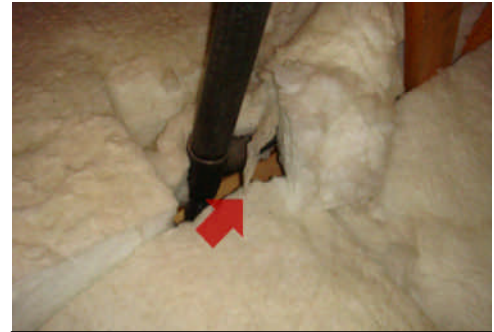
The insulation should be in contact with the ceilings without voids or on top of other materials.

Void, on top of pipe and framing.

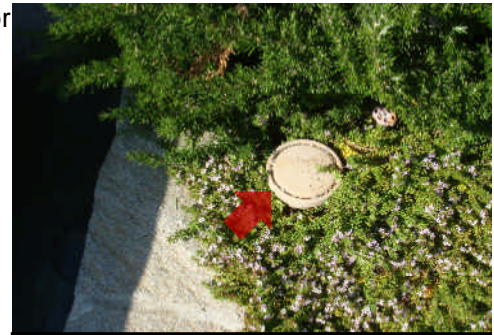
[FE] The pool fill valve should be evaluated for backflow /anti-siphon device /requirements.

Suspected pool fill valve.
