# *Pre-purchase Home Inspection Report*

Sample of a 51 year old 1,600 square foot house

***Steve Garcia Inspections***

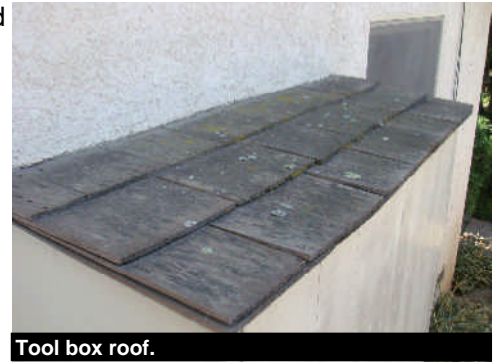
**322 COMMENTS** [FE] The right side added tool box has a wood shingle roof. The shingles appear weathered but functional. The low slope surface is not approved for the shingles. The shingles and wall connection is not sealed.

I recommend drilling vent holes at the bottom and top of the tool box doors.

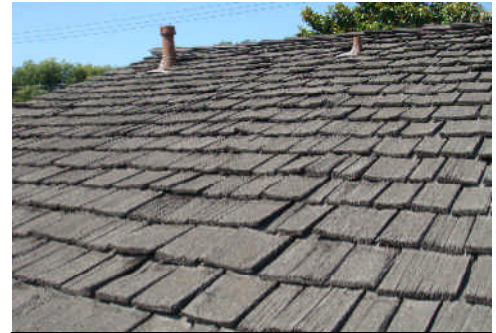
Front left view of the roof.

I walked on the roof at the rear only to inspect the chimney and roofing components. The roofing material is weathered /damaged and was walked carefully to prevent additional damage.

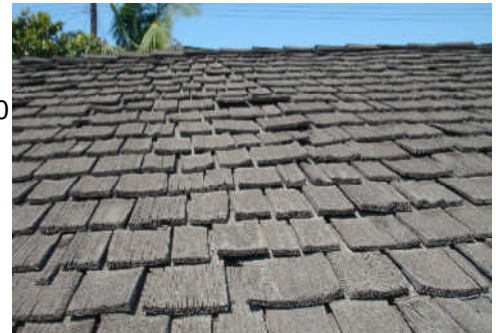
Front center view.

The wood shake roof is approximately 25 to 30 years old.

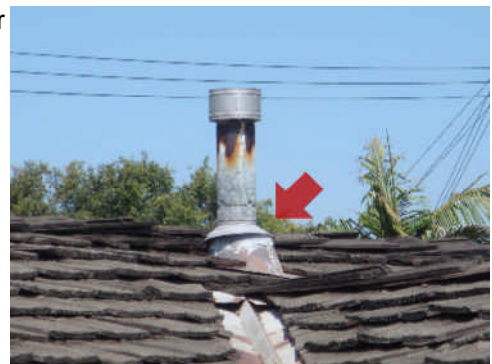
**521 GAS FLUE PIPE(S)** [CR] The furnace jack flashing is oversized for the flue.

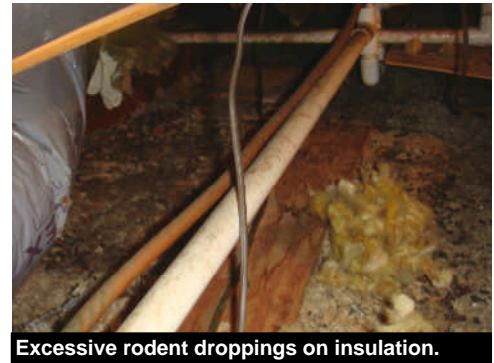
**602 COMMENTS** [SC] Excessive rodent droppings are in the attic insulation and on the furnace, ducts and cooling coil.

Excessive rodent droppings on insulation.

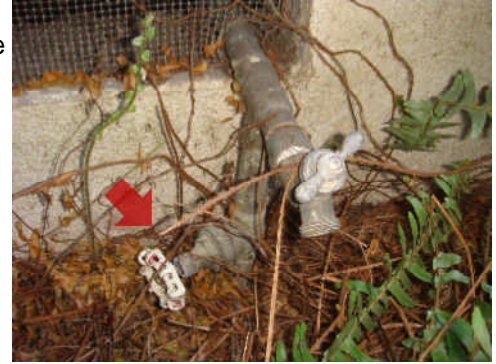
The main water shutoff valve was not completely turned off to test. This type of valve could break or leak if shutting off completely.

[RU] I recommend replacing the main water supply valve with a 1/4 turn ball valve.

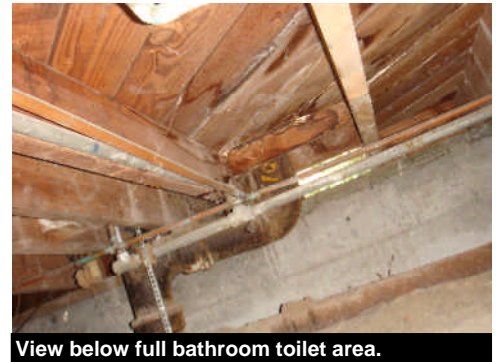
Materials: Copper piping has been added replacing the original abandoned galvanized pipes.

I recommend removing all of the abandoned galvanized pipes to prevent any contact with the copper pipes, to be sure galvanized pipes are not in use, and for working access.

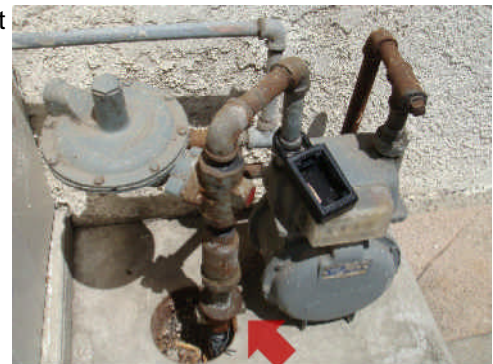
[RU] The main gas supply shutoff was not operated. There is no emergency shutoff wrench present. I recommend providing a wrench or installing a seismic automatic shut off valve for emergencies.

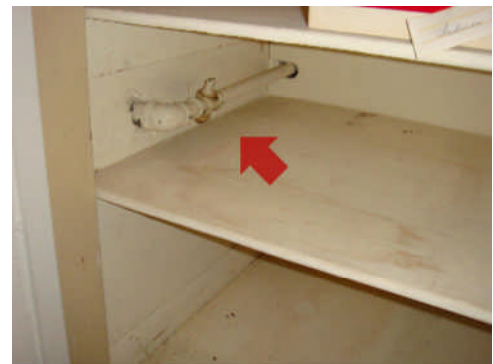
[FE] The abandoned gas supply pipe and valve in the hall cabinet where the original furnace was has a gas smell.

I recommend the gas valve be removed and a left /right nipple used to connect the pipes, if the pipes are not removed.

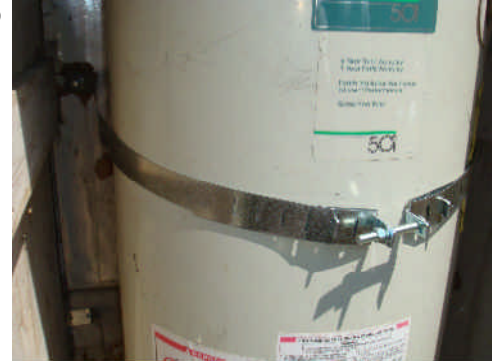
The tank straps are installed improperly. See below.

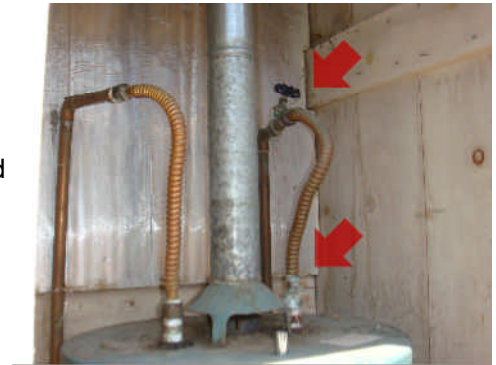
[CR] The water supply valve and cold connector are corroded. Replace the valve with a ball valve.

[CR] The water supply connectors are not insulated. I recommend insulating the exposed water piping to minimize heat loss.

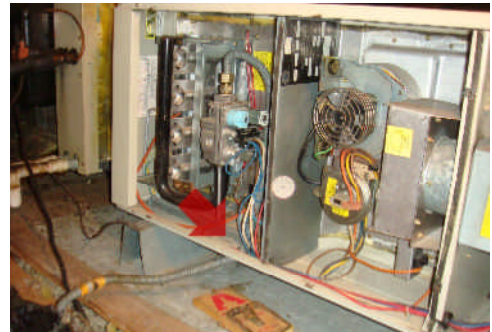
[CR] The furnace gas flex connector is not hard piped through the furnace housing.

Gas flex connector in contact with housing

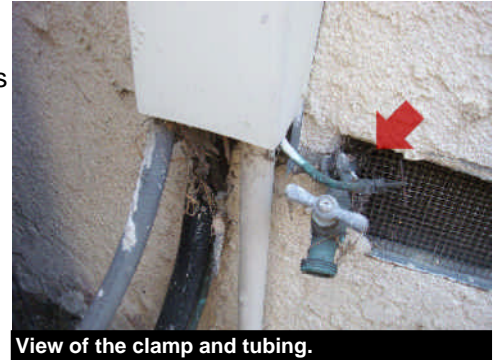
[CR] The humidifier water supply is a tubing and 1/4" needle valve tap that has been installed into the faucet water supply pipe. This is a substandard valve /installation.

View of the clamp and tubing.

I recommend removing the valve /clamp and tubing.

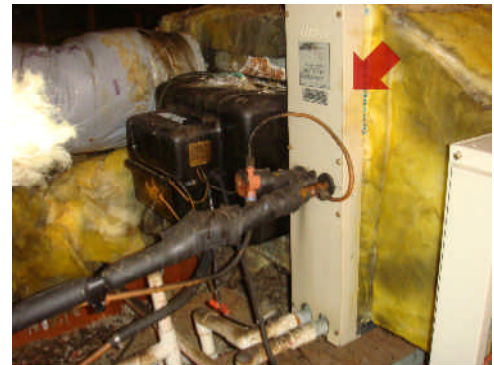
"Split system" The condensing unit is at the exterior and the evaporator /cooling coil is connected to the furnace as visible in the picture.

[CR] I recommend the coil be removed and cleaned outside due to the soiled system /fan blades and excessive rodent droppings for health!

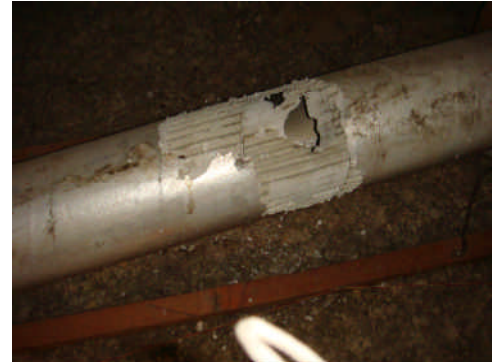
[SC] [RU] The ducts /system should be replaced for health, due to the conditions and rodent damage /contamination.

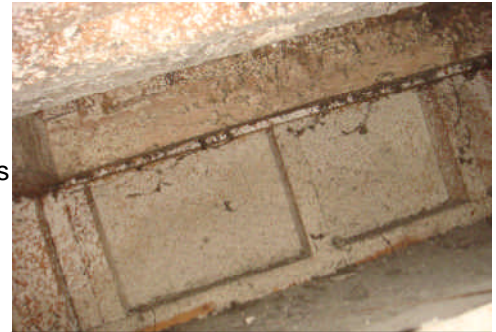
View in the hall return.

The hall return air is soiled and should be cleaned.

[RU] I recommend installing filters /grills at this location to prevent the return air and duct from becoming soiled.

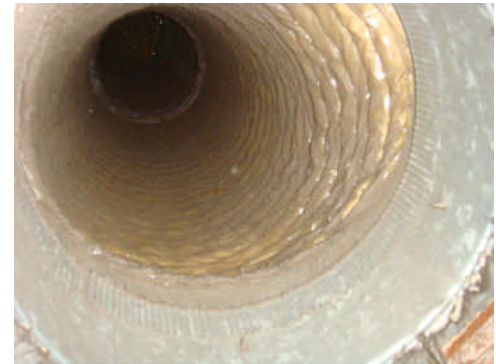
[RU] The return air duct is soiled, I recommend replacing the duct when the air supply ducts are replaced.

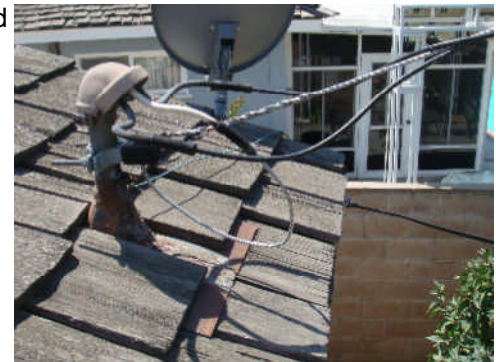
[RU] The overhead service entrance cables are hung too low over the roof.

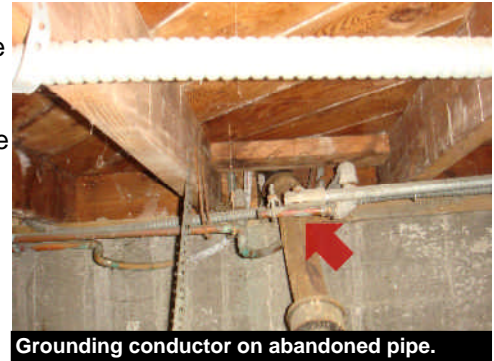
[SC] The visible grounding and bonding connection is on an abandoned pipe below the kitchen.

[CR] A ground rod below the panel should be installed for proper grounding, and a bonding conductor should be attached to the updated copper pipes.

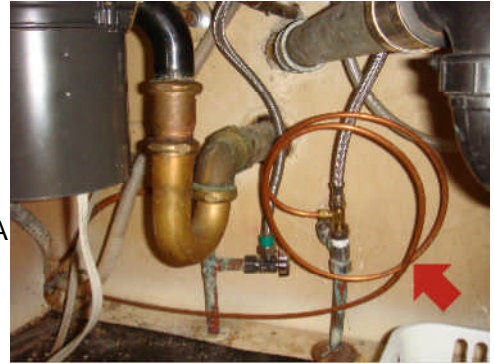
**1305 DISHWASHER(S)** The dishwasher functioned through the "Normal Cycle", no evidence leakage.  
**[CR]** The dishwasher is not secured properly.  
**[SC]** The dishwasher is connected directly to the drain pipe /garbage disposal. This installation is improper and a health concern. A required air gap device is lacking.  
**[FE]** The water supply tube appears to be undersized.

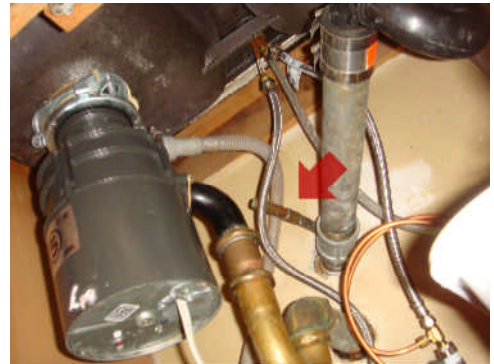
**1317 COMMENTS** **[FE]** Function of copper pipe is unknown.

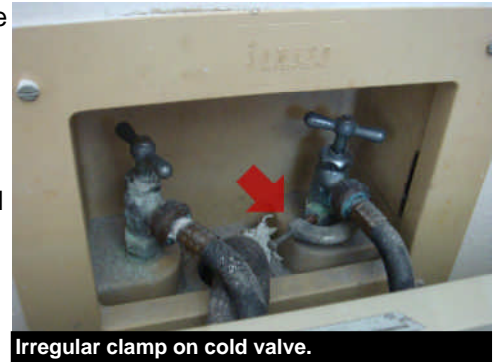
[CR] The laundry faucets are corroded. I recommend the faucets be replaced with a single lever ball valve that controls the hot and cold simultaneously to shutoff the water off after washing, to prevent the hoses from breakage and water damage.

I recommend installing a leak drain pan below the washing machine.

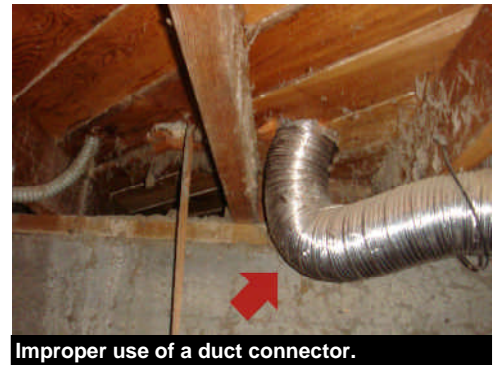
[SC] The dryer vent duct is a connector. This condition is a fire safety concern.

[CR] Connectors should not be used in place of a metal smooth wall solid duct as required.
