Building Inspection *Photo Documentary Report*

12 Journey, Aliso Viejo, CA. 92656

Steve Garcia Inspections

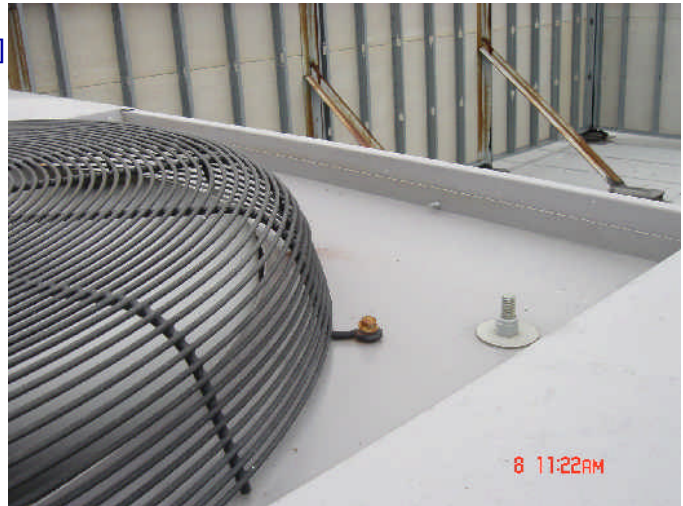
PHOTO # 39

Condenser air discharge fan with loose mounting screw. [CR]

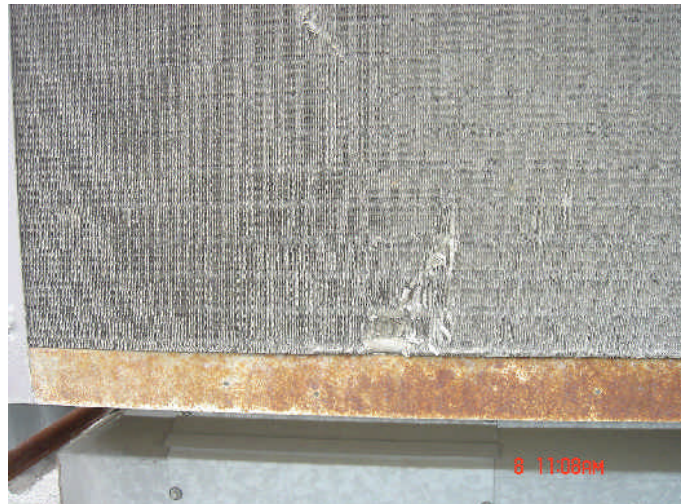
PHOTO # 40

Damage to the exterior condenser coil fins. [FE] [CR]

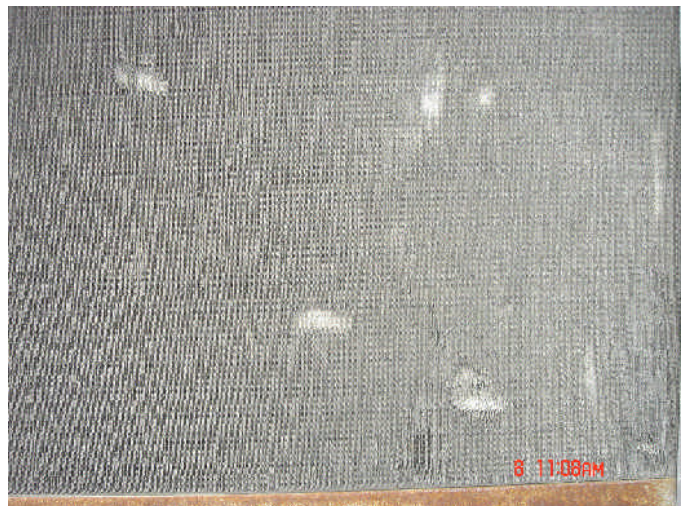
PHOTO # 41

More damage to the exterior condenser coil fins. [FE] [CR]
