Pre-purchase Home Inspection Report

Sample report of a 6 year old 4,400 square foot house

Steve Garcia Inspections

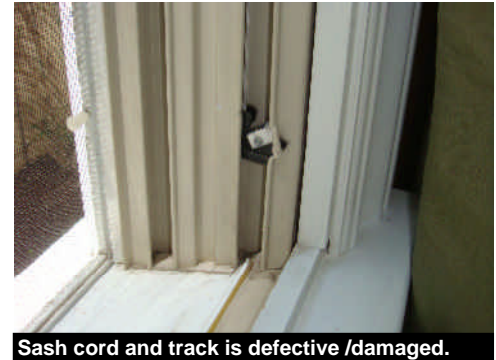
[CR] Two kitchen windows, one dining room window and entry window could not be opened. Windows should not have to be forced opened.

[CR] One latch is missing at a kitchen window and a few are not secured properly.

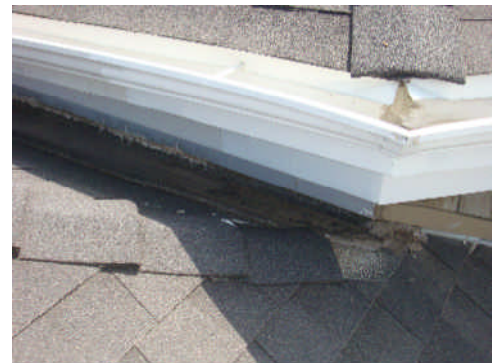
504 INSPECTOR NOTES

Patching will not correct the condition around the upper bedroom roof to wall intersection.

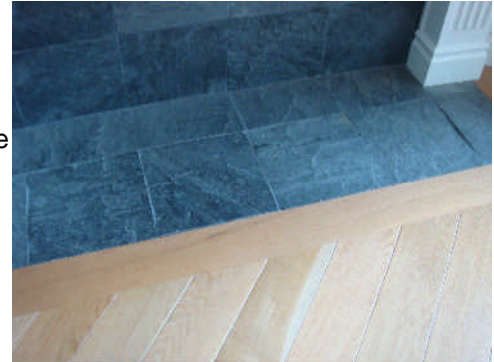
[FE] The family room hearth tiles sounded hollow when walked or tapped on as if they are not bonded to the slab.

I recommend an inspection by a qualified fireplace specialist. My inspection of the chimney flues is limited to the readily visible portion from the fireboxes only. The inner / upper reaches of the flues are inaccessible. A qualified fireplace specialist will remove the chase and flue caps, use a specialized video camera as needed to evaluate the flues.

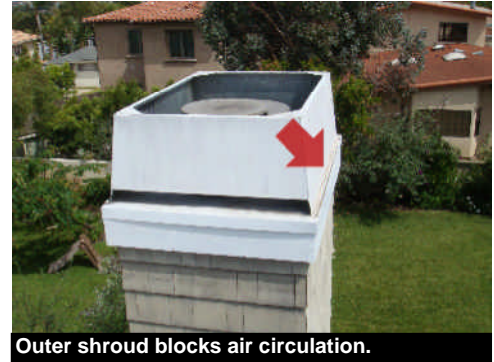
Fastener tabs not in place for air flow.

713 COMMENTS [FE] The chimney chase shrouds should be evaluated to be an approved component on the chimneys.

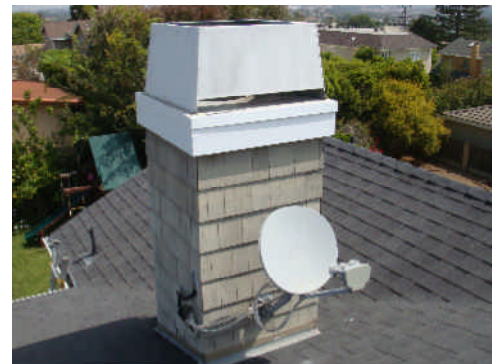
711 CHIMNEY The master bedroom chimney has a satellite dish installed.

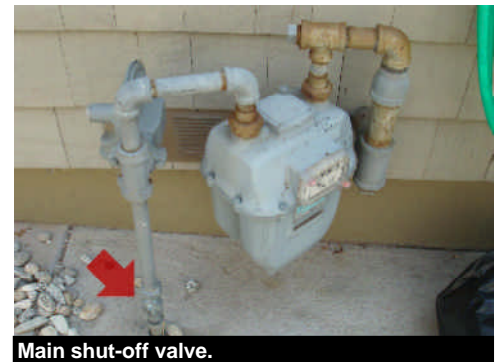
[RU] The main gas supply shutoff was not operated. There is no emergency shutoff wrench present. I recommend providing a wrench or installing a seismic automatic shut off valve for emergencies.

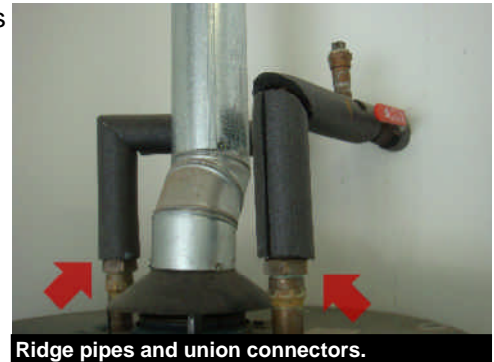
The water heater is connected to the water supply using rigid pipe and union connectors.

I recommend replacing the pipes and unions with flexible connectors to prevent the unions from leaking during seismic movement.

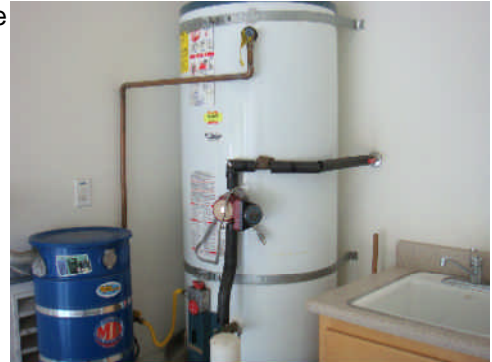
1014 SEISMIC SAFETY STRAPS

[FE] It is unknown if the two seismic straps are approved for a 75 gallon tank. A middle third strap may be required.

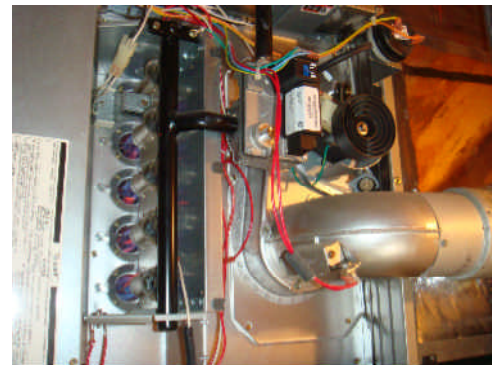
[FE] There is no proper working clearance around the unit /equipment.

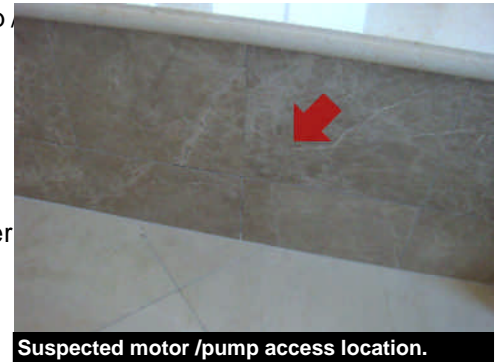
[FE] The whirlpool tub was not filled with water for testing and was not inspected.

Suspected motor /pump access location.

Access should be made for inspection of the tub support, electrical wiring, GFCI protection, and pump /motor bonding.

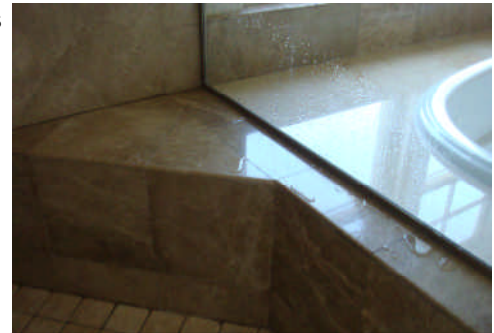
[NOTE] Horizontal seats or ledges in showers tend to hold water and are prone to leakage. Horizontal surfaces in showers should be wiped dry after use as a precaution against moisture intrusion into concealed spaces.

Master shower & 3/4 bath have seats.

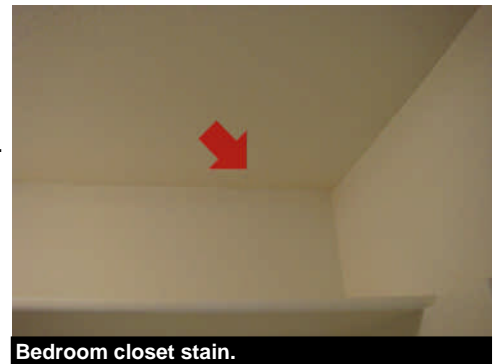
[FE] Moisture stains are evident on the second floor hall and front left bedroom closet. See roof section for explanations of the stains.

[FE] The family room taping finish is irregular and visible.

3 very slight light spots on the kitchen ceiling between the island and main counter.
