Pre-purchase Home Inspection Report

23 year old 2,500 square foot house with spa

Steve Garcia Inspections

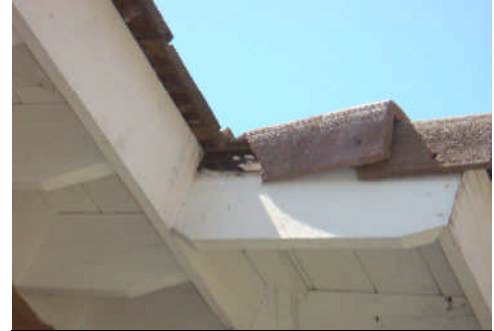
Broken rake tile. Evaluate water stains.

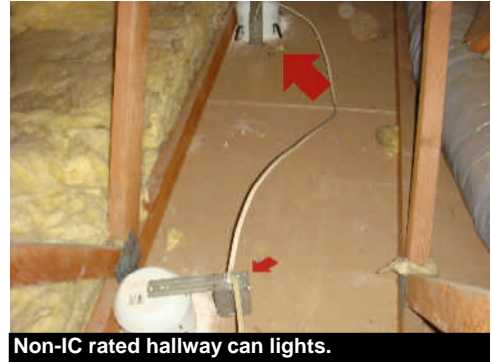
612 COMMENTS The added /updated hallway recessed can lights are not IC rated for insulation contact.

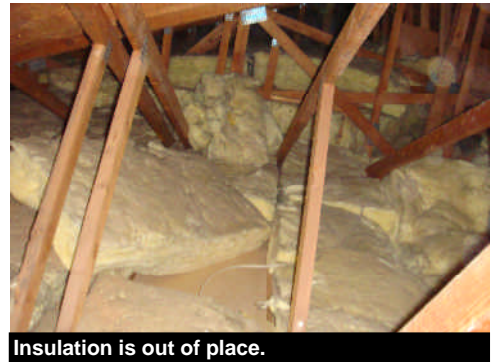
618 INSULATION [CR] The insulation is out of place/missing in areas. This condition minimizes the overall value of the insulation.

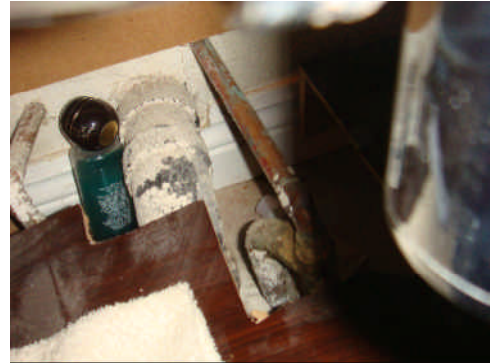
[FE] Irregularly exposed pipes below the first floor hall basin. Unable to inspect due to the cabinet.

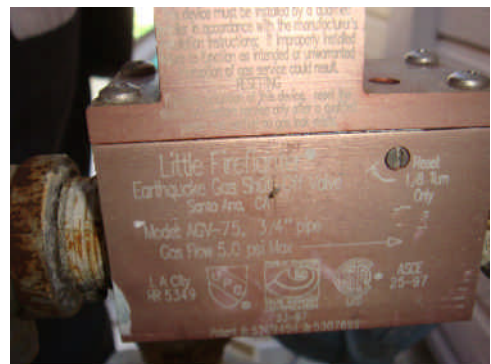
View of the seismic automatic shut off valve / reset.

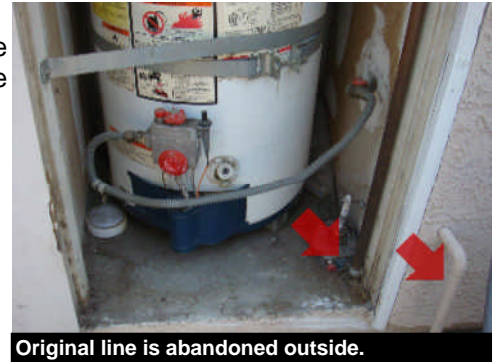
[CR] A temperature & pressure relief valve and discharge line are installed. The discharge line did not extend to the exterior properly. The pipe should be extended to the exterior and terminate facing downward.

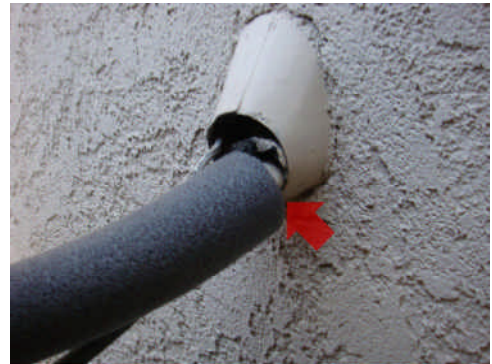
[FE] The copper pipe should not be in contact with the wall flashing.

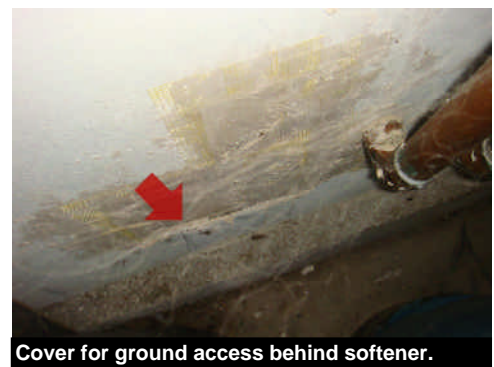
[FE] The grounding connection was not accessible/visible/located below and behind the panel in the garage due to the water softener location.

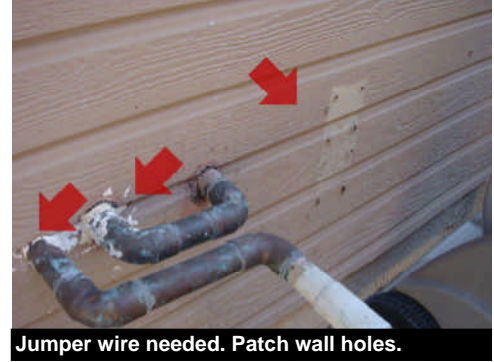
[CR] A jumper wire should be installed onto the water softener added pipes.

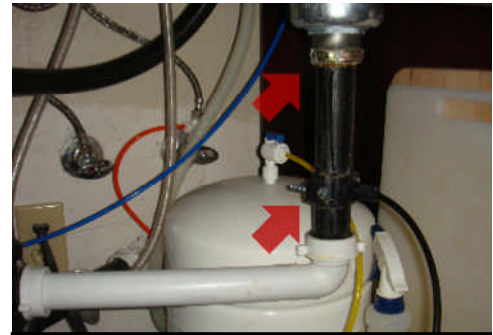
[CR] The sink drain leaks at the pipe to sink connection.

[RU] The dishwasher water supply angle stop valve is corroded.

Improper saddle clamp on drain pipe.

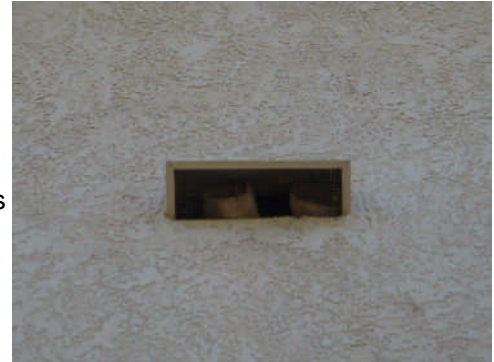
[CR] The exterior exhaust vent hood screen is open at the right exterior.
