Pre-purchase Home Inspection Report

Sample of a 4 year old 2,500 square foot house with pool & spa

Steve Garcia Inspections

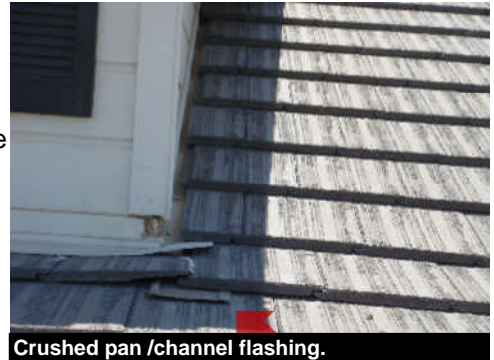
518 FLASHINGS [FE] At the rear left area the tile to wall intersection is irregular, uneven and the channel flashing is below the field and rake tiles.

[FE] The wall rake pan /channel flashing is crushed and the mortar material is irregular at this location.

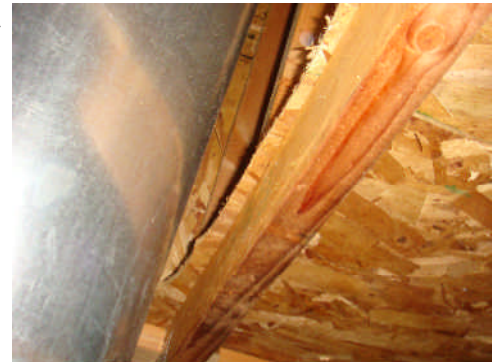
[FE] The chimney may be too close to combustible materials, attic framing. Typical clearance is 2", this separation from the sheathing appears to be less.

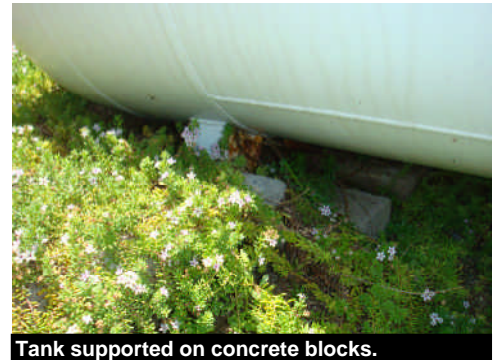
[SC] The tank is not supported /secured on a solid platform, and is leaning.

Tank supported on concrete blocks.

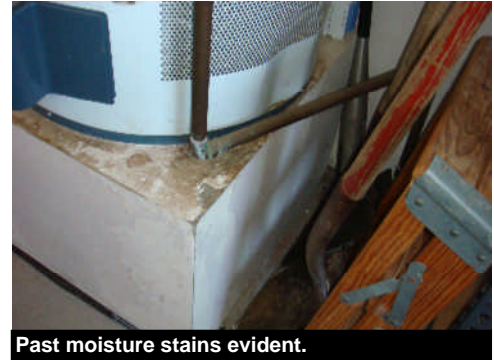
There is no drip pan and drain line under the water heater to catch and divert any dripping water to the exterior.

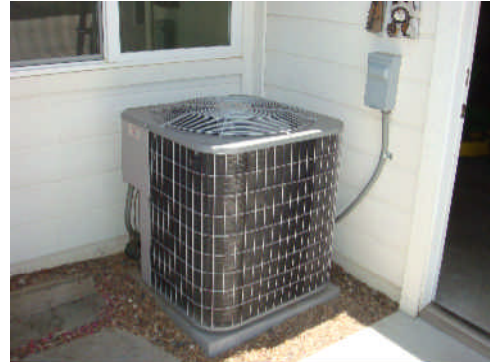
[CR] The refrigerant line is in contact with the metal straps improperly.

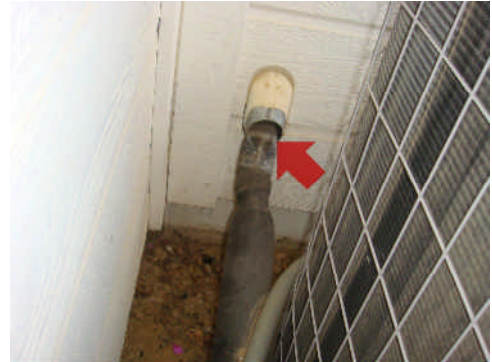
[CR] The coolant lines wall flashing is not sealed where they entered the building to prevent rodent access.

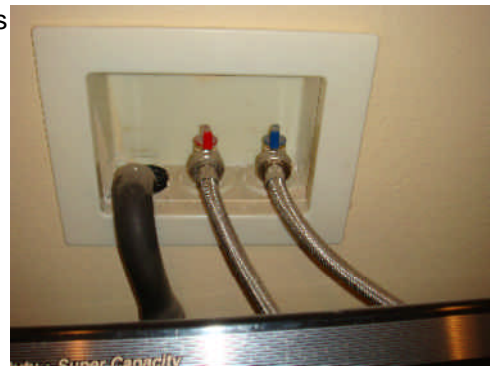
The laundry faucets are in use, no visible leaks or corrosion. Washing machines are not operated.

[RU] I recommend the faucets be replaced with a single lever ball valve that controls the hot and cold simultaneously to shutoff the water off after washing, to prevent the hoses from breakage and water damage.

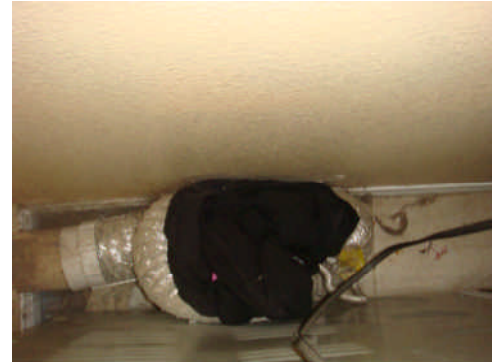
[FE] The dryer hookup connection was not visible due to clothes blocking view.

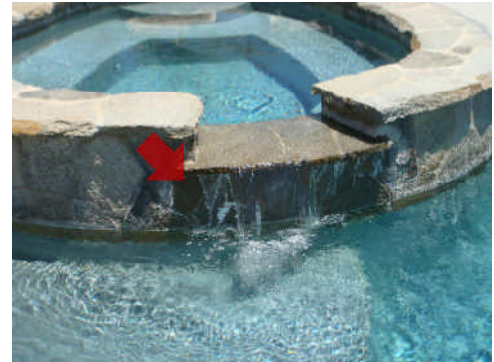
[FE] Calcium /mineral deposits are evident below the water spill.

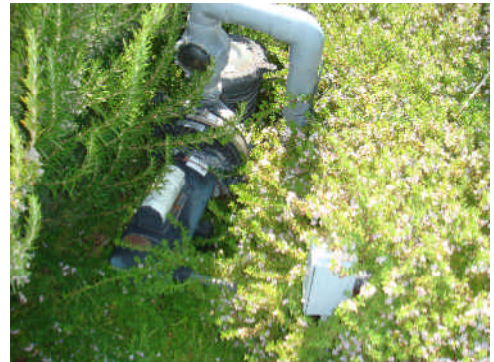
[FE] The spill /trough pump /motor is covered in the foliage.

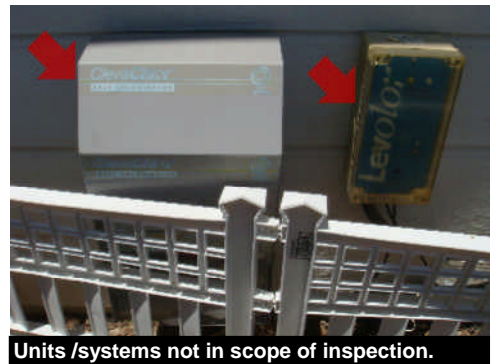
[FE] These units /systems are outside the scope of the inspection and are not inspected. I recommend a full evaluation by a specialist.

Units /systems not in scope of inspection.
