Building Inspection *Photo Documentary Report*

12 Journey, Aliso Viejo, CA. 92656

Steve Garcia Inspections

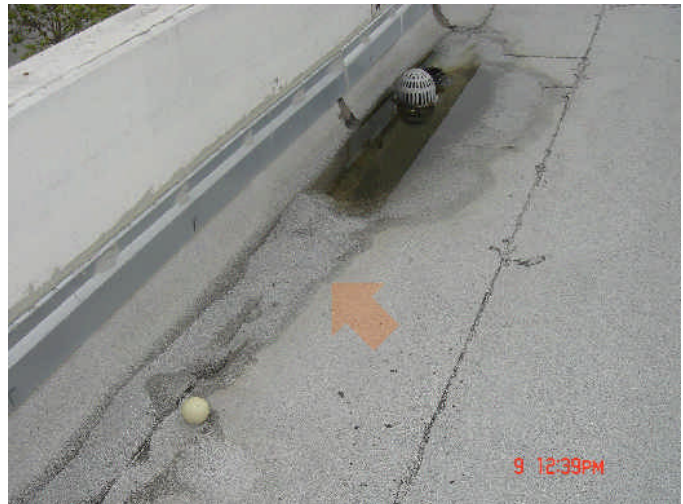
PHOTO # 1

The Roof surface drains show water is not properly draining at the perimeter and the roofing material's granular covering is washing down to the drain areas. [CR]

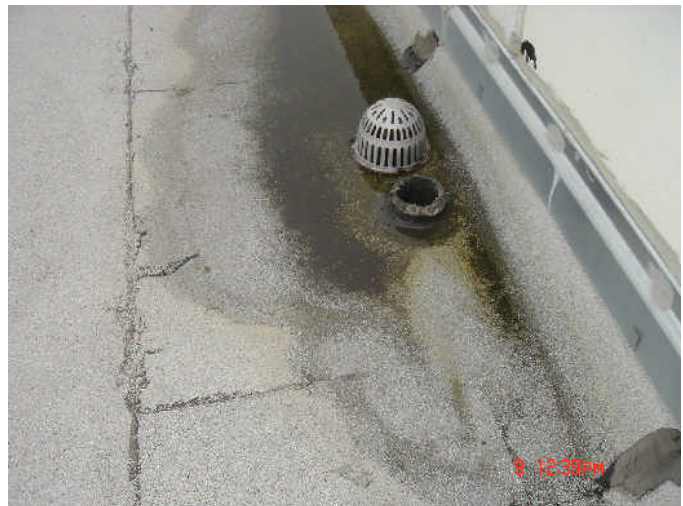
PHOTO # 2

Second picture of #1.

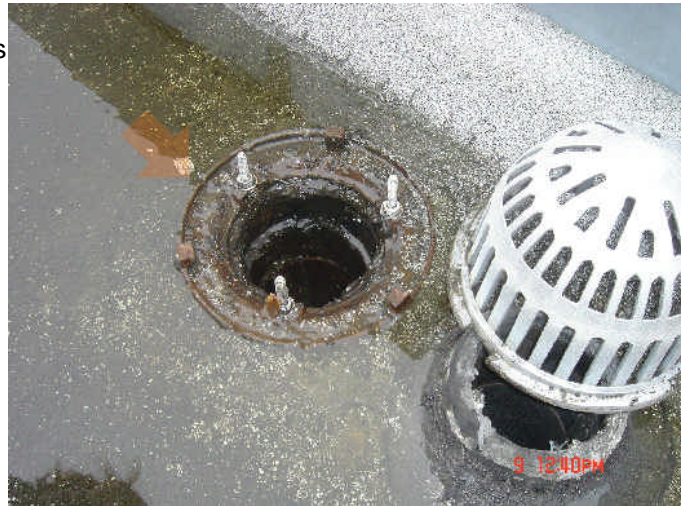
PHOTO # 3

When the drain screen was removed and the drain openings were cleared, the water was able to drain better. [CR]

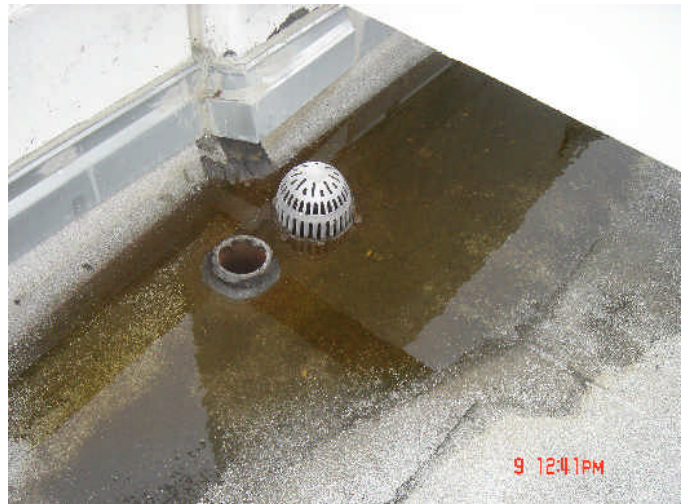
PHOTO # 4

All roof drains should be cleaned and the loose granular material should be cleared off the low points of the roof. [CR]

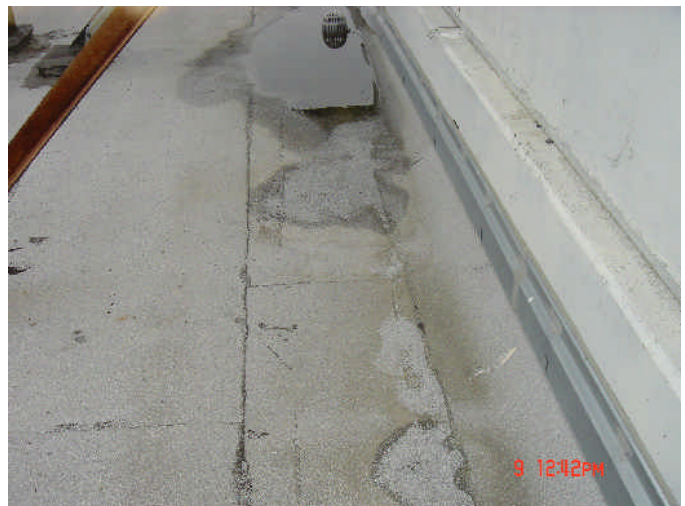
PHOTO # 5

Second picture of #4.

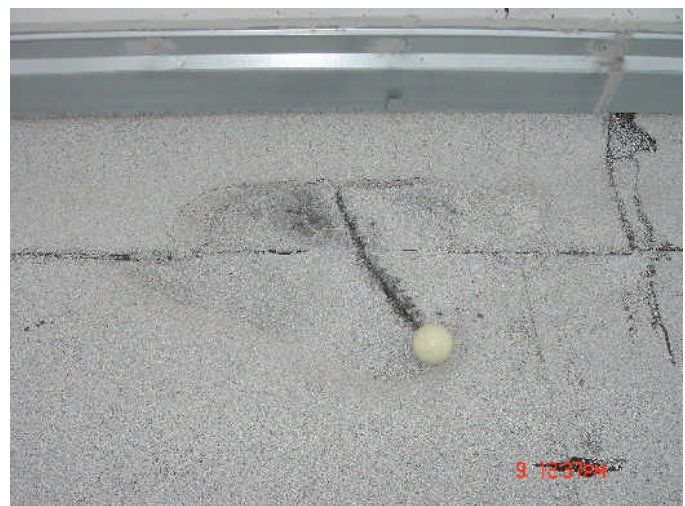
PHOTO # 8

The loose granular material build-up should be removed for proper water runoff to the roof drains.

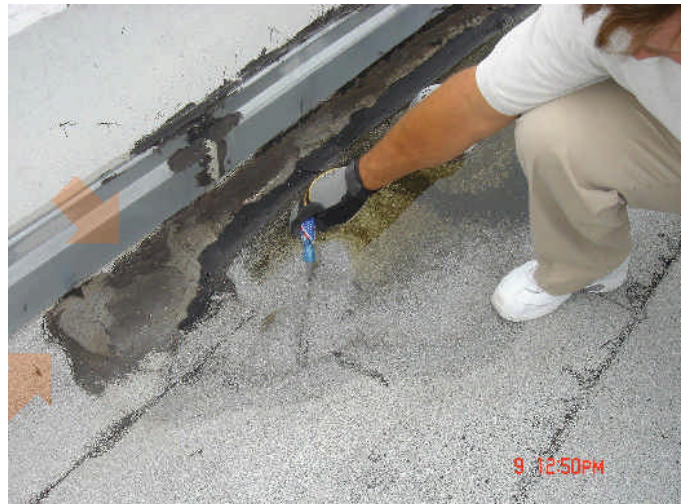
PHOTO # 10

Excessive mastic patching at the side walls is causing the roofing material to crack. [FE] [CR]

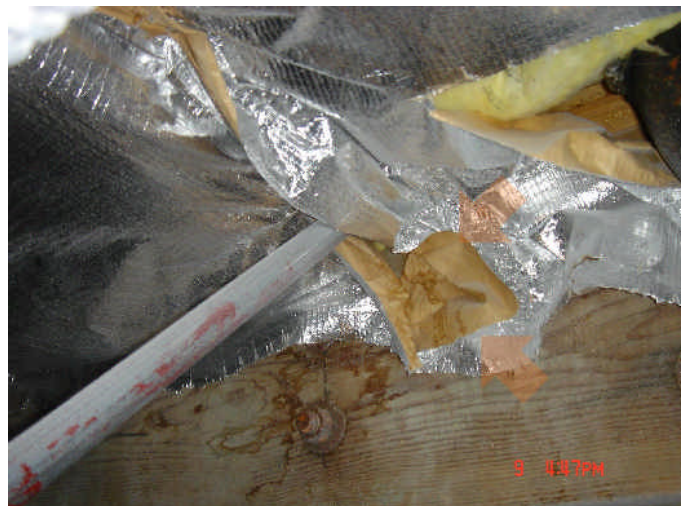
PHOTO # 11

Water stains below one of the roof drains. [FE] [CR]

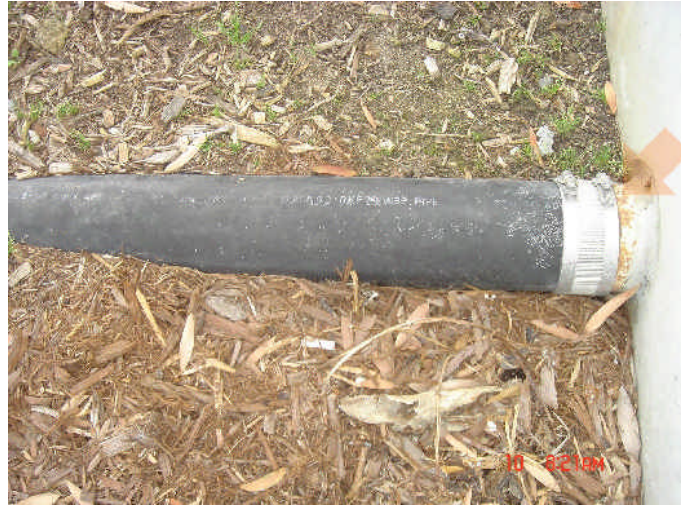
PHOTO # 12

The roof drain downspouts terminate at the bottom of the building walls.

The exterior ABS plastic drain pipe is not protected and the metal strap is improperly in contact with the soil. [CR]

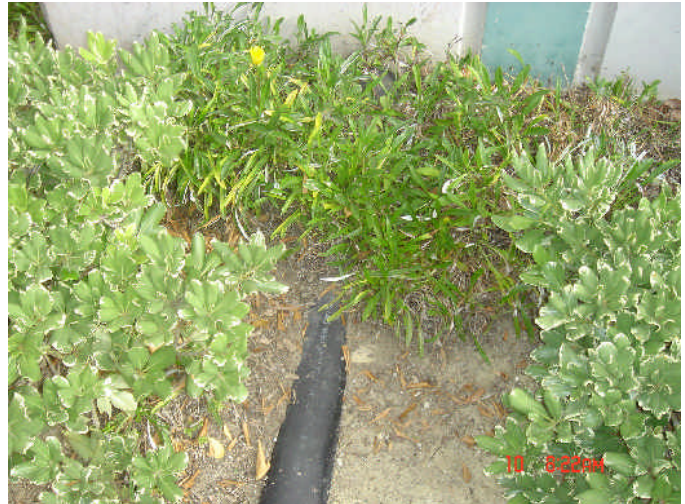
PHOTO # 13

Second picture of #12.

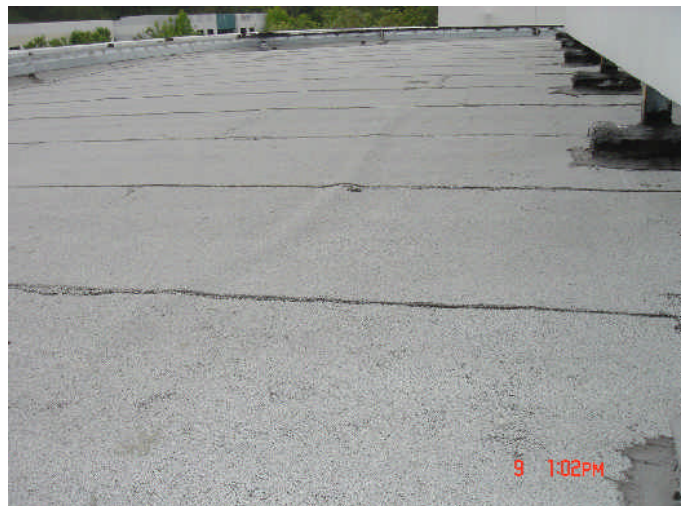
PHOTO # 14

The built-up asphalt roofing material used on this roof has a few evident buckles. [FE]

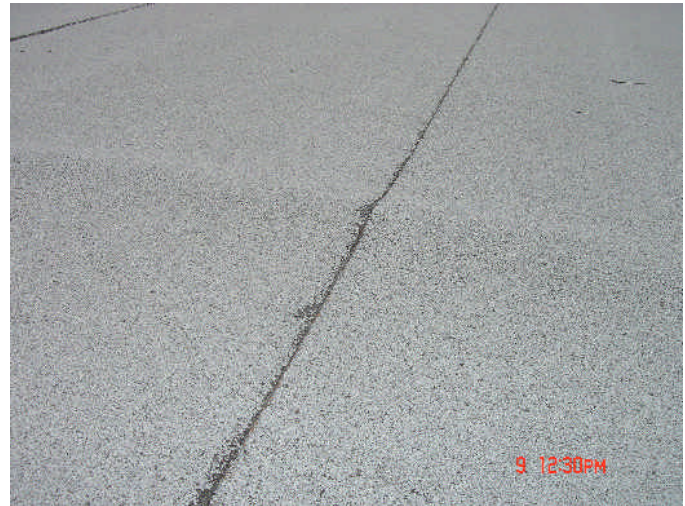
PHOTO # 15

Second picture of #14.

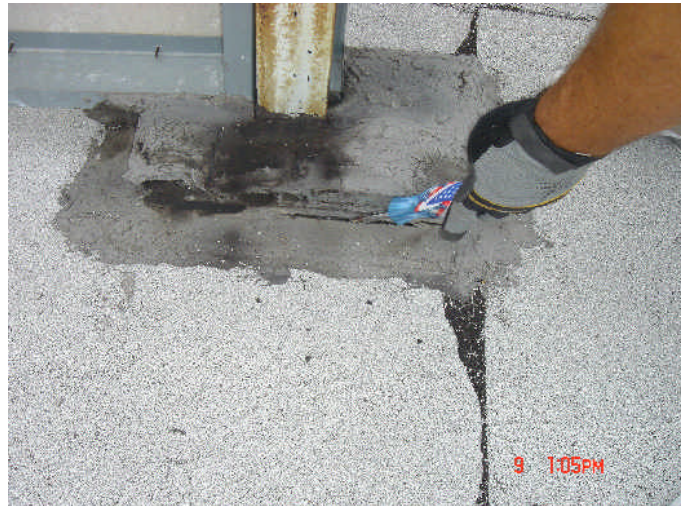
PHOTO # 18

The proper mastic material should be used for repairing cracks of this type at these maintenance intensive pitchpan locations. [CR]

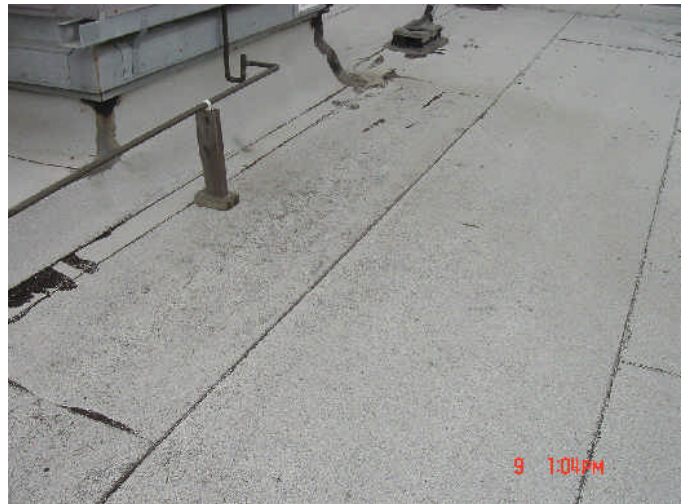
PHOTO # 19

This roofing material is not protected from the walking necessary to perform maintenance on the packaged units located on the roof. [CR]

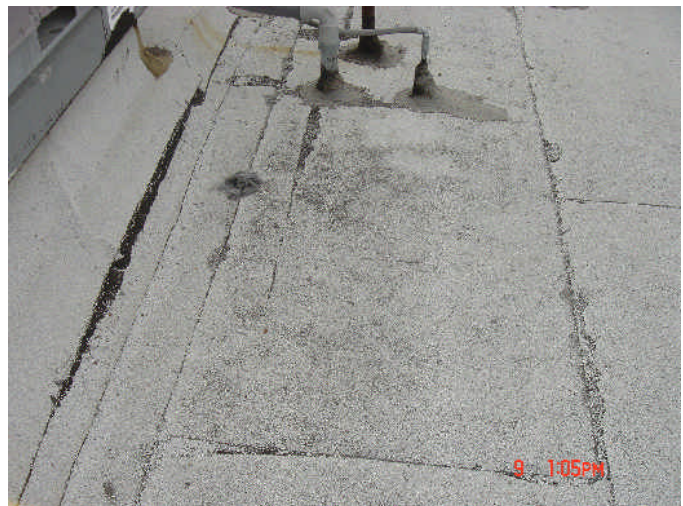
PHOTO # 20

Second picture of #19.

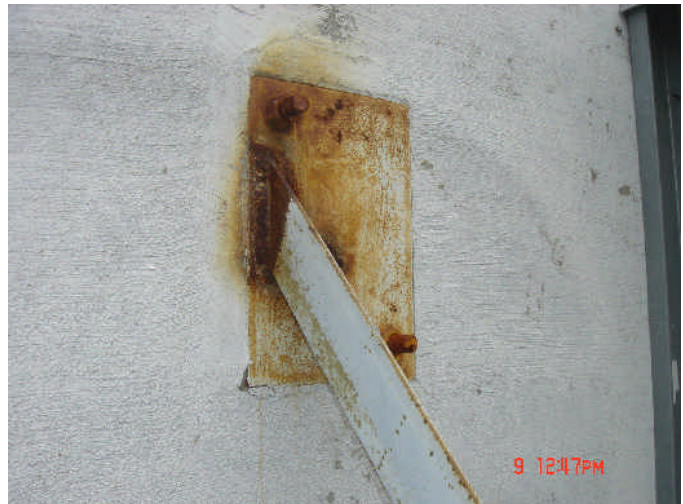
PHOTO # 22

The fasteners and iron supports for the screen facade are rusting. These items should be cleaned and painted.

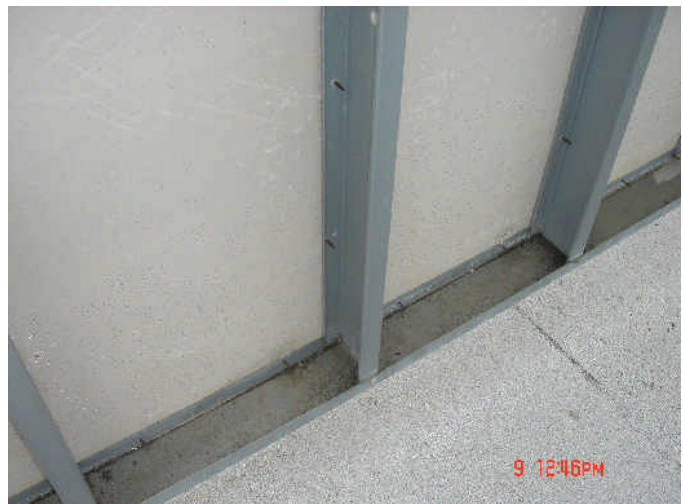
PHOTO # 23

The fasteners for the screen facade's cementitious board surface material are also rusting. [FE] [CR]

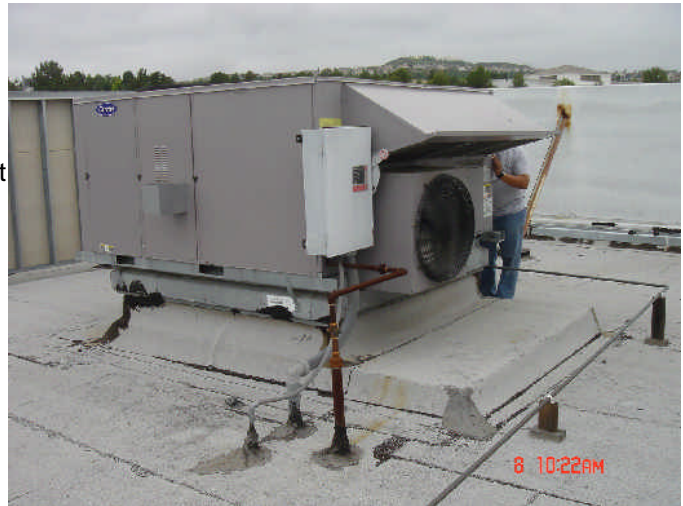
PHOTO # 24

The heating and air conditioning package unit is 6 years old and has a 25-ton capacity.

It is located at the the north west side of the roof above the second floor occupied office.

The power supply is 175 amp service disconnect at the main electrical cabinet feeding a box attached to this unit. the box could not be opened without shutting down the unit and thereby not inspected.

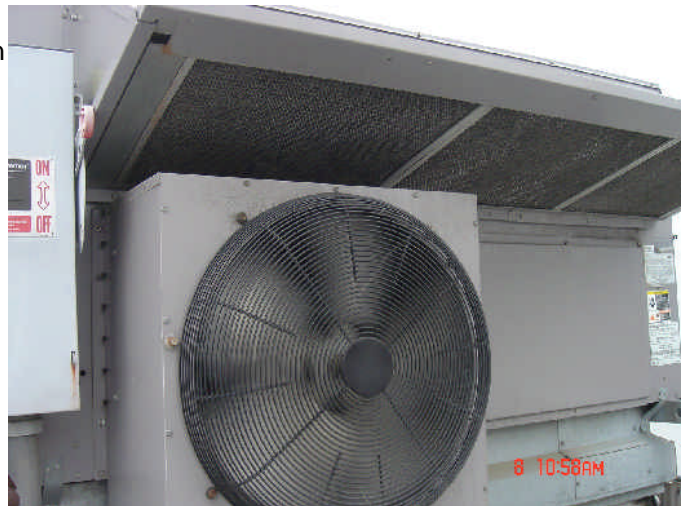
PHOTO # 25

Picture of the power exhaust economizer is malfunctioning on the unit shown in picture #24.

The exhaust economizer was improperly running nonstop for the entire 90 minutes it took to inspect both units. [FE] [CR]

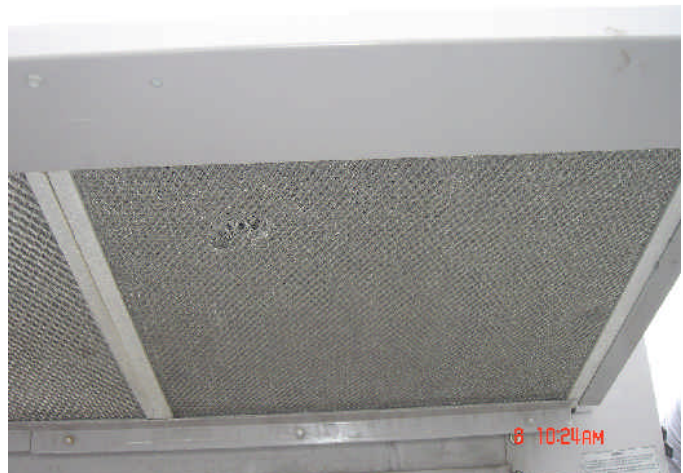
PHOTO # 26

Close up of damage to the exterior air intake filter above the power exhaust economizer. [FE] [CR]

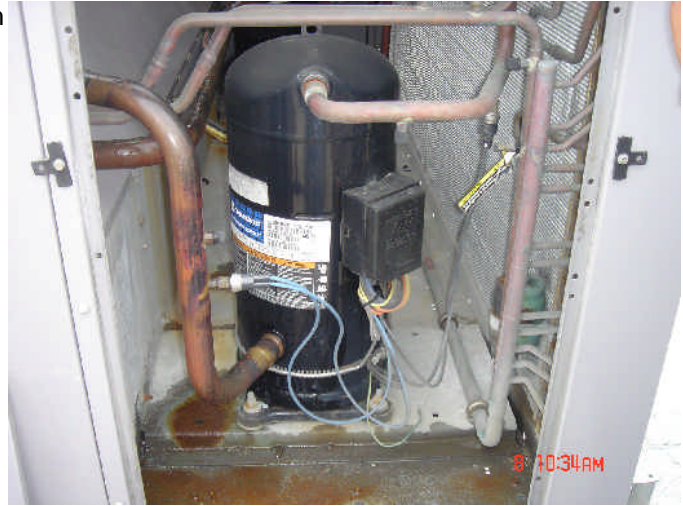
PHOTO # 30

Close up of the compressor with uninsulated evaporator line, dripping condensation onto the platform creating rust. [CR]

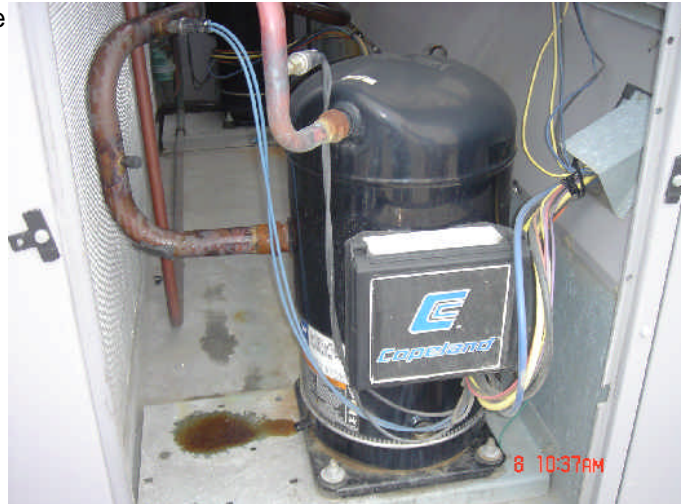
PHOTO # 31

Second compressor in the same unit with the same problem. [CR]

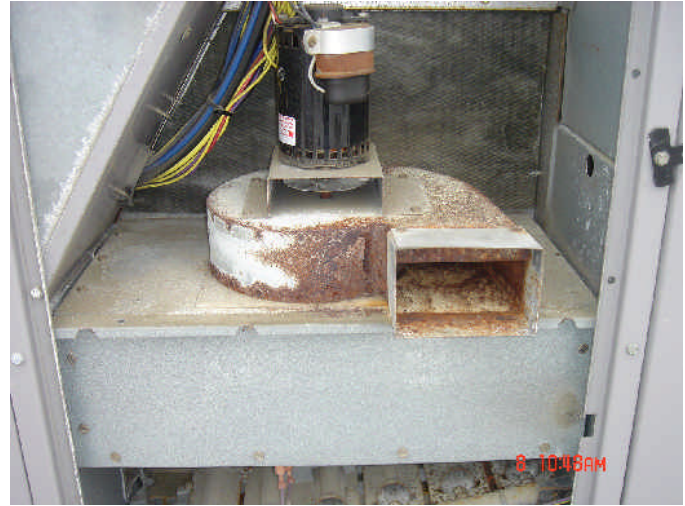
PHOTO # 36

Close up of the rusted induced blower motors. [FE] [CR]

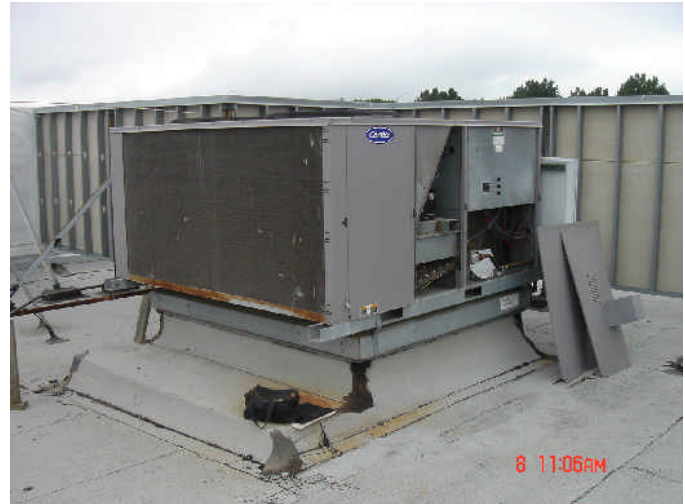
PHOTO # 37

The other heating and air conditioning package unit is also 6 years old and a 25-ton capacity, located on the south west area.

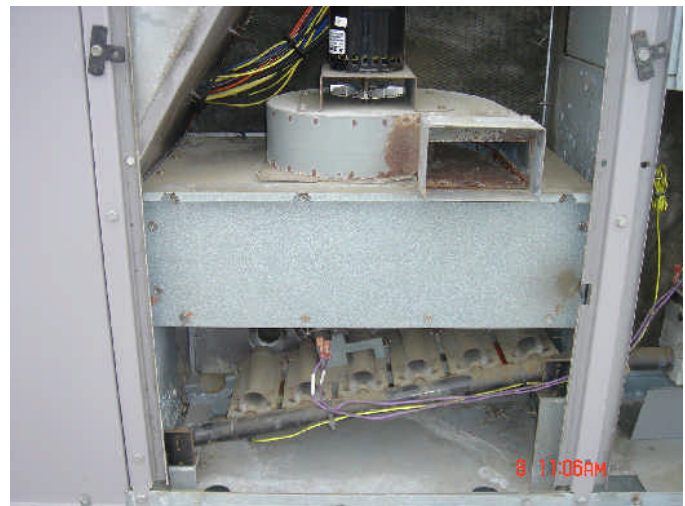
PHOTO # 38

View of the other 206,000 - 274,000 BTU heater's gas exhaust side with rusted induced blower motors. [FE] [CR]

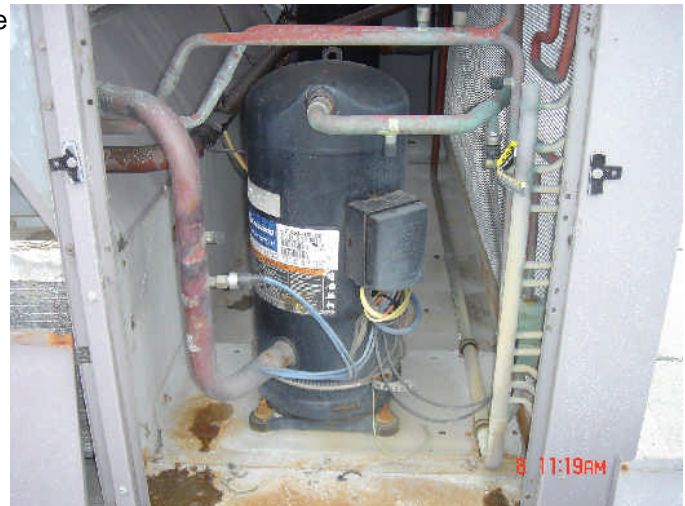
PHOTO # 43

Second compressor in the same unit with the similar condition. [CR]

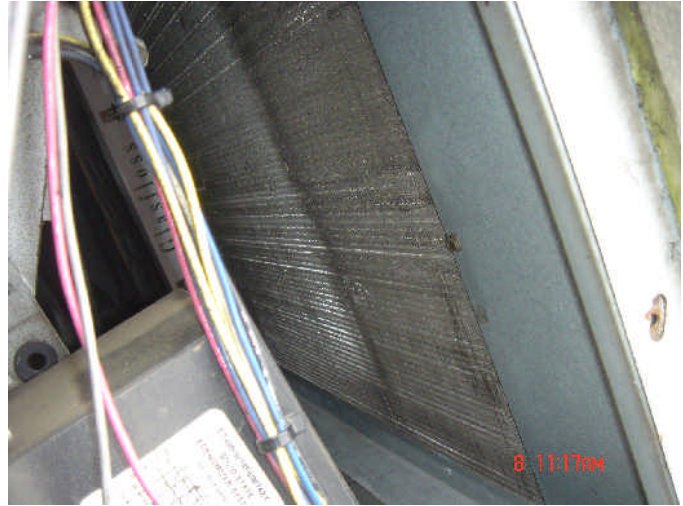
PHOTO # 45

Close up of soiled evaporator coils. [FE] [CR]

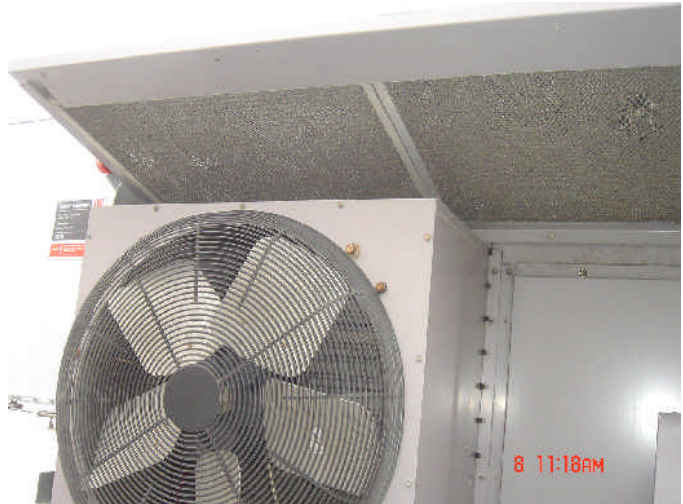
PHOTO # 46

Picture of the power exhaust economizer and filtration system.

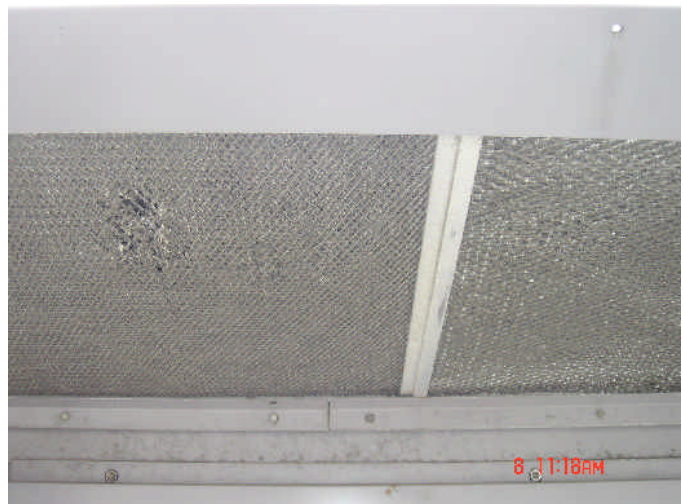
PHOTO # 47

Close up of damage to the exterior air intake filter above the power exhaust economizer. [FE] [CR]

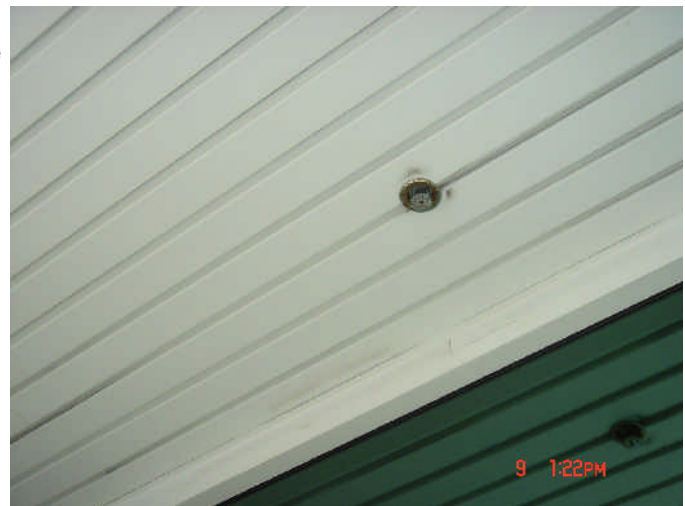
PHOTO # 49

Another example of improper pressurization seen in the same area. [FE] [CR]

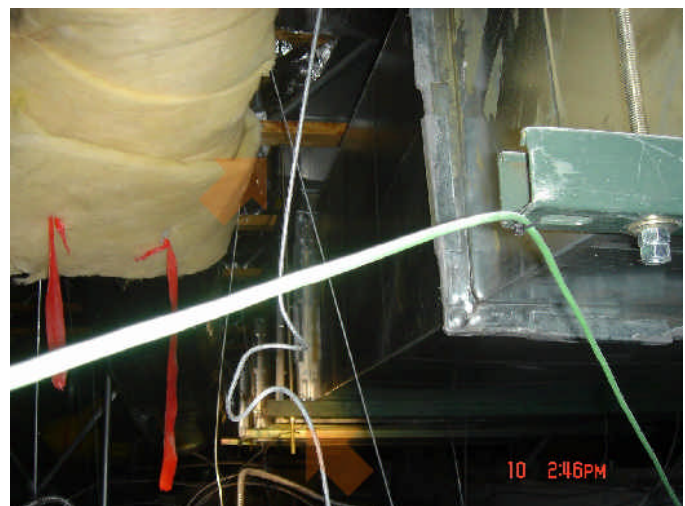
PHOTO # 50

Metal duct assembly and support system is not all visible or accessible and should be evaluated before the close of this real estate transaction. [FE] Manual dampers are provided.

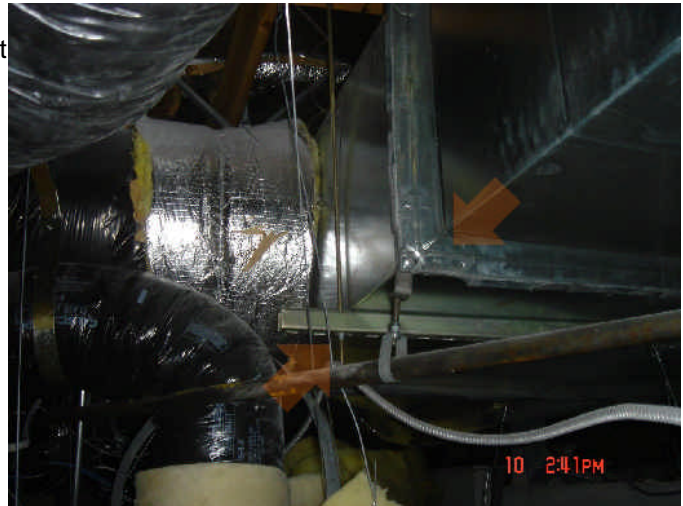
PHOTO # 52

Third picture of #50, view above the south side office space of the first floor, spacing of the supporting system should be evaluated. [FE]

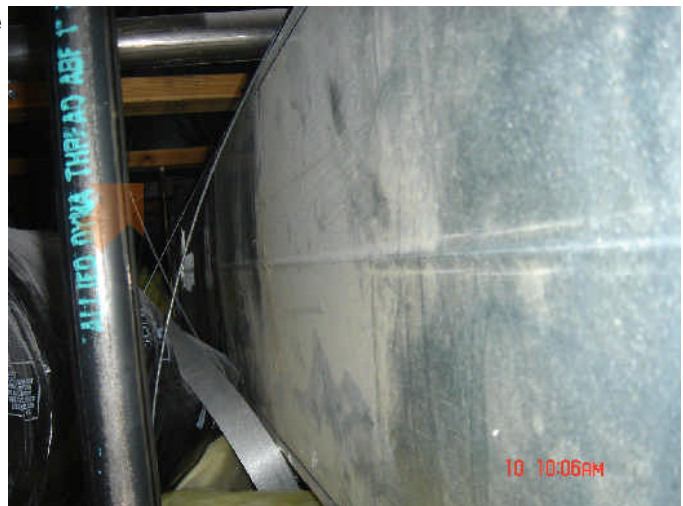
PHOTO # 53

Fourth picture of #50, view above the south side office space of the first floor. [FE]

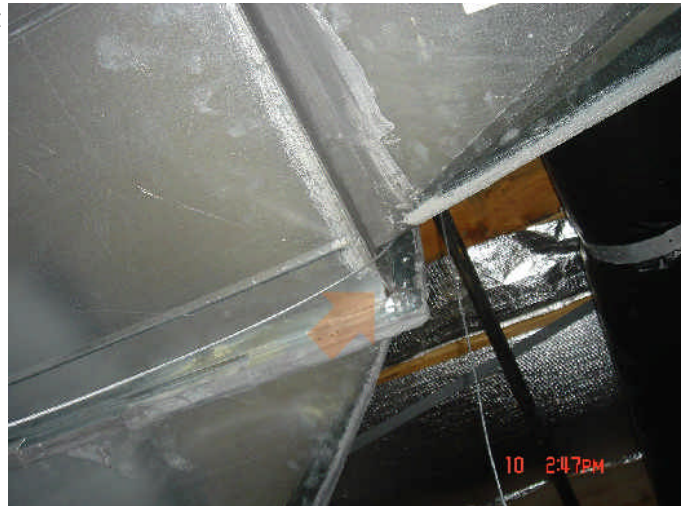
PHOTO # 55

Duct and plenum condensate leak above the second story occupied office. [FE] [CR]

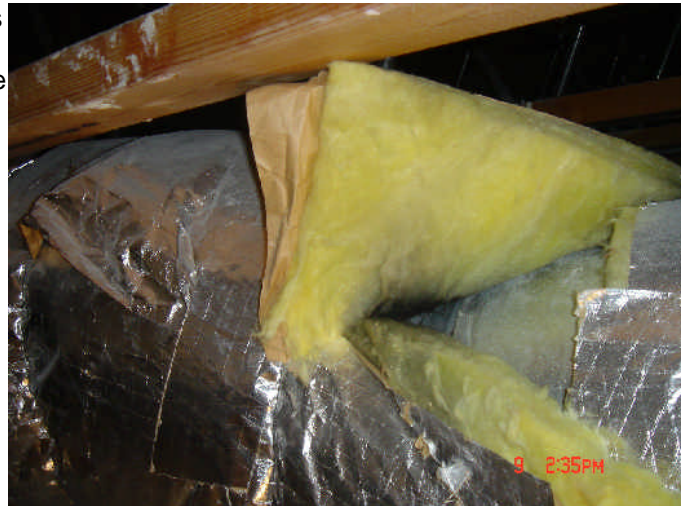
PHOTO # 58

Crushed flex duct by a metal duct. [CR]

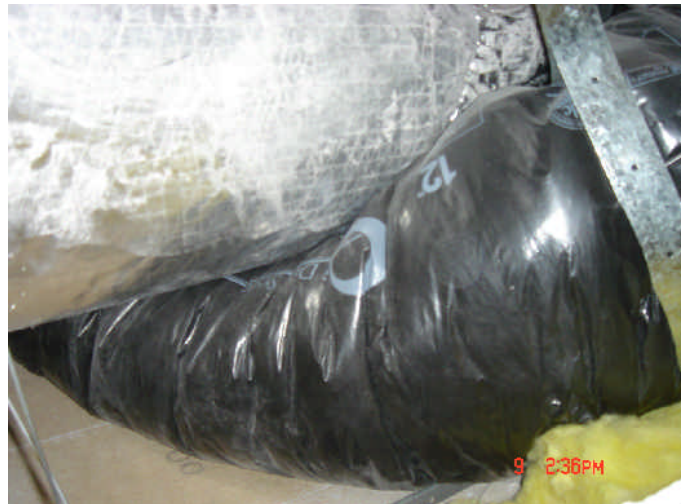
PHOTO # 59

Thin duct strap. [CR]

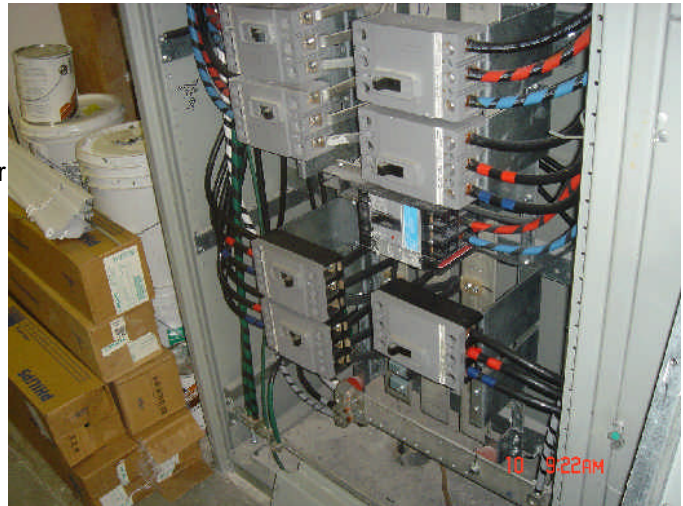
PHOTO # 64

Sub panel "H" is a 225 Amp. panel, right of the main service cabinet; no defects evident.

A second sub panel "LP" is 200 Amp on left of the main cabinet; see next picture #65

Two sub panels are located at the second floor corridor, panels "2P" & "2L" are both 200 Amp. panels; see picture #66

The first floor rear of the vacant office is a 200 Amp. sub panel marked "P-P"; this panel cover has improper screws. [CR]

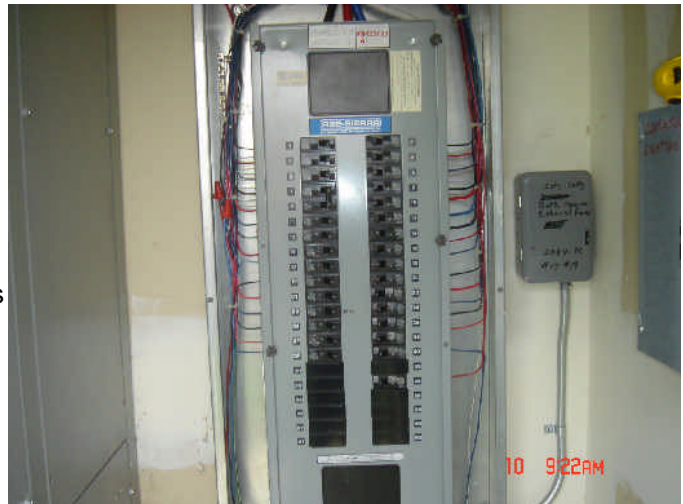
PHOTO # 65

Sub panel left of the main service cabinet has an irregular green wire attached to the box screw hole and the conduit appears to be over filled. [FE] [CR]

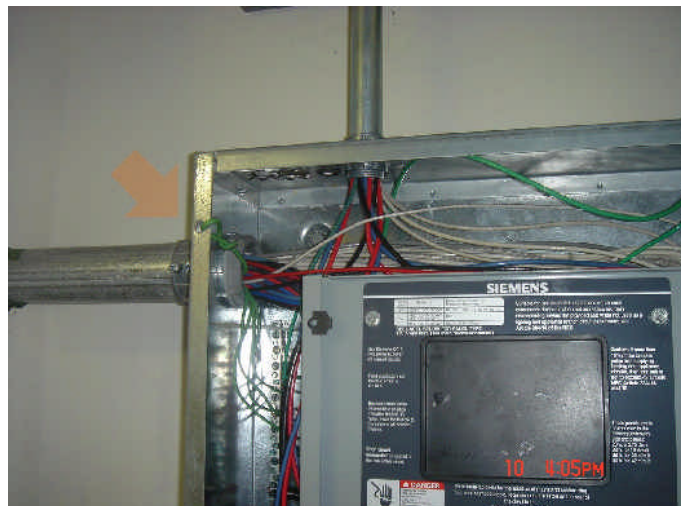
PHOTO # 66

Sub panel located at the second floor corridor at the rear of the building, has an improper added wiring in the box without a bushing, a loose bushing and a missing knockout. [CR]

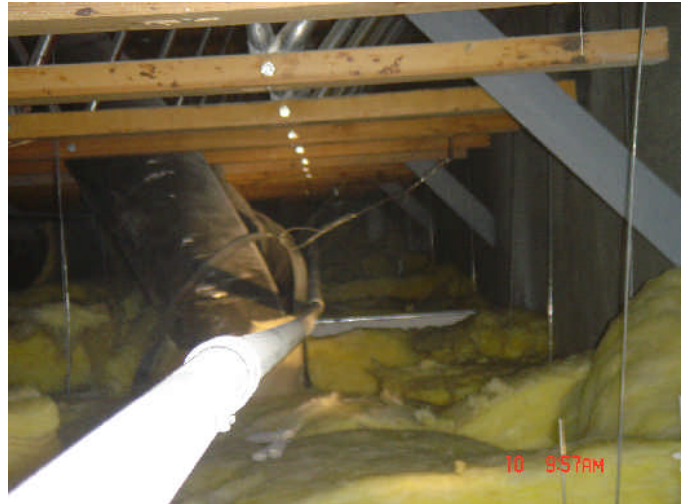
PHOTO # 68

Unsecured wiring and junction box above the second story ceiling. [FE] [CR]

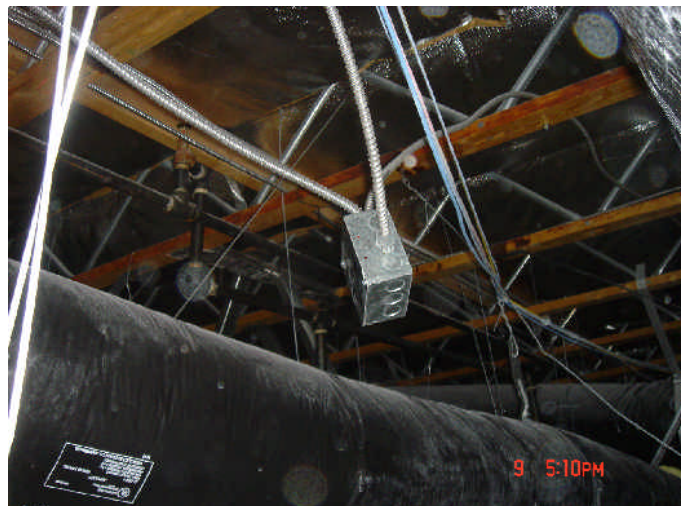
PHOTO # 69

Unsecured wiring and junction box without a cover above the second story ceiling. [FE] [CR]

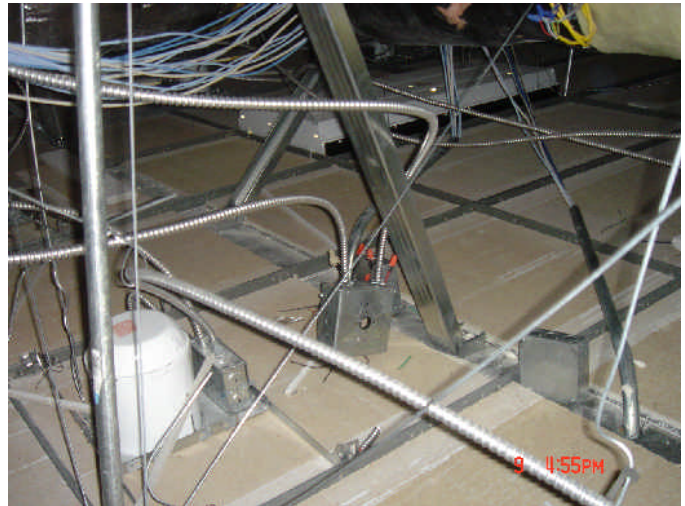
PHOTO # 70

Open junction box above the second story office ceiling. [CR]
The open end of the conduit is not sealed for fire separation, fire separation should be evaluated before the close of this Real Estate transaction. [FE]

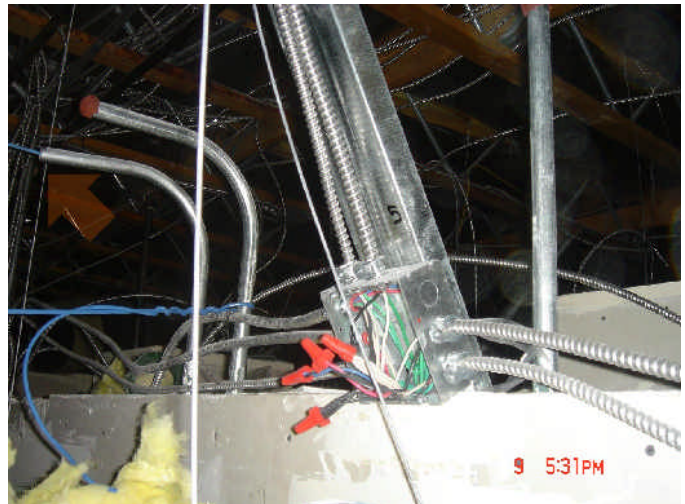
PHOTO # 71

Junction box is improperly supported on the light fixture above the second story ceiling. [CR]

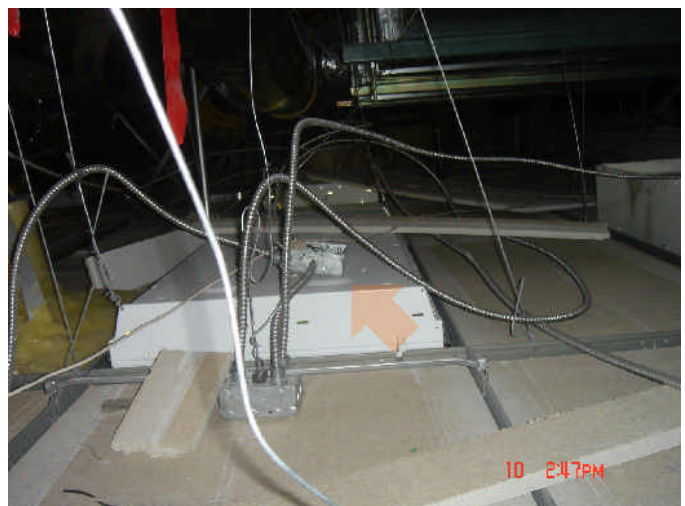
PHOTO # 72

Doubled junction boxes located above the second story ceiling is irregular and should be evaluated. [FE] [CR]

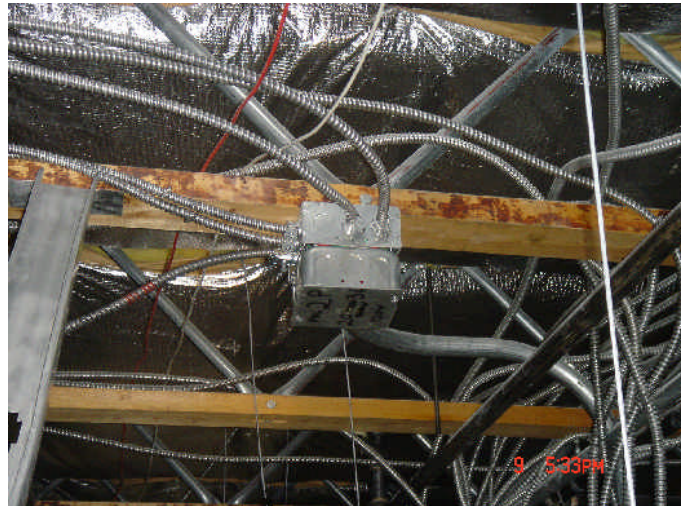
PHOTO # 73

Open junction box above the second story ceiling. [CR]

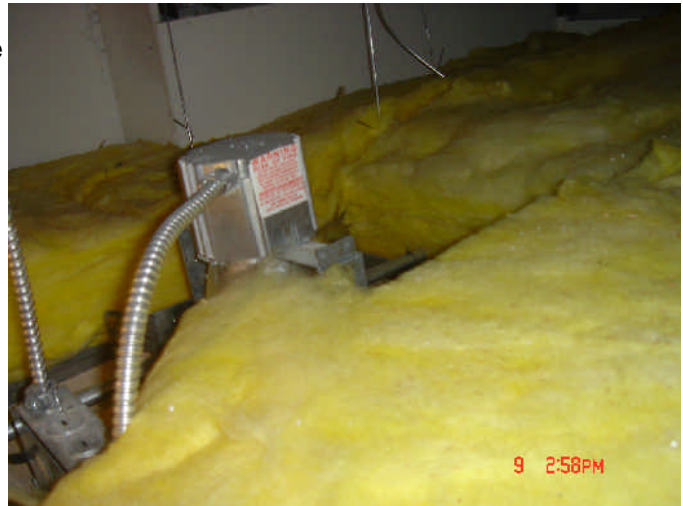
PHOTO # 76

Improperly secured light fixture at the first floor office ceiling.

All light fixtures and suspended ceilings should be evaluated for proper installation. [FE] [CR]

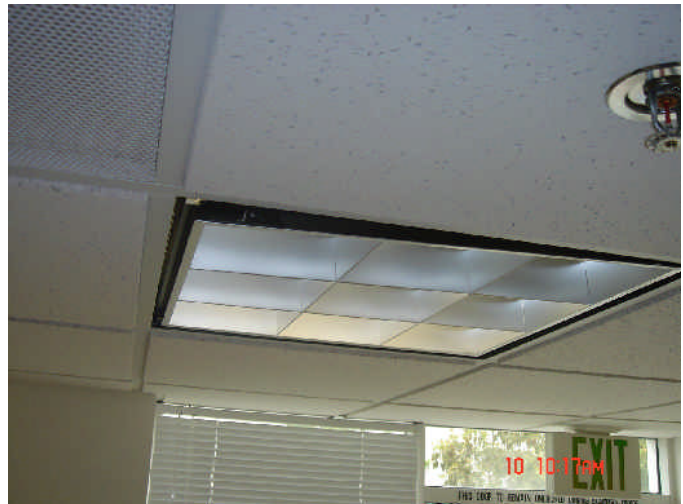
PHOTO # 77

Improper wire ties above the first floor ceiling. [FE] [CR]

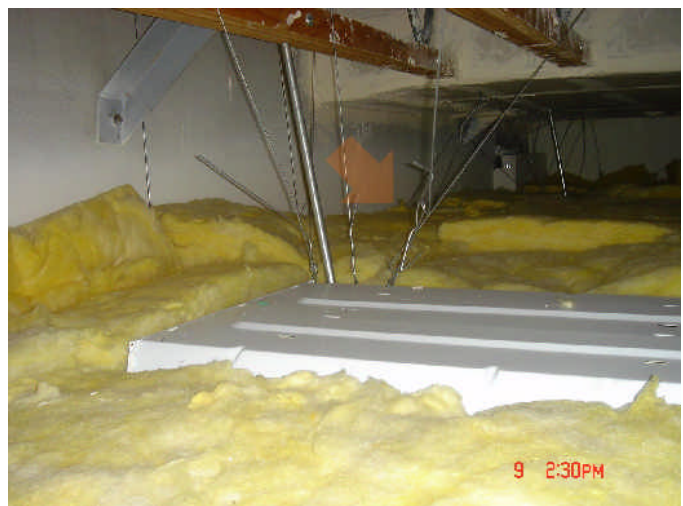
PHOTO # 78

Light fixture only secured by one wire above the first floor ceiling.
[FE] [CR]

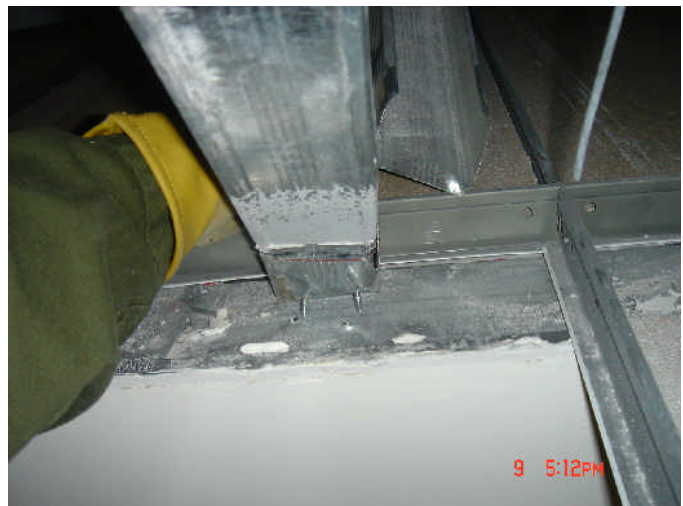
PHOTO # 90

Second picture of #89 [CR]

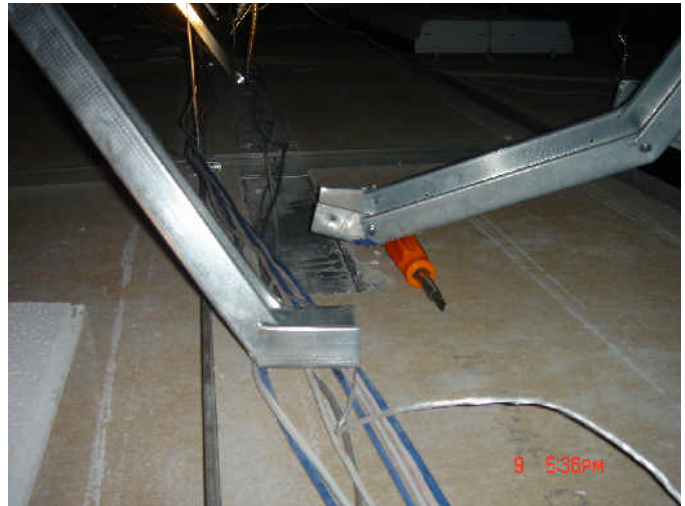
PHOTO # 91

Damaged partition wall support at the second floor office space. [CR]

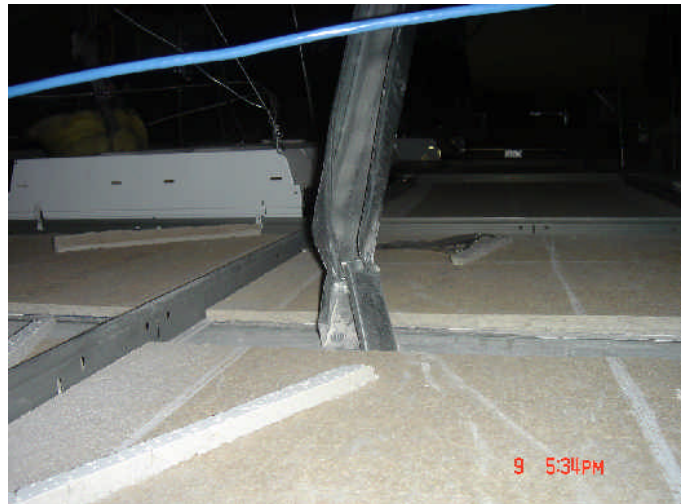
PHOTO # 92

First floor fire separation wall was not sealed at the other side of the electrical room. [CR]

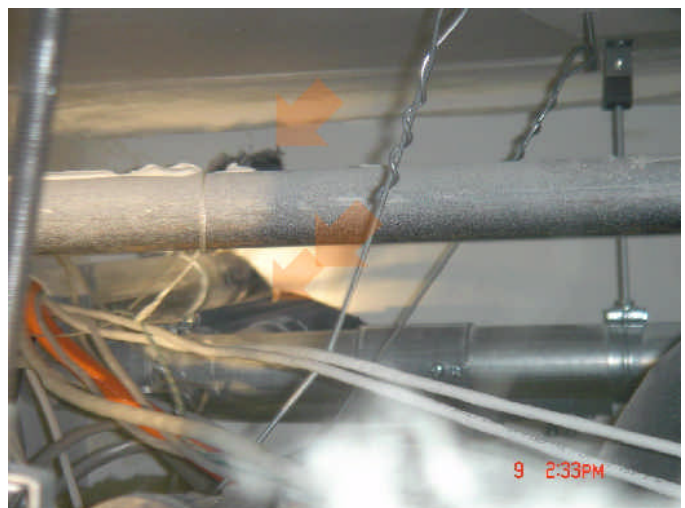
PHOTO # 93

Improper material used in place of fire caulk at the rear fire separation wall of the first floor occupied office above the ceiling. [CR]

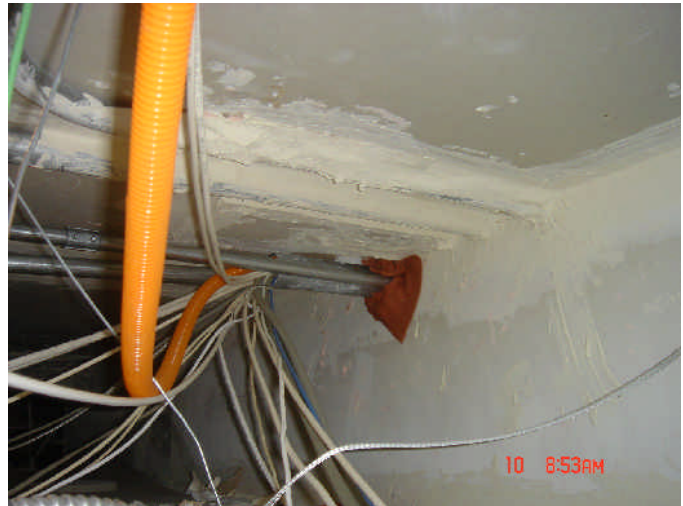
PHOTO # 94

Hole cutout at the rear of the first floor fire separation wall above the ceiling. [CR]

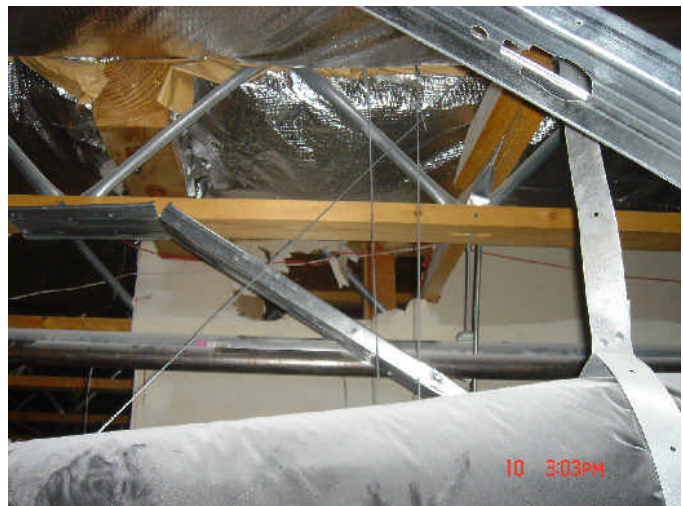
PHOTO # 96

Large hole made in the fire separation wall above the second floor occupied offices.
[CR]

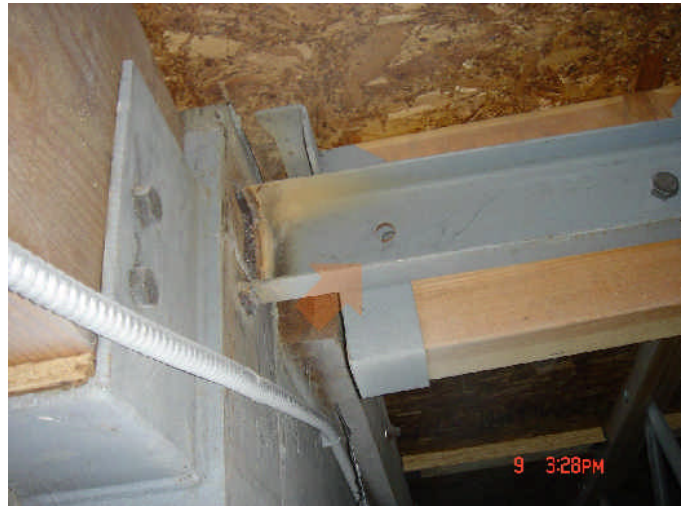
PHOTO #100

Second picture of #99, second lag bolt missing. [FE] [CR]

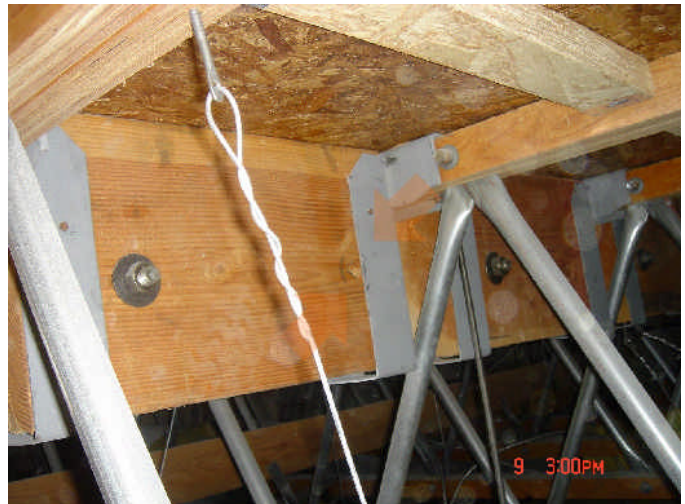
PHOTO #101

Third picture of #99, a third bolt missing. [FE] [CR]

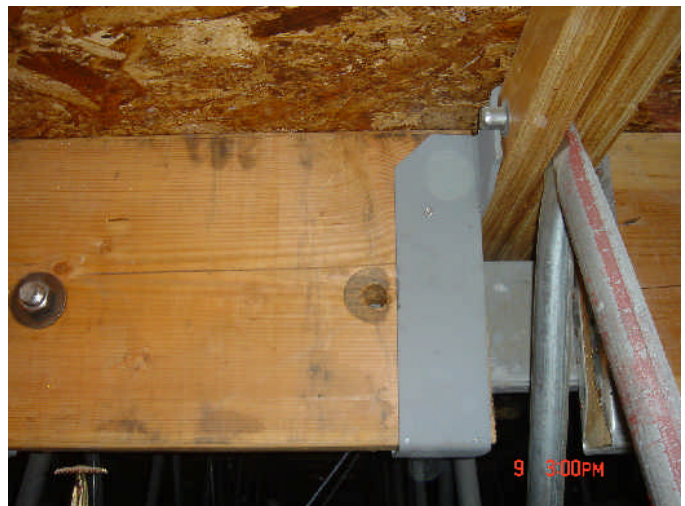
PHOTO #102

Second story floor framing support system at the front of the building is unconventional and should be evaluated with the building plans. [FE]

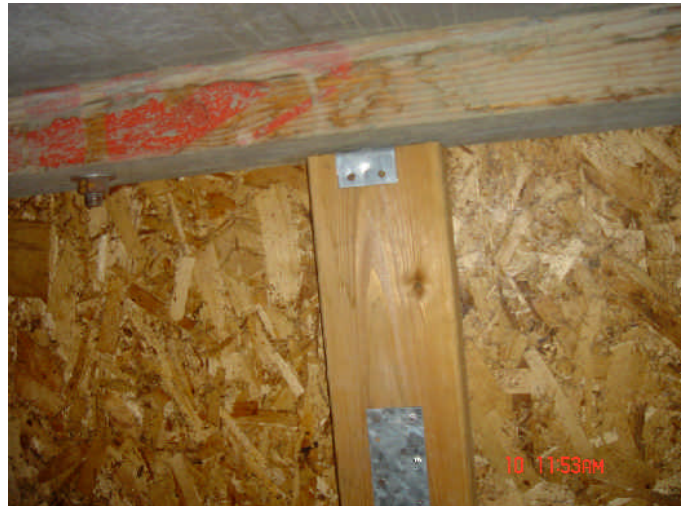
PHOTO #103

Second picture of #102 appears to be a drag strap, irregular installation. [FE]

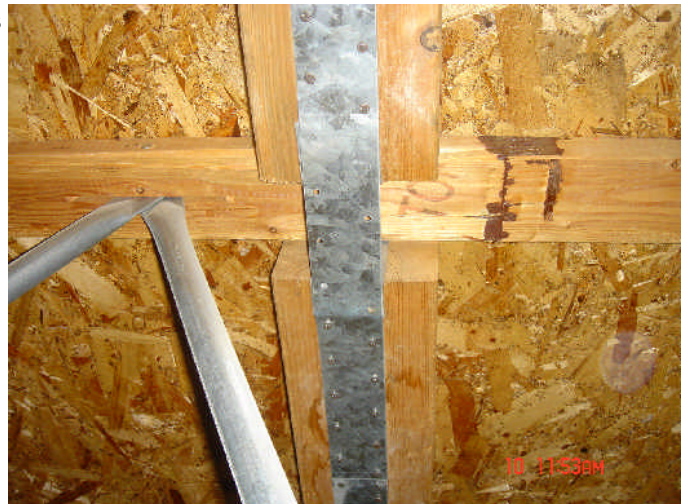
PHOTO #104

Third picture of #102, strap is not continuous and not connected to the exterior wall. [FE]

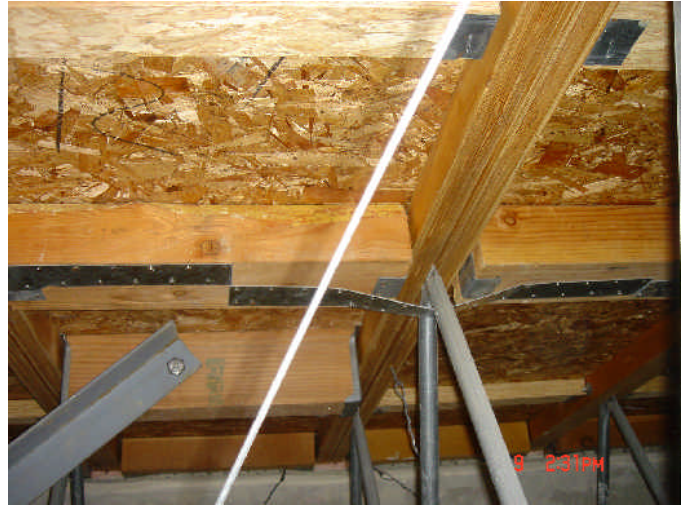
PHOTO #105

View at the rear of the building second floor framing, irregular installation of a drag strap. [FE]
[CR]

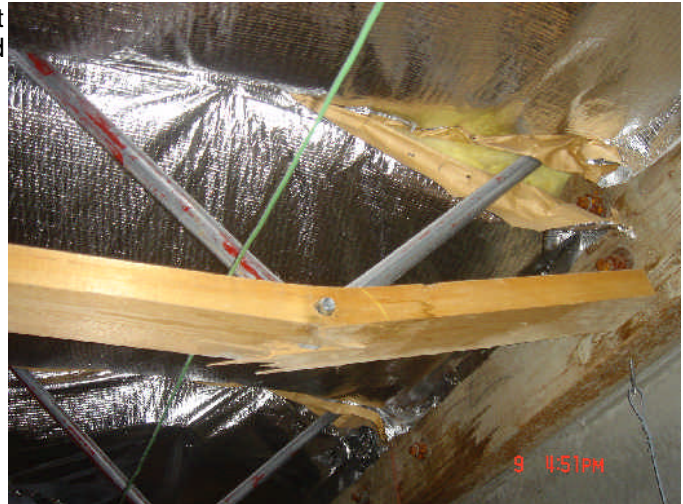
PHOTO #106

Broken truss cord at the rear left of the building below the second story floor. [CR]
