Building Inspection *Photo Documentary Report*

12 Journey, Aliso Viejo, CA. 92656

Steve Garcia Inspections

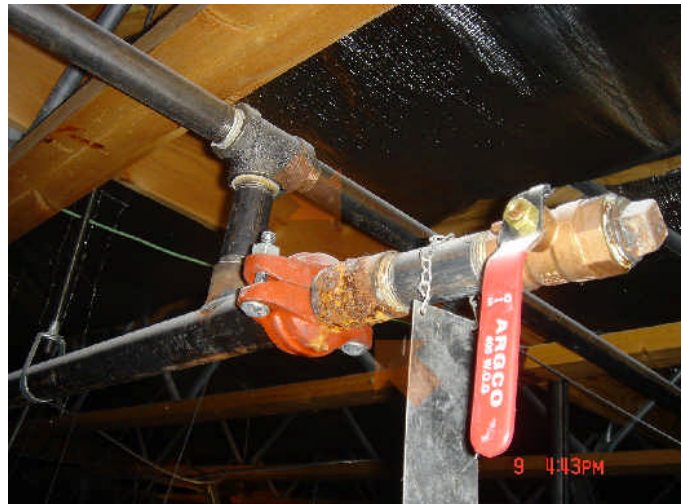
PHOTO #107

Fire sprinkler fitting with excessive rust is located at the rear left of the first floor. [CR]

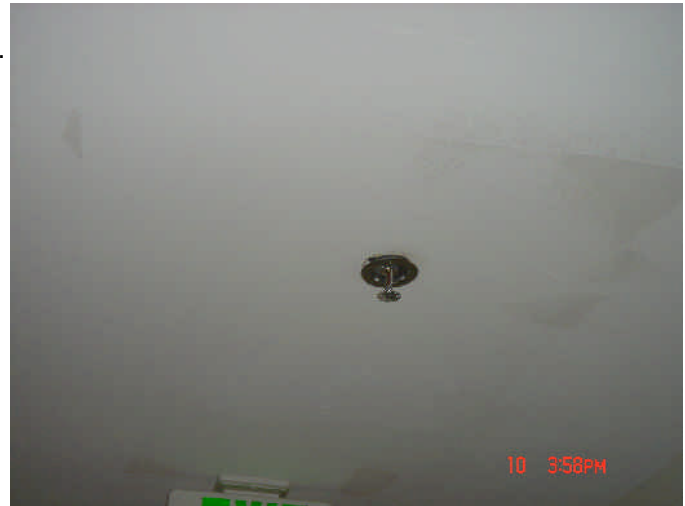
PHOTO #108

Fire sprinklers escutcheons have gaps between the ceilings.
[FE] [CR]

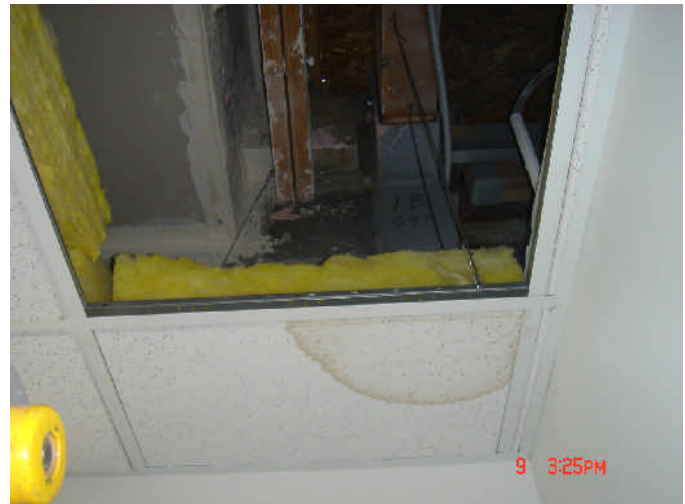
PHOTO #109

View of the first floor vacant office water stain below the exterior wall joint.

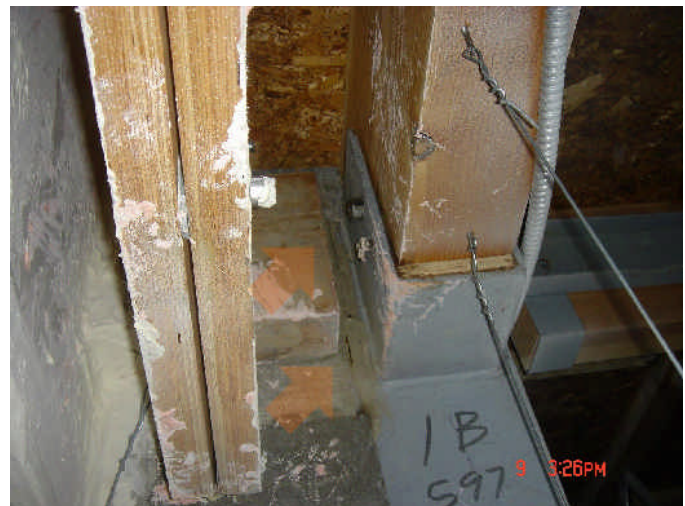
PHOTO #110

Second picture of #109 of the leaky wall joint. [FE] [CR]

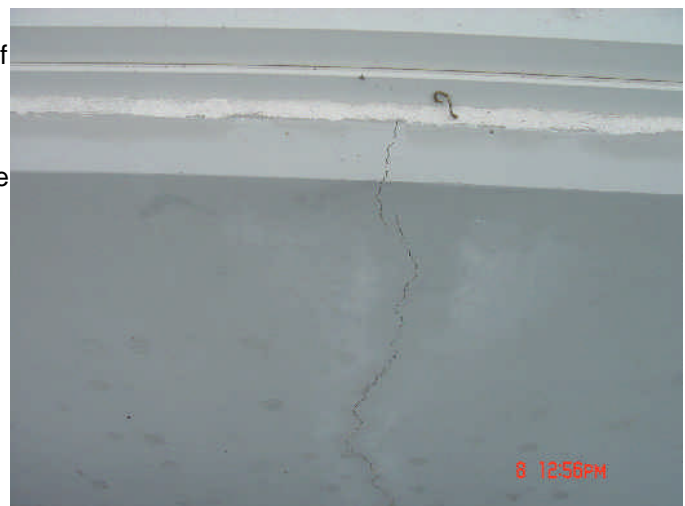
View of the largest building wall crack that is visible at the rear of the building is approximately 1/16". [FE]

Patching of the exterior concrete wall surface was noticed at the front right of the entry about halfway up the wall. [FE]

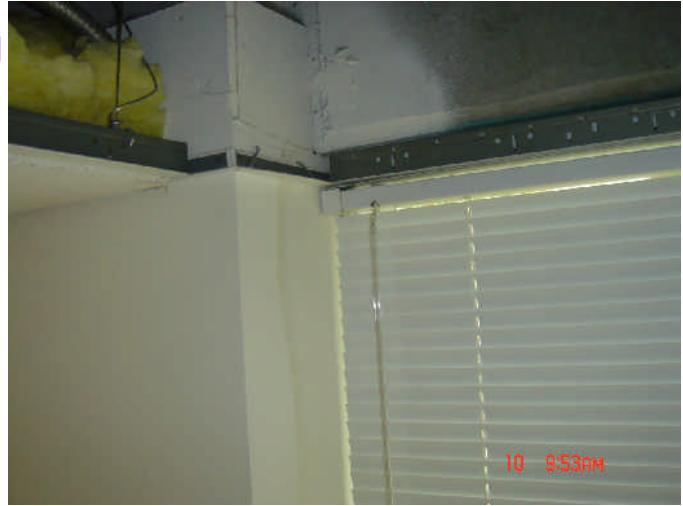
PHOTO #114

Water stain at the south side of the first floor office window. [FE]

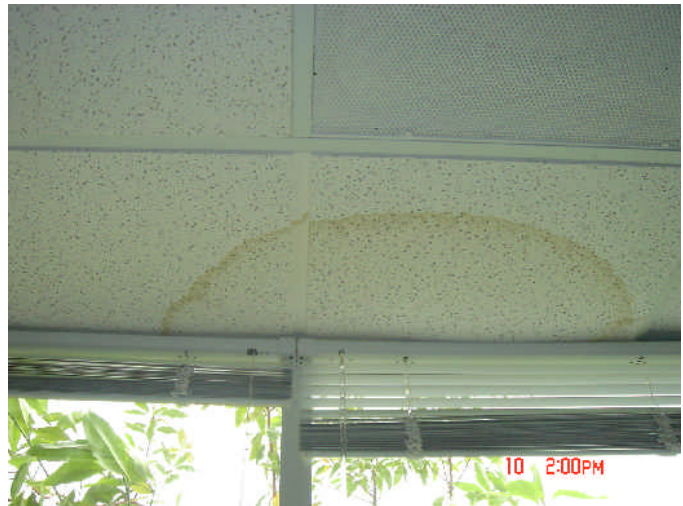
PHOTO #115

Second picture of #114.

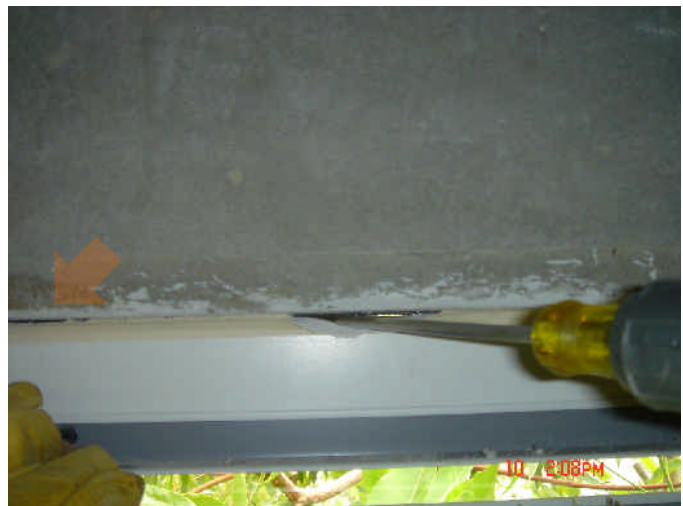
PHOTO #116

Third picture of 114, at the top of the window frame improper sealant is separating. [FE][CR]

The window manufacturer should be contacted to evaluate the windows installation.

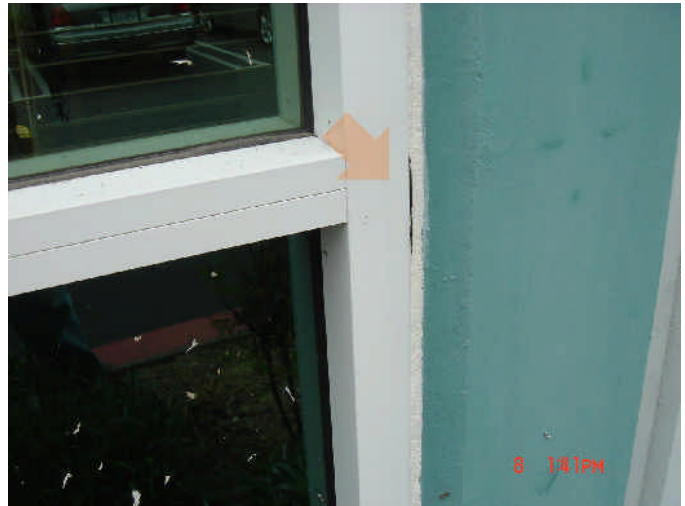
PHOTO #117

South side window caulking is separating and deteriorating.
[FE] [CR]

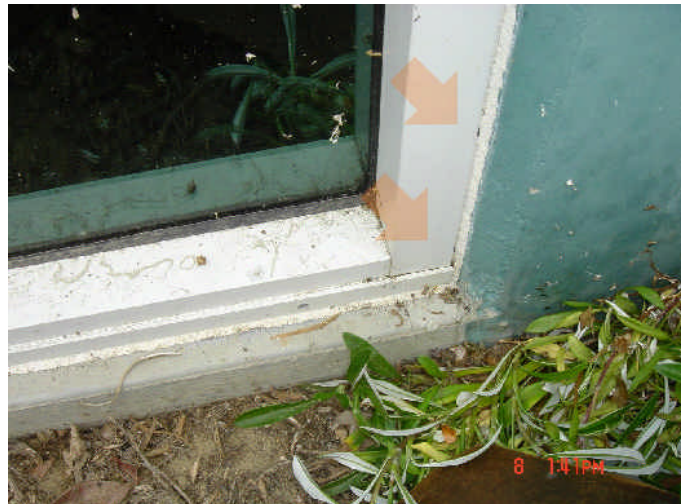
PHOTO #118

Second picture of #117.

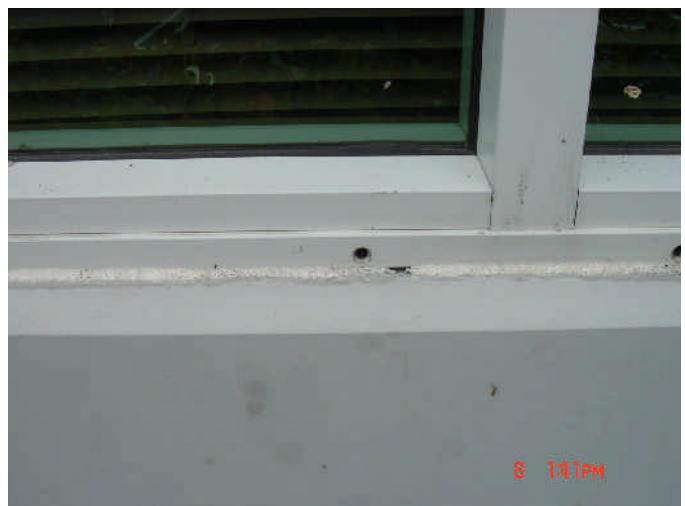
PHOTO #119

Third picture of #117.

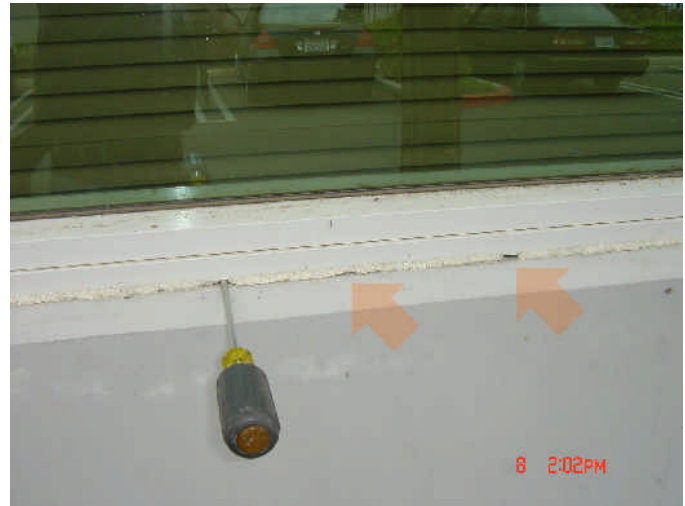
PHOTO #120

Fourth picture of #117.

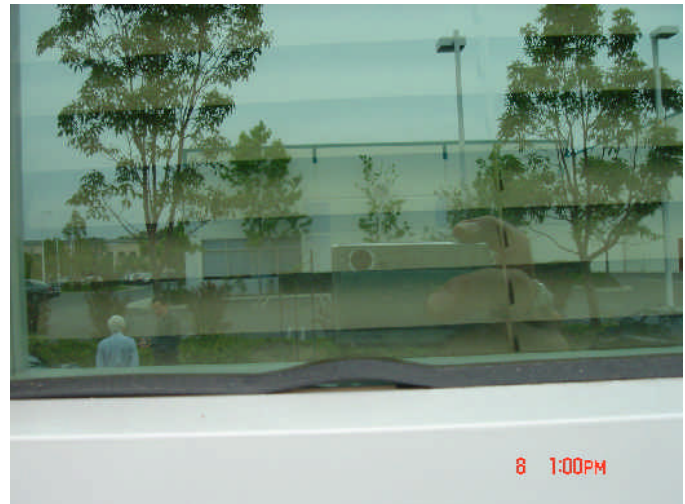
PHOTO #121

North side rubber is separating from the frame and glass. [FE] [CR]

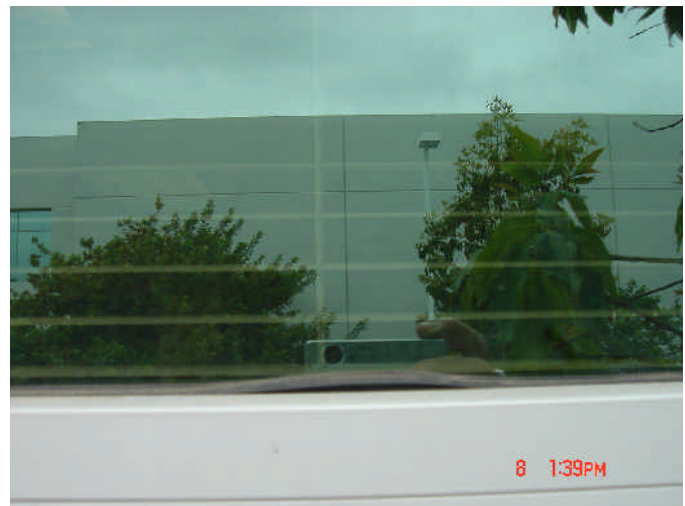
PHOTO #122

Second picture of #121.

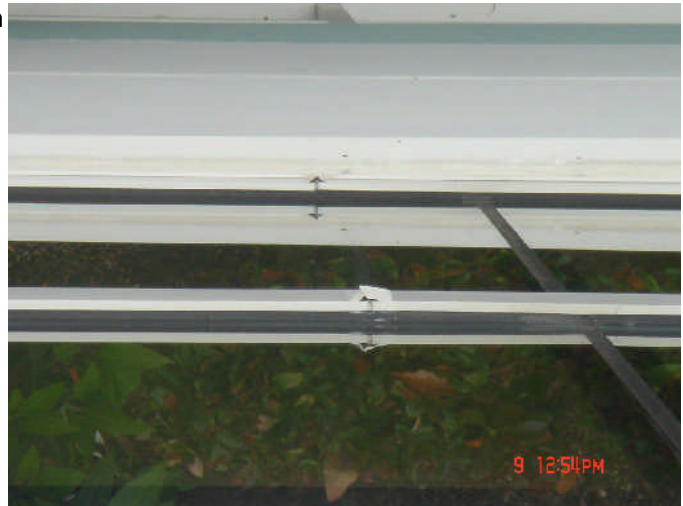
PHOTO #123

View from the roof looking down at the south side second story window, of possible separations in the window frame. [FE] [CR]

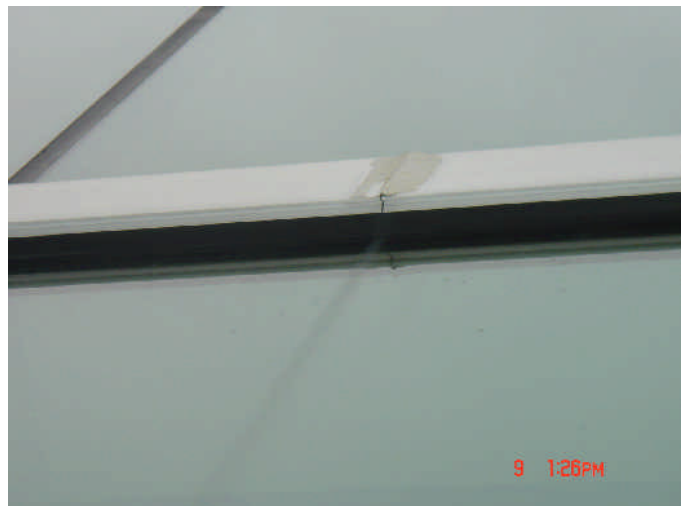
PHOTO #124

Second picture of #123.

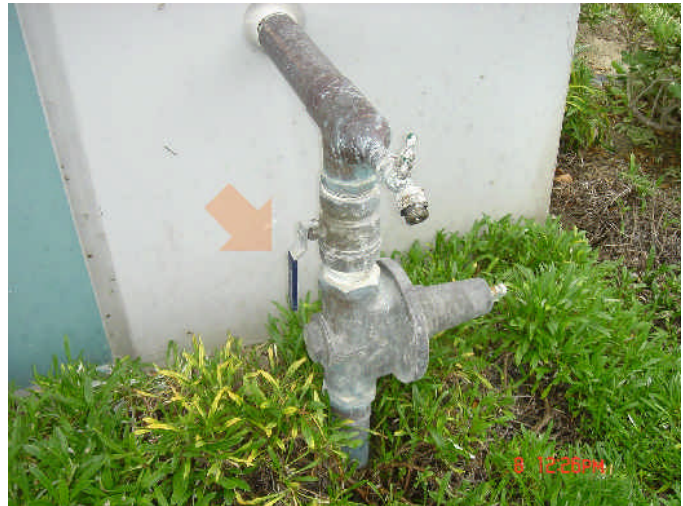
PHOTO #129

Main water supply valve at the street side of the building was not operational. [CR]

The supply line is a 2 1/2 " copper pipe, the water pressure was 63 Psi.

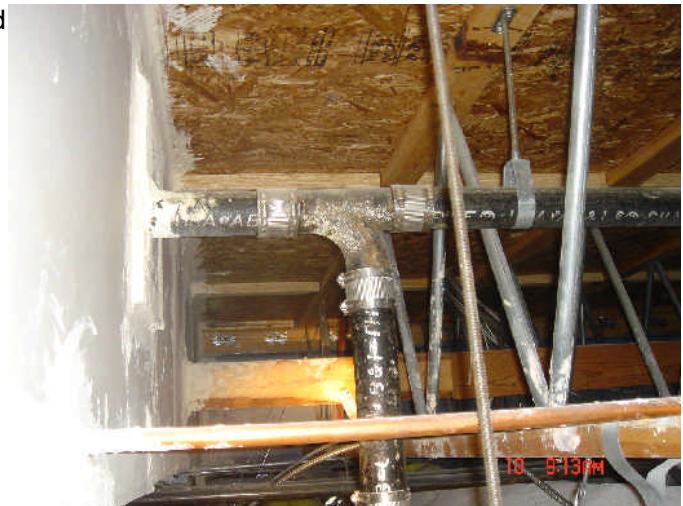
PHOTO #130

View of an improperly supported cast iron pipe joint with a questionable transition fitting adjacent to first floor restrooms. [FE] [CR]

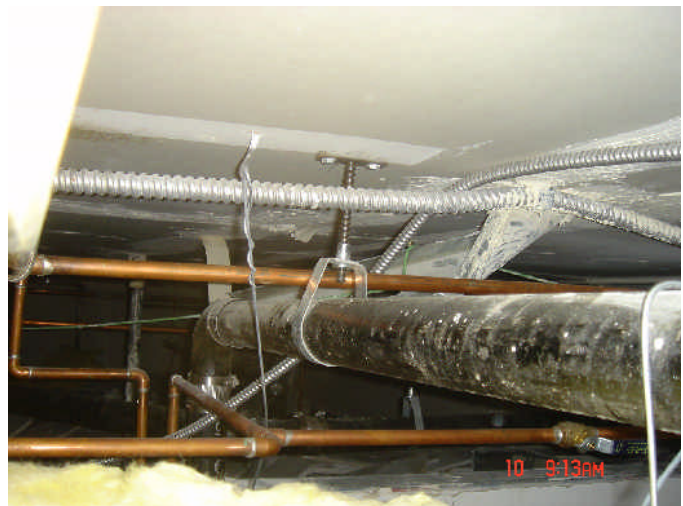
PHOTO #131

1/2" type L copper water supply pipe improperly in contact with cast iron drain pipe support, adjacent to the first floor restrooms. [CR]

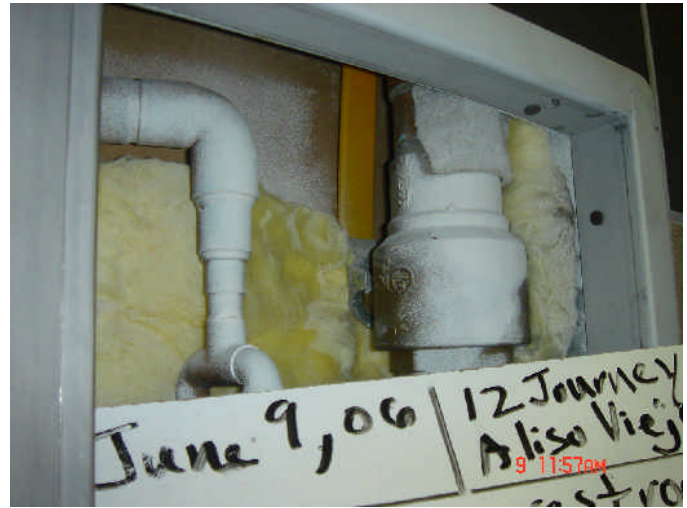
PHOTO #132

Cold water 1/4 turn ball shut-off valve in second floor woman's restroom handicap stall has been installed on the opposite side of the access opening and was not able to be turned. [CR]

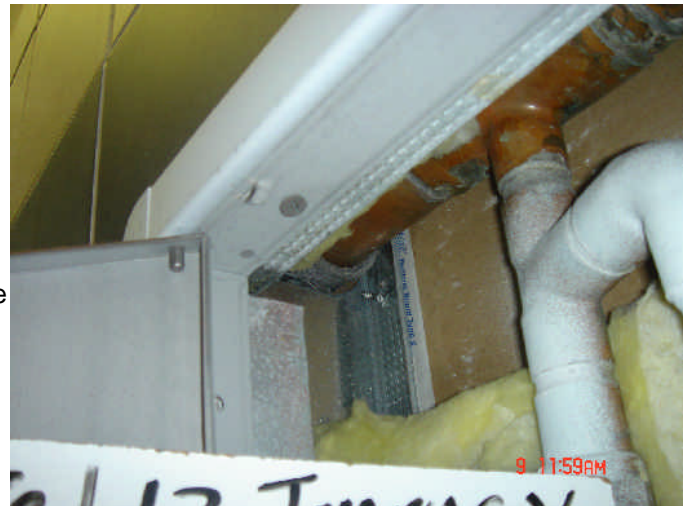
**PHOTO #133**

Upper copper pipe is unprotected too close to the drywall in same compartment described in previous picture. [CR]

Note the drywall is labeled type X denoting the possibility of a firewall separation between restrooms, if this is the case, the access door is improper. [FE] [CR]

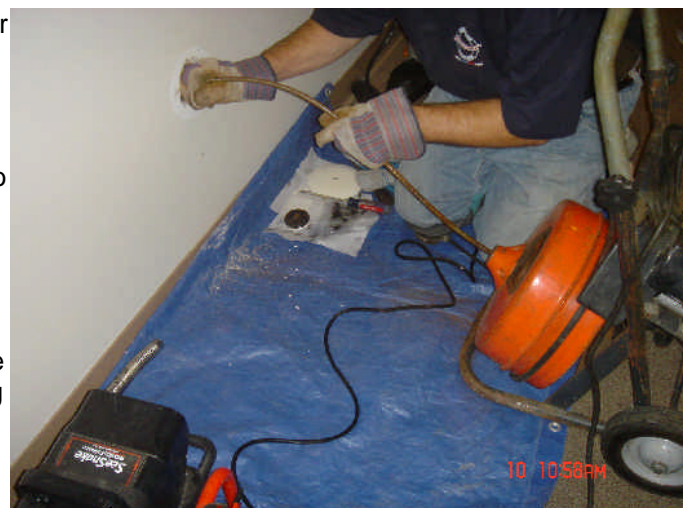
**PHOTO #134**

Cleanout located in the first floor main corridor.

Plumber ran the snake until it stopped at 75 feet followed by the camera which was unable to reach the stopping point of the snake or the building drain termination point at the exterior of the building.

We recommend hydrojetting the system and locating or installing a cleanout at the building drain termination point. [FE] [CR]

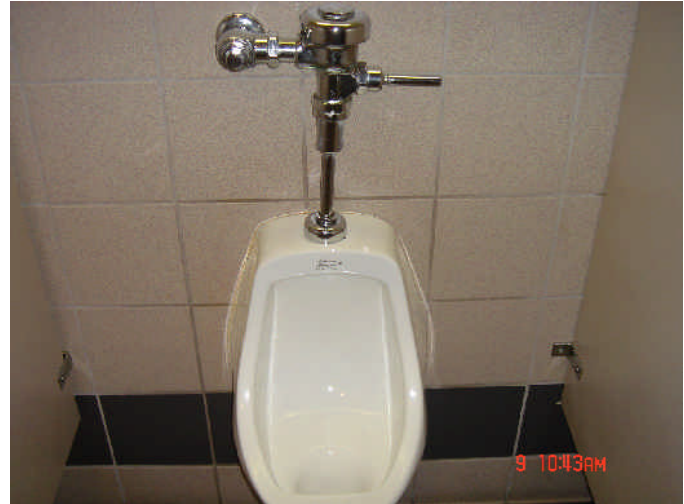
PHOTO #135

First floor men's restroom urinal has moved 1/4" from the location it was caulked at, making the flushvalve out of level.

Other flushvalves were also found to be out of level. [FE] [CR]

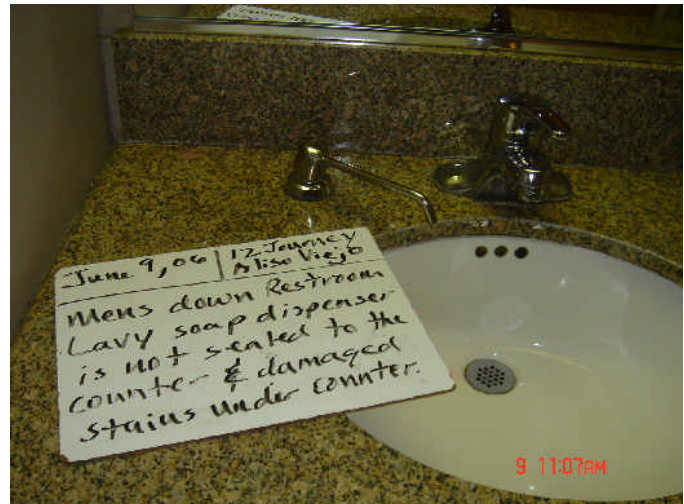
Fixtures including lavatory not properly sealed to the countertop.

This condition is typical throughout the restrooms. [CR]

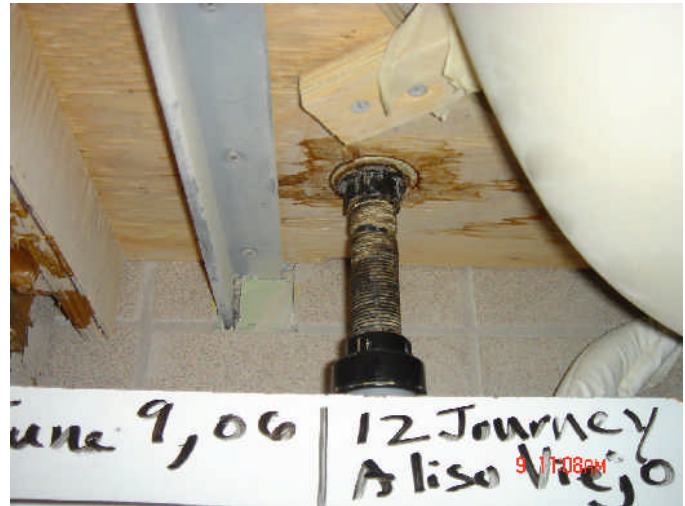
PHOTO #141

Signs of leakage under the restroom countertops at the fixture cut-outs typical throughout the bathrooms. [CR]

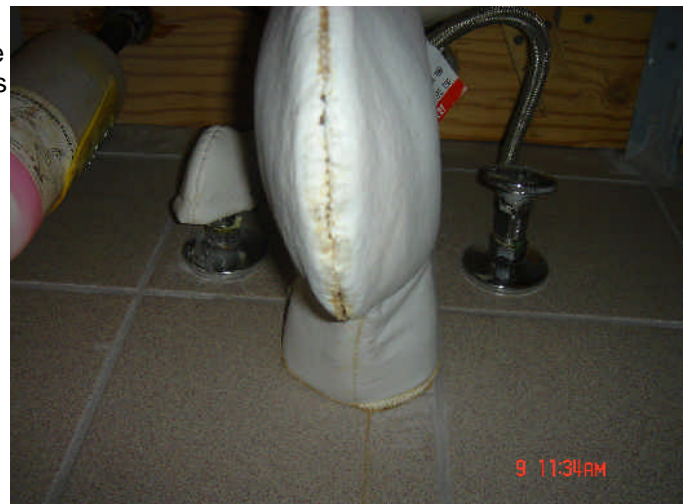
PHOTO #146

Lavatory under-counter drain cover shows water stains on the seams in the second floor men's restroom. [FE] [CR]

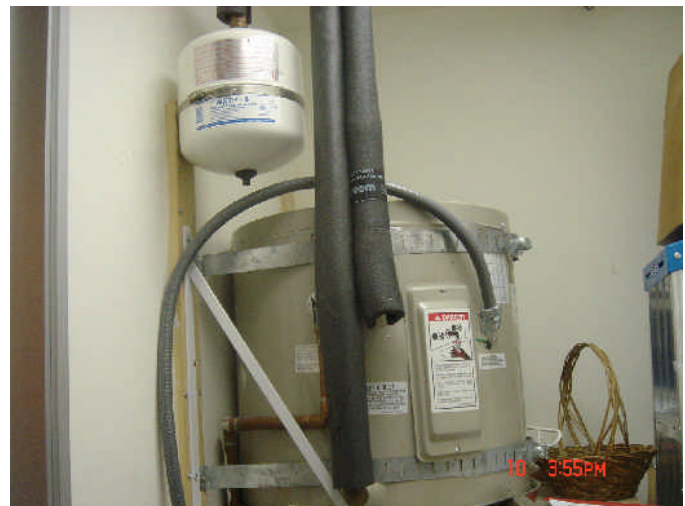
PHOTO #152

20 gallon, 6 year old, 208 volt, 3000 watt electric water heater located in the janitor's closet in the first floor women's restroom with no defects observed.

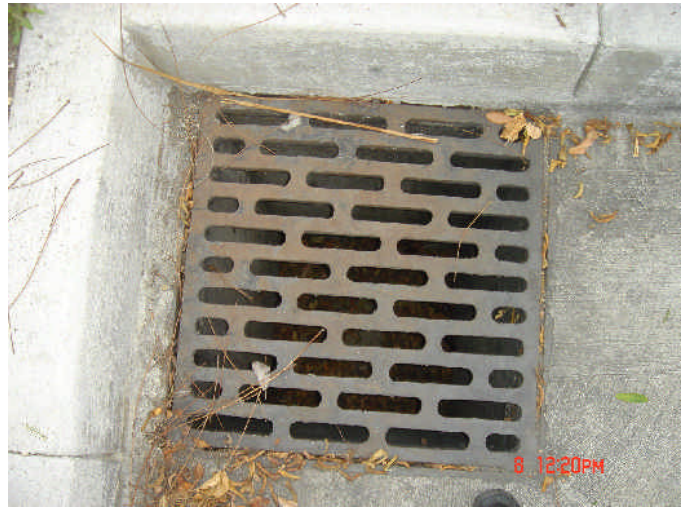
PHOTO #156

The sole surface drain for the parking area located at the southwest corner of the parking area should be cleaned and properly maintained. [CR]

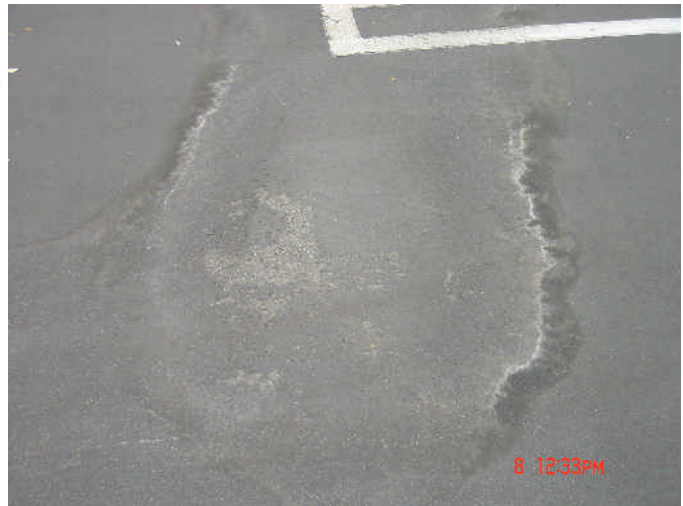
PHOTO #157

Picture of the parking area surface at the north side of the parking area deteriorated by the obvious puddling of water.

This area and any areas like it should be properly maintained.

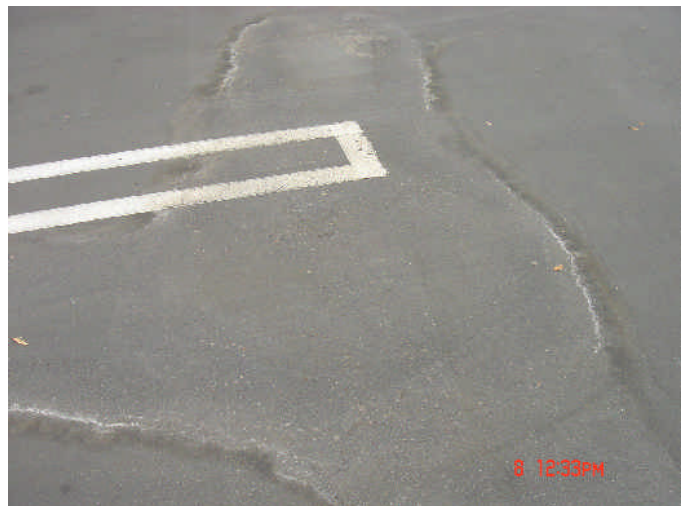
PHOTO #158

Area adjoining the area shown in picture #157 showing the same condition.

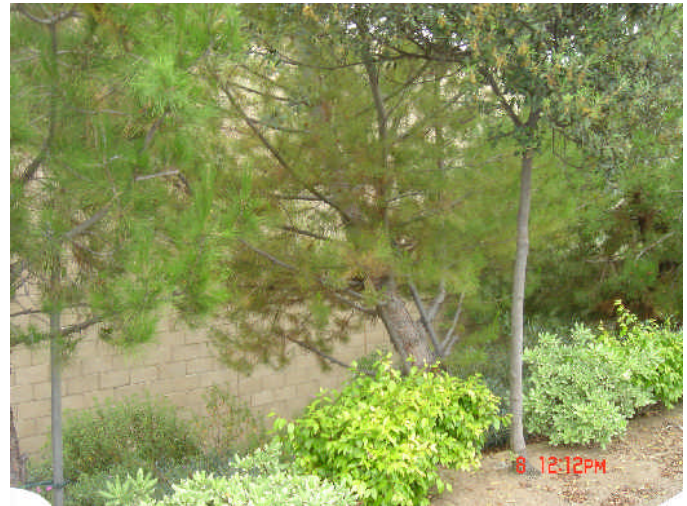
PHOTO #159

Landscape area at the southeast corner of the lot contains a steep slope out of which a tree is growing.

This tree may be falling. [FE]
[CR]

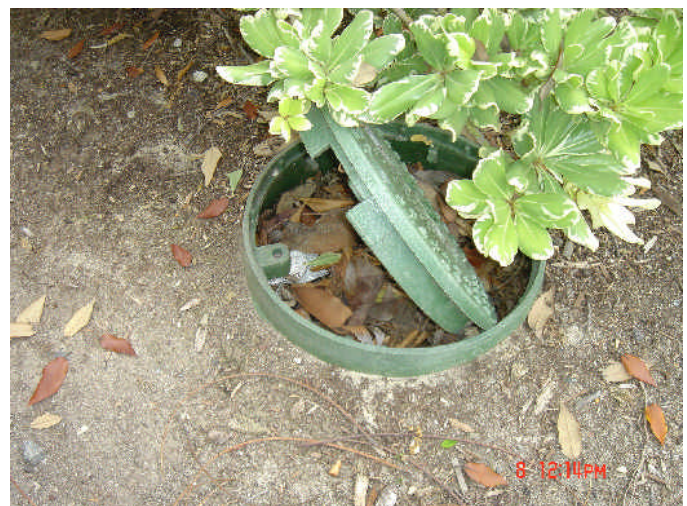
Landscape Sprinkler box found in the open position, filled with debris.

Sprinkler systems are outside the scope of this inspection but should be evaluated and properly maintained. [FE] [CR]
